Comprehensive Building Assessment

Rentschler Field at Pratt & Whitney Stadium

September 7, 2022
DRAFT FOR
DISCUSSION ONLY

CRDA | Capital Region
Development Authority

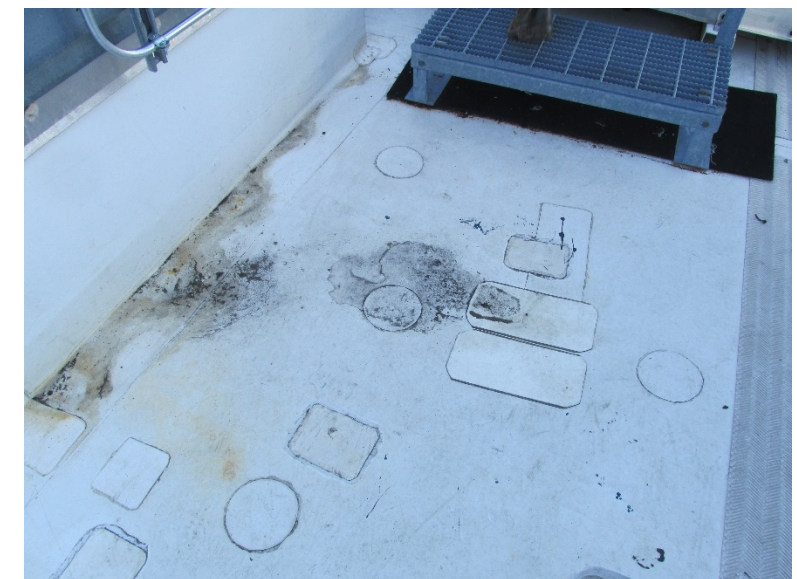
Tower Building: The existing low-slope TPO single-ply membrane roof covering systems generally appear to be in very poor condition. There are active moisture leaks into the building interior that, we were informed, have not yet been addressed. We understand that the TPO roofing/flashing membrane has previously sustained burns/damage/leakage in many places, resulting from pyrotechnics/fireworks that were previously launched from the roofs. There are numerous patches/repairs throughout the Tower Building roofs. It was also noted that the membrane base flashings surrounding an equipment curb (west penthouse roof) are delaminated from the field roof membrane, and non-watertight. Based upon a visual examination of the roof covering system, it is evident that there is substantial moisture saturation of the roof insulation and roof deck substrate beneath the roof membrane, and it is very likely that an extensive portion of the roof insulation/underlayments and the concrete roof deck are moisture-saturated.

There are numerous small patches in the TPO roof membrane on the main roof of the Tower Building. We were informed that many such patches result from burns to the membrane from pyrotechnics/fireworks being detonated from the roof, as well as foot/equipment traffic on the roofs associated with the several cellular telephone/data system carriers and their equipment.

In our opinion, the single-ply membrane roof covering systems on the Tower Building require complete removal/replacement, as soon as fiscally possible.

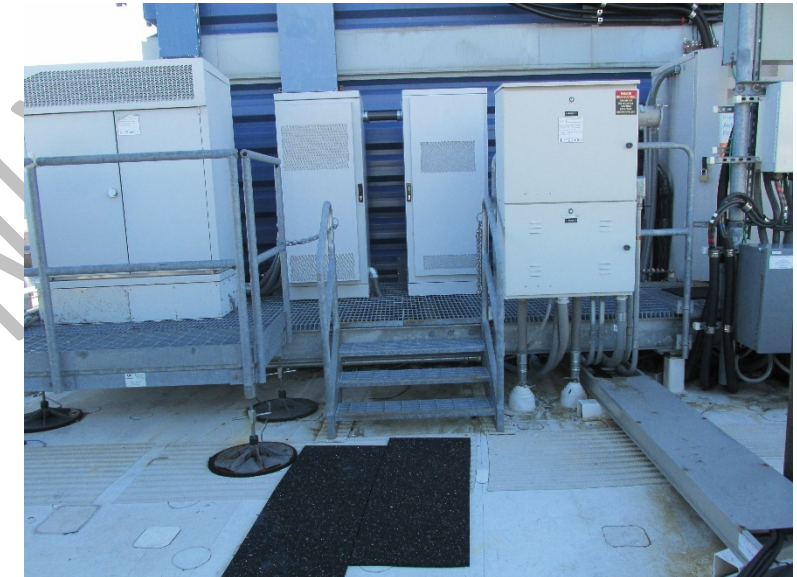
A labyrinth of telecom equipment/cabling is installed atop the Tower Building roofs. The equipment is installed, operated, and maintained by several independent cellular carriers, and much of this equipment is installed directly atop the surface of the roof covering system, often with little or no protection of the roofing/flashing membrane.

2. Tower Building: Coordinate with all telecom carriers with equipment/cabling on the roofs, for temporary removal/reinstallation of their equipment from the roofs, so as to provide full access to all areas of the roofs, for removal/replacement of the roof covering systems. Completely remove the existing roof covering systems, including all membrane, insulation/underlayments, sheet metal flashings, etc., down to the concrete roof deck. Make all necessary repairs to any damaged/deteriorated roof deck/ substrates. Allow the concrete roof deck to properly dry, prior to applying new insulation/roofing materials. Make repairs to the existing drainage elements or remove/replace the roof drains/overflow drains. Install a new roof insulation assembly, to meet current codes for thermal efficiency and wind uplift. Install a new single-ply membrane roof covering system that is fully-adhered to the roof insulation assembly/substrate, and to comply with current wind uplift requirements. Install all new pre-finished sheet metal flashings associated with the roof replacement. Design and install new fall protection equipment (that may also include reinstallation of exiting equipment, to meet current codes/safety requirements. Install safety/fall protection equipment, to comply with current codes/regulations.

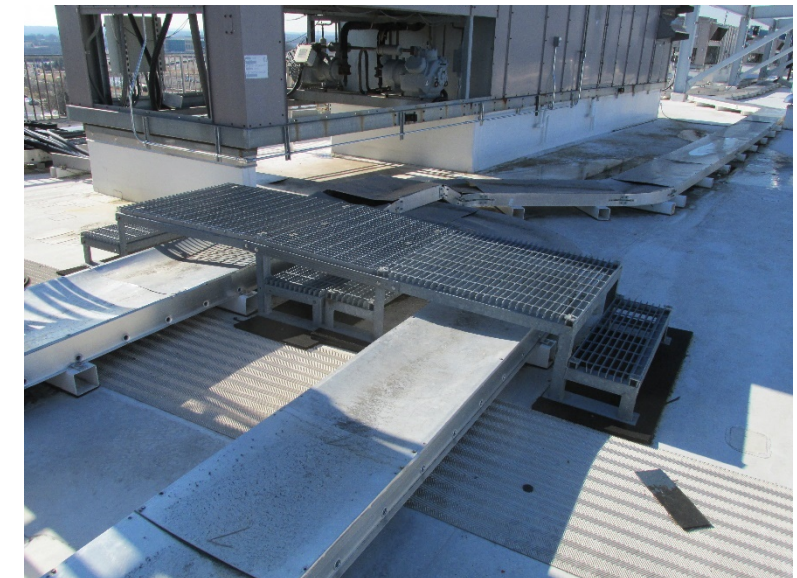
A small portion of the rooftop telecom equipment is supported above the roof on steel dunnage; however, there is insufficient clearance beneath the equipment/dunnage to accommodate access to the roof covering systems for maintenance/repair/replacement.

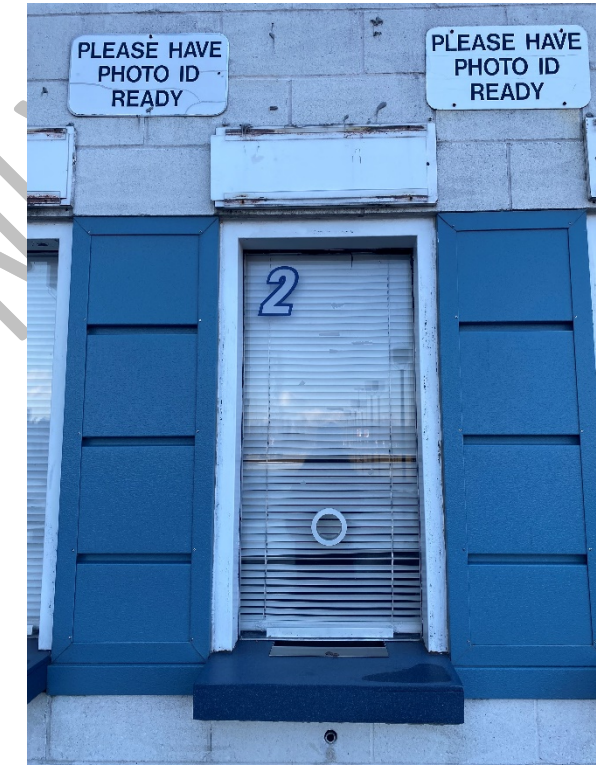
Ticket window at end of life.

Ticket window at end of life - rust observed; window shades at end of life

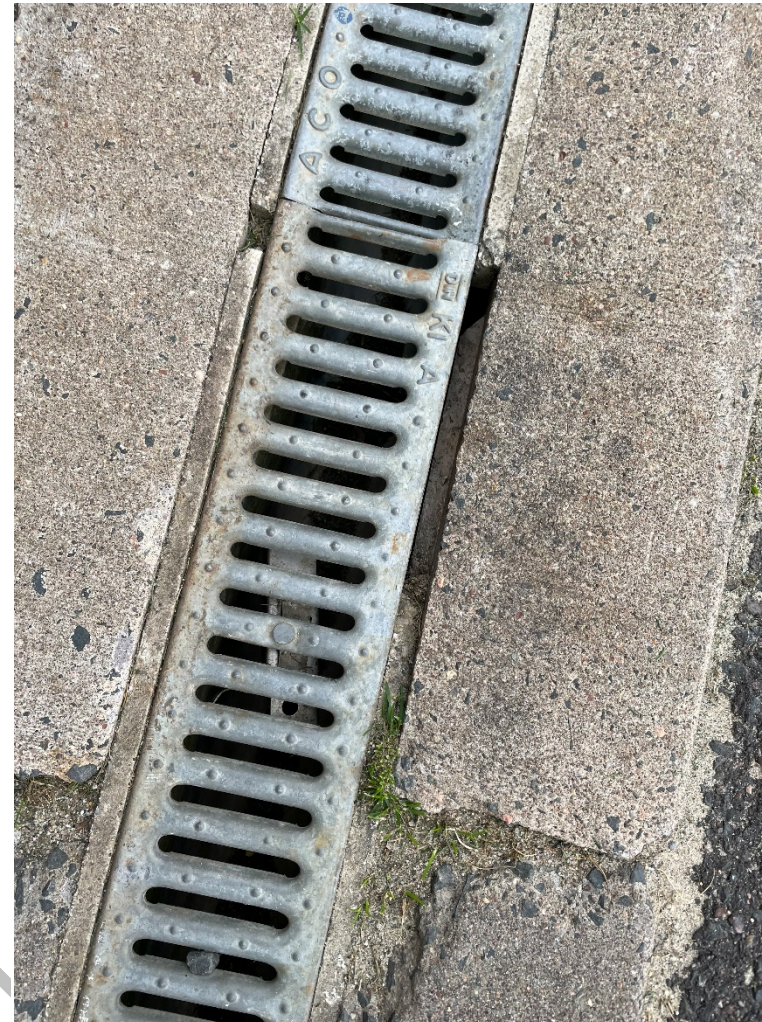
The perimeter trench drains are significantly damaged, displaying broken drain edges and damaged grates. Additionally, the installed grates do not appear to be rated for truck traffic at the field access tunnel.

Broken trench drain edge

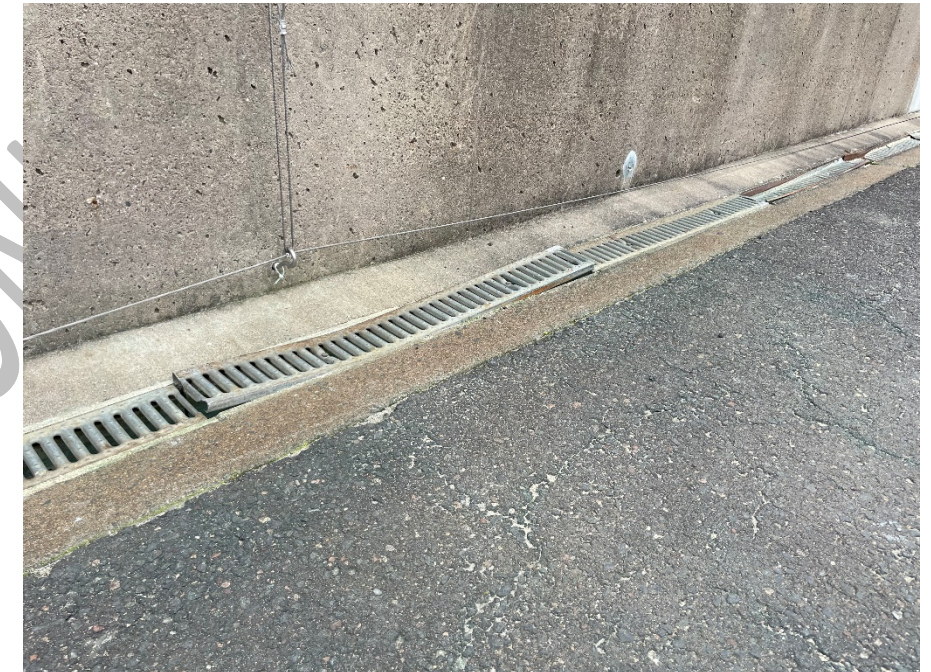
Damaged trench drain grates

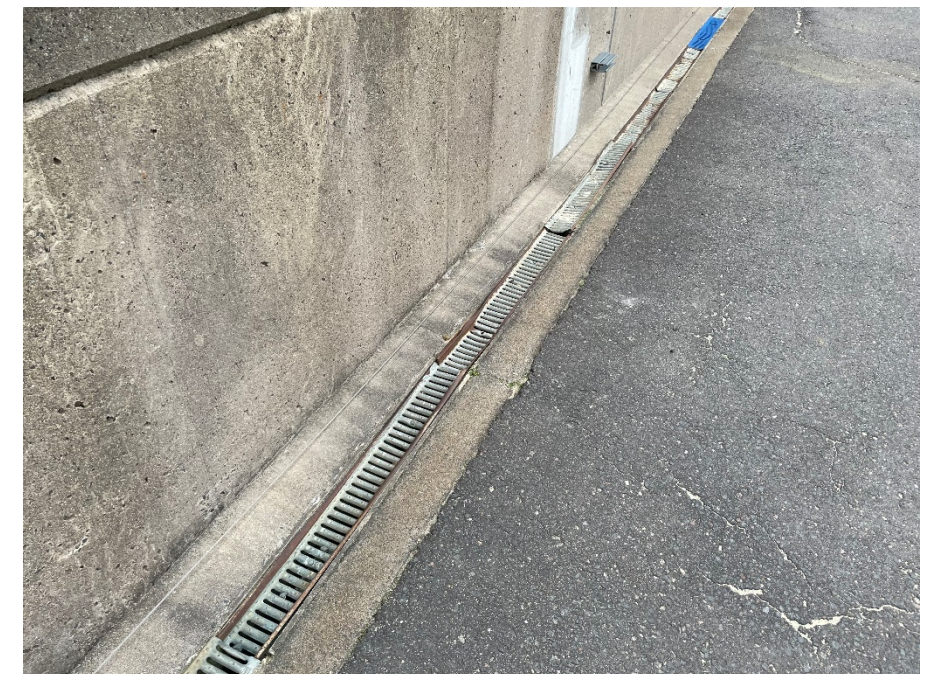
Damaged trench drain grates

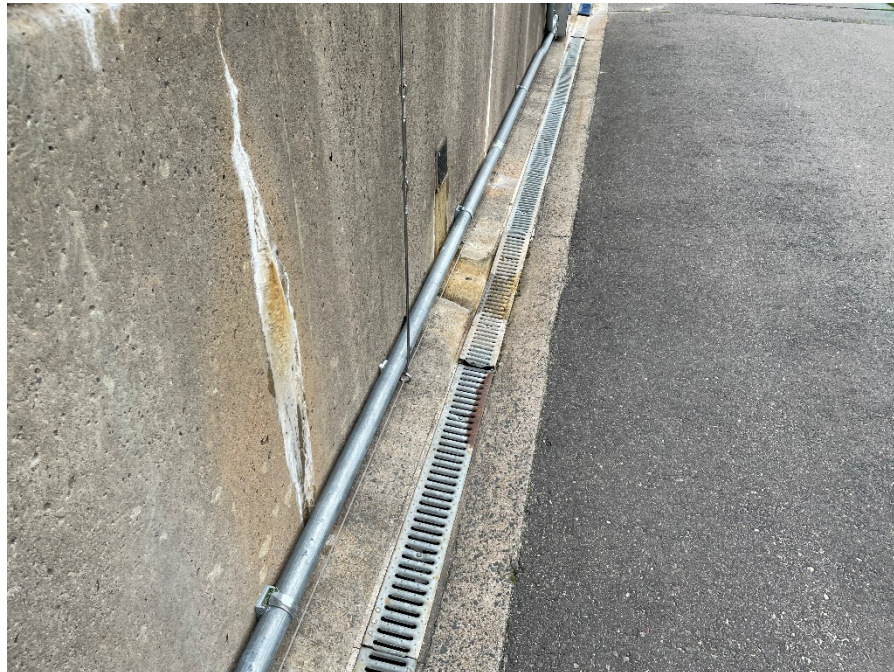
Damaged trench drain grates

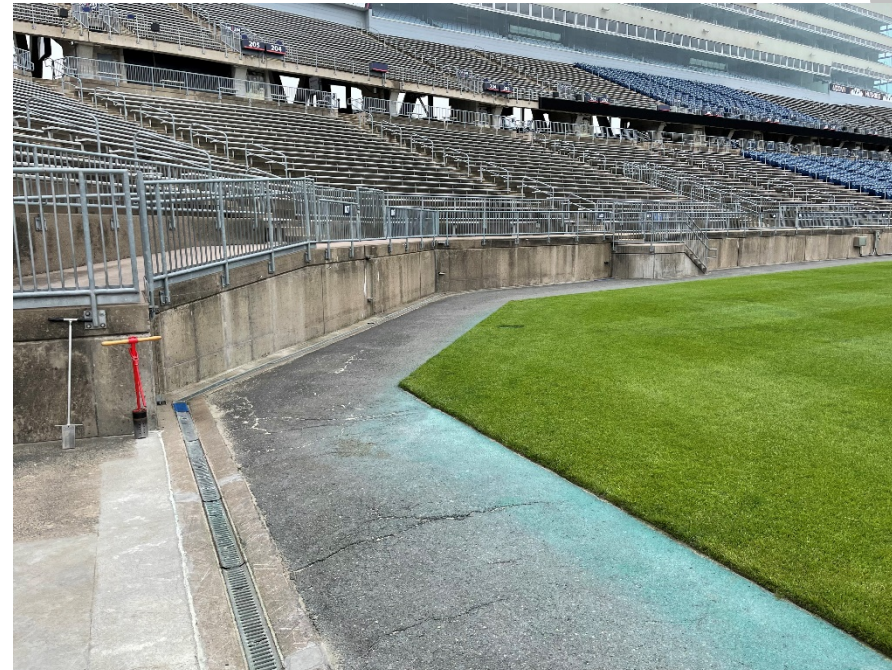
Perimeter track at Service Tunnel

The Perimeter Track displays significant cracking. There are significant gaps in the pavement where it has been cut out for the installation of conduits.

The perimeter track should be replaced with concrete or heavy-duty asphalt within its current extents and be expanded as noted in Appendix A to allow the passage of maintenance equipment/vehicles without impeding on the turf area. It is recommended that the pavement be covered with a synthetic running track material along the sidelines where soccer player benches will reside as to prevent slippage of players wearing cleats. The track should slope from the field edge to the field wall to accommodate drainage.

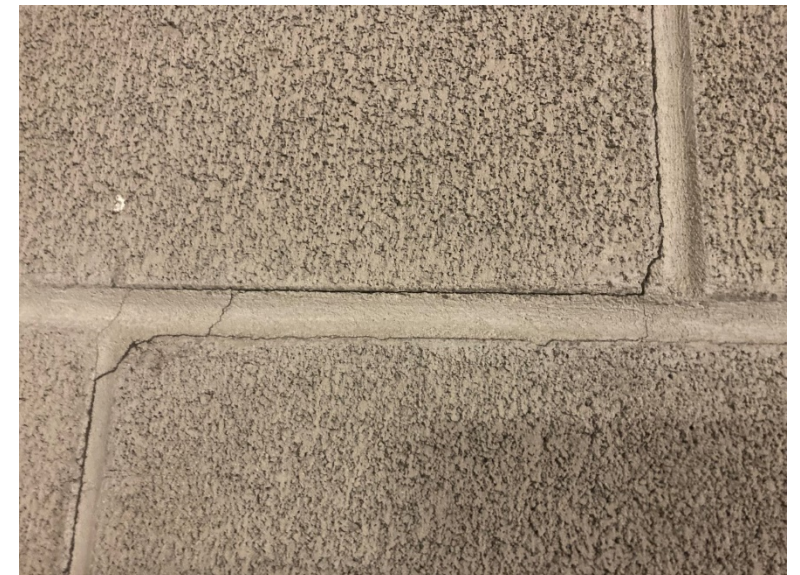
Cracked mortar on CMU walls on Service Level (interior walls in hallway)

Recommendation: Replace cracks CMU and repoint cracks mortar joints.

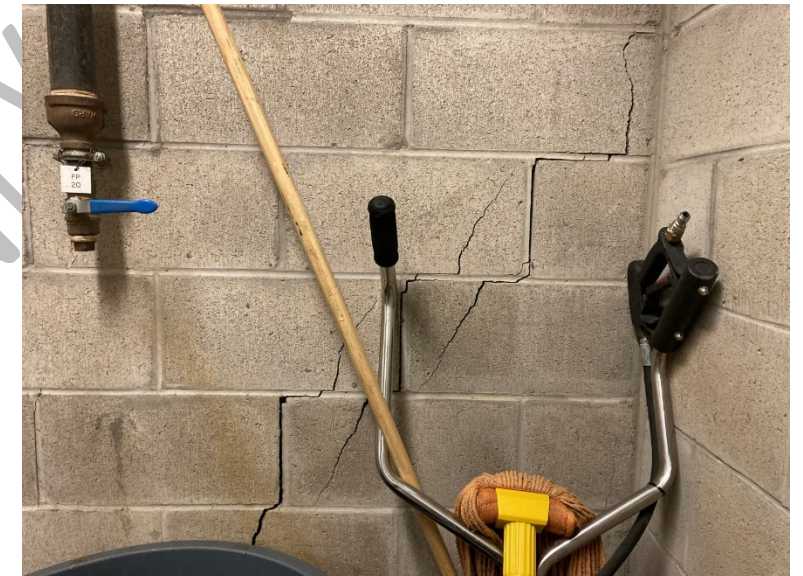
Evidence of settlement through step cracking at CMU wall near transition referenced above (within storage area of Restroom)

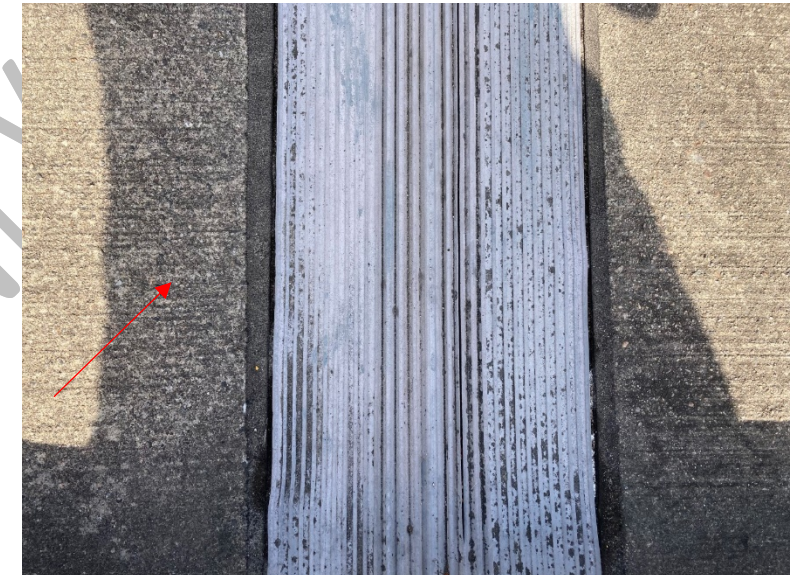
Deteriorated expansion joint at upper bowl (adhesive failure, typical throughout)

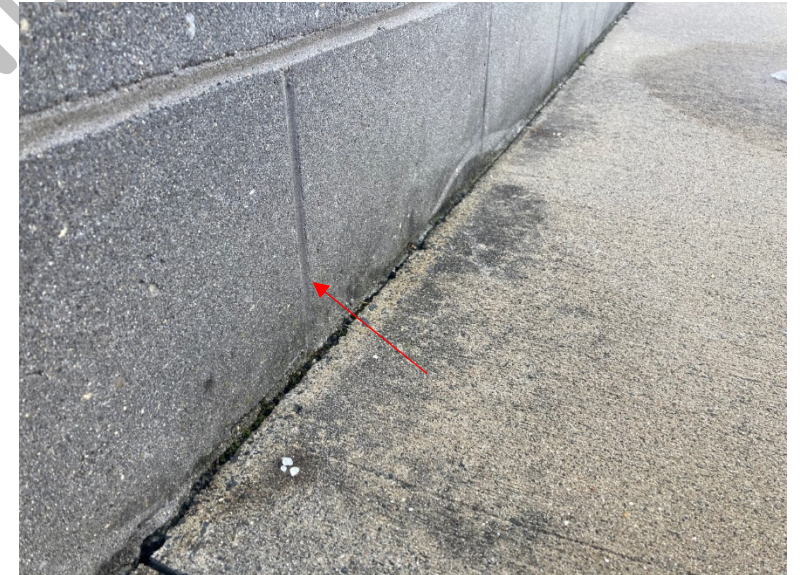
No cove joints installed on Main Concourse above Service Level at base of Concession and Restroom walls

Recommendation: Install cove sealants.

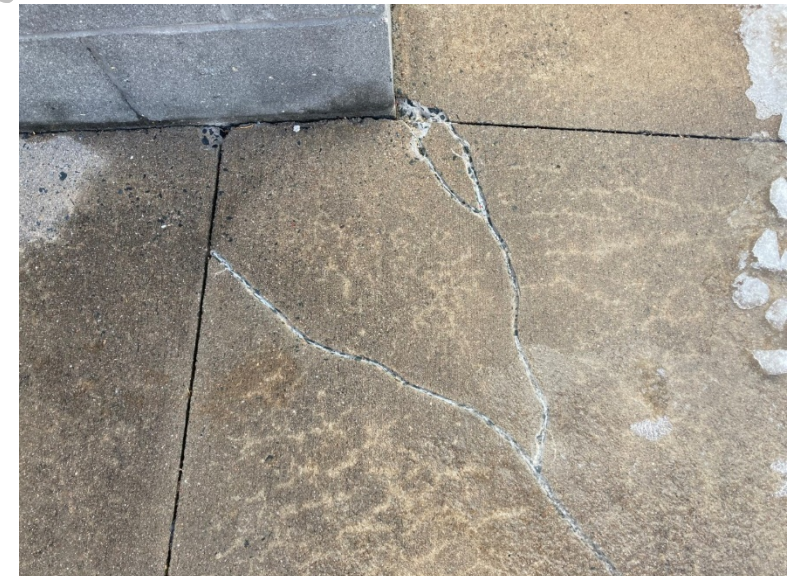
Concrete cracks in elevated slab on Main Concourse above Service Level

Recommendation: Rout and seal slab cracks.

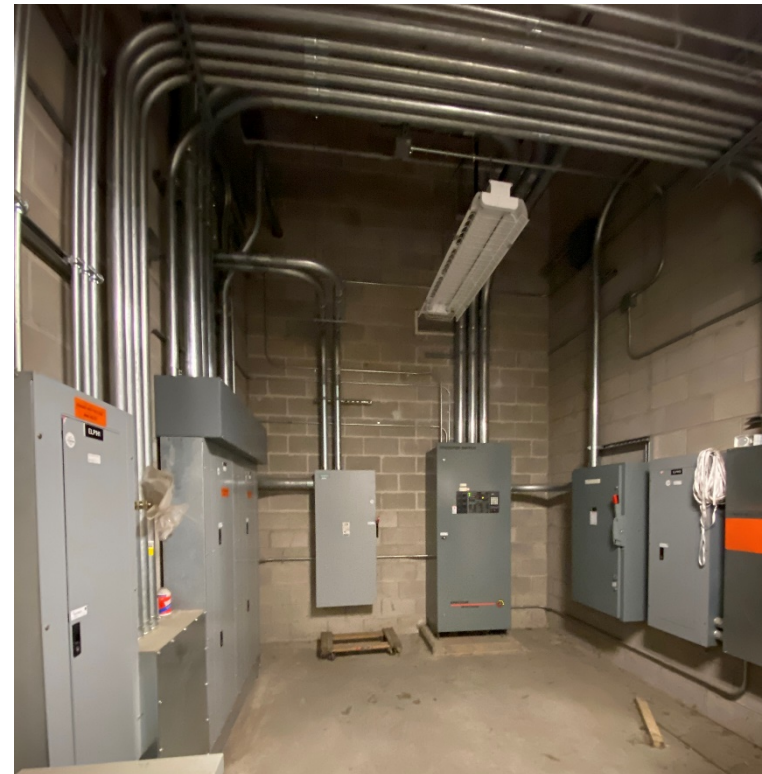
A majority of existing interior luminaires feature fluorescent lamps, which have a shorter lifespan and lower energy efficiency than equivalent LED light sources. As such, lamp replacements are a frequent task for facilities maintenance personnel, requiring time and expense to access light fixtures, remove lensing, and maintain a large stock of spare inventory.

Failed lamps in back-of-house equipment room luminaire

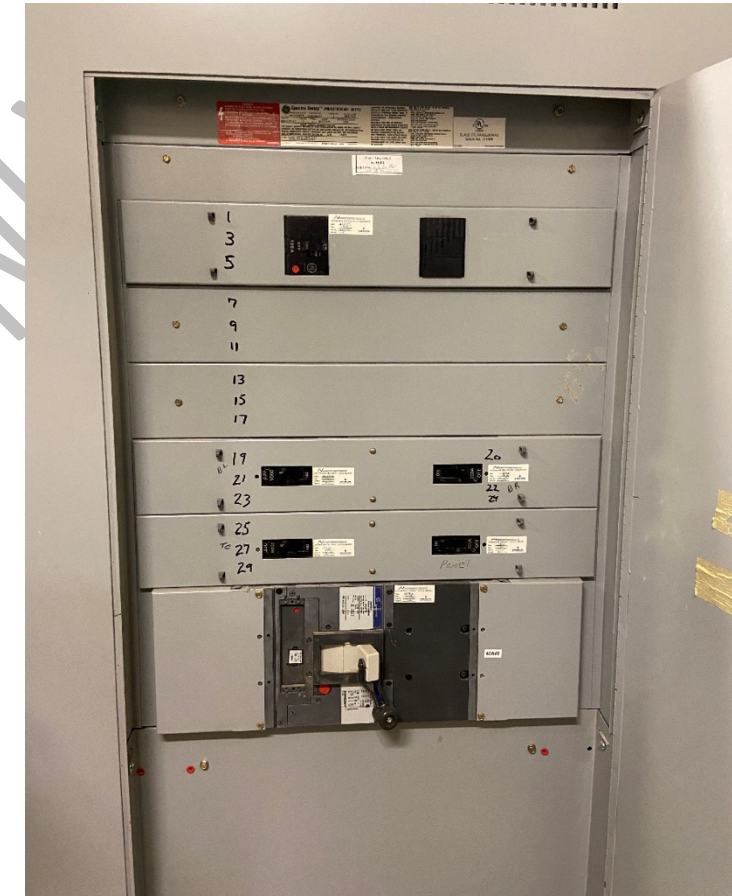
Acknowledging the electrical system panels and overcurrent protection devices original to the building are now 20 years old, it is prudent to comprehensively test them for safe and reliable operation. For example, low voltage molded case circuit breaker (MCCB) interior components such as copper contacts and spring-loaded operating mechanism lubrication can wear down over time, causing delayed trip clearing times and increasing risk of fire from an overload or fault condition. Similar testing and lubrication are recommended for medium voltage power circuit breakers located in unit substations and switchgear throughout the facility, with additional consideration given to replace any worn arcing contacts.

Typical distribution panel with MCCB breakers.

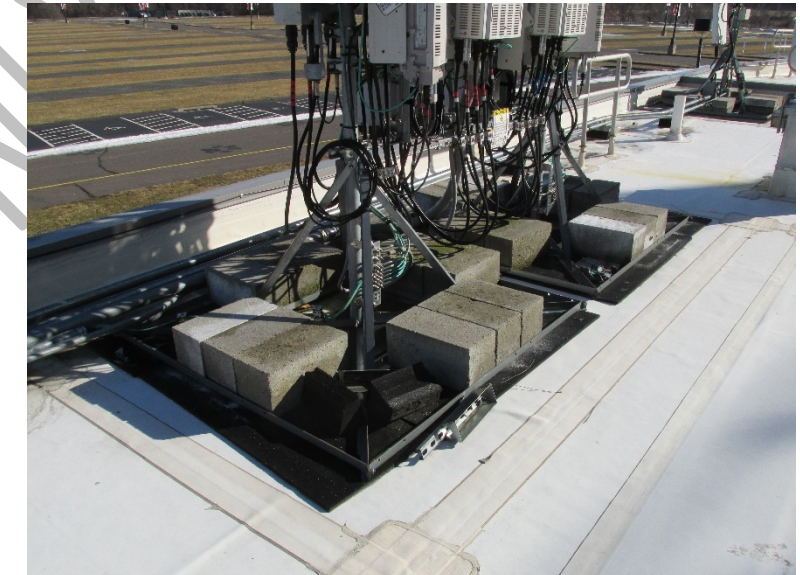
course is out of place and portions of the equipment supports are bearing directly on the roof membrane surface.

Numerous roof areas have telecom equipment that is mounted onto a support frame that is installed atop the roof surface. Typically, some type of protection course, such as walk pads, rubber padding, or extra plies of membrane are installed beneath the equipment/support frames.

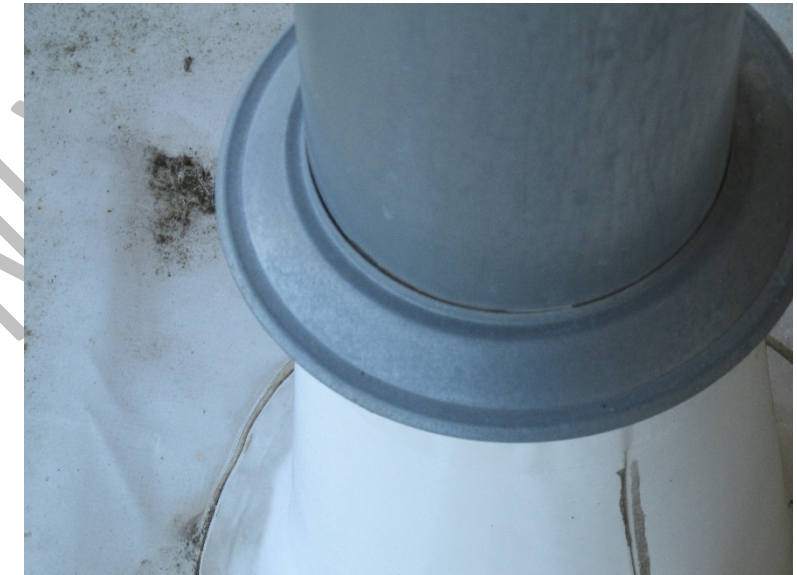
The metal storm collar surrounding this metal flue stack lacks any type of sealant around the joint between the storm collar and the flue stack. As a result, moisture may potentially enter behind the membrane base flashing and damage the roof covering system and/or structural/interior elements.

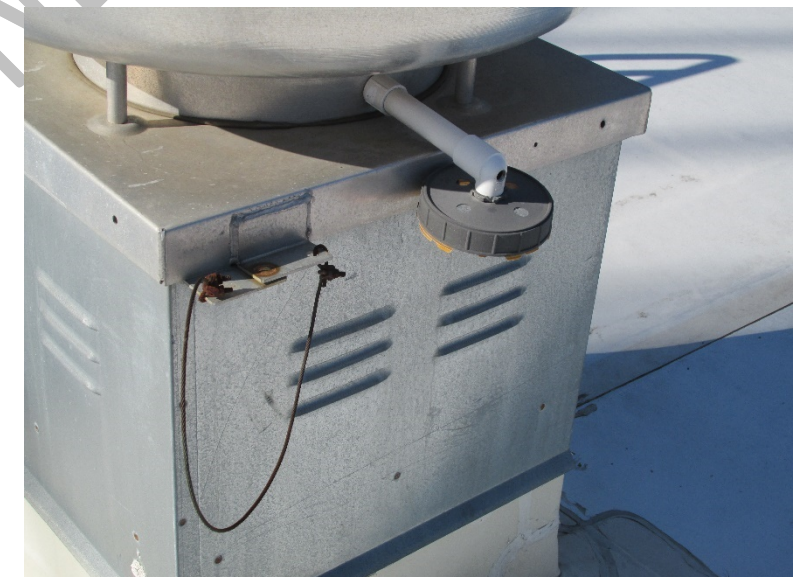
Another rooftop exhaust fan above a concession stand kitchen is equipped with a grease collector; however, the container (presumably some type of screw-on plastic receptacle) is broken/missing. As a result, kitchen grease may drop directly onto the roof surface, causing damage to the roofing/ flashing membrane.

This type of rooftop exhaust fan is typically fitted with a container/receptacle to hold the kitchen grease effluent; however, the grease receptacle appears to be broken or missing from this fan (Building 3).

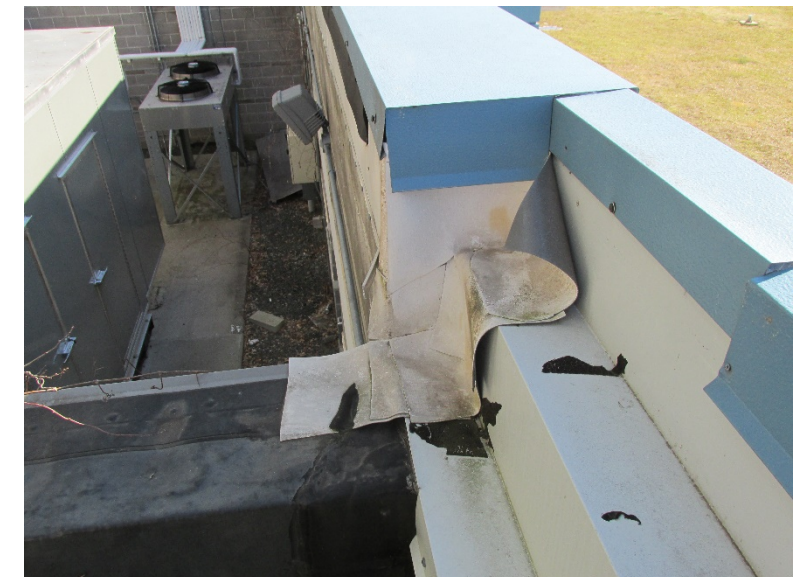
A section of TPO flashing membrane is loose/detached/non-watertight, at the junction of parapets/walls along the south building perimeter (Roof Area 8-D). It appears likely that the membrane may have never been properly adhered to the substrates at the time of original installation. It was also noted that this section of membrane appears to be TPO; however, the adjacent roof covering system is constructed with EPDM membrane, which is incompatible with TPO, unless the TPO were to be simply adhered (rather than heat-welded) to the EPDM membrane.

A section of TPO membrane is loosely installed in a corner at the junction of a wall and two perpendicular parapets (Roof Area 8-D). The TPO membrane is not adhered in place, and is not watertight. The roof covering system on this area utilizes EPDM membrane, which is not compatible with TPO for heat-welded seams.

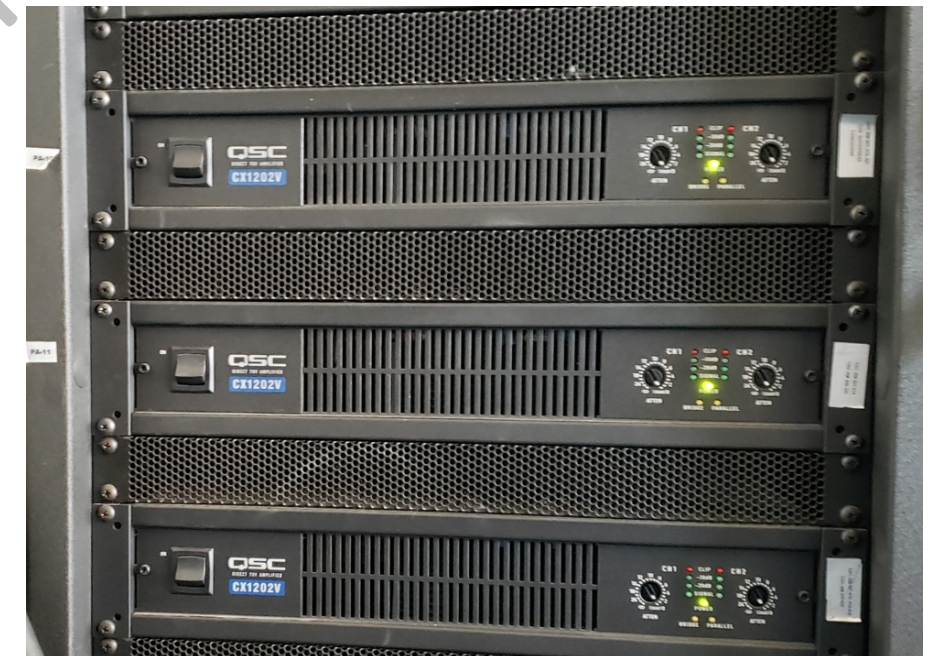
The bowl sound mixing equipment is near or at the end of service life. The QSC CX series amplifiers, while known for very long service life, are likely to require repair or replacement in the next five years. The operator could not confirm whether the various AV closets around the bowl were on emergency power, so as to maintain bowl audio for emergency announcements.

Aging amplifiers

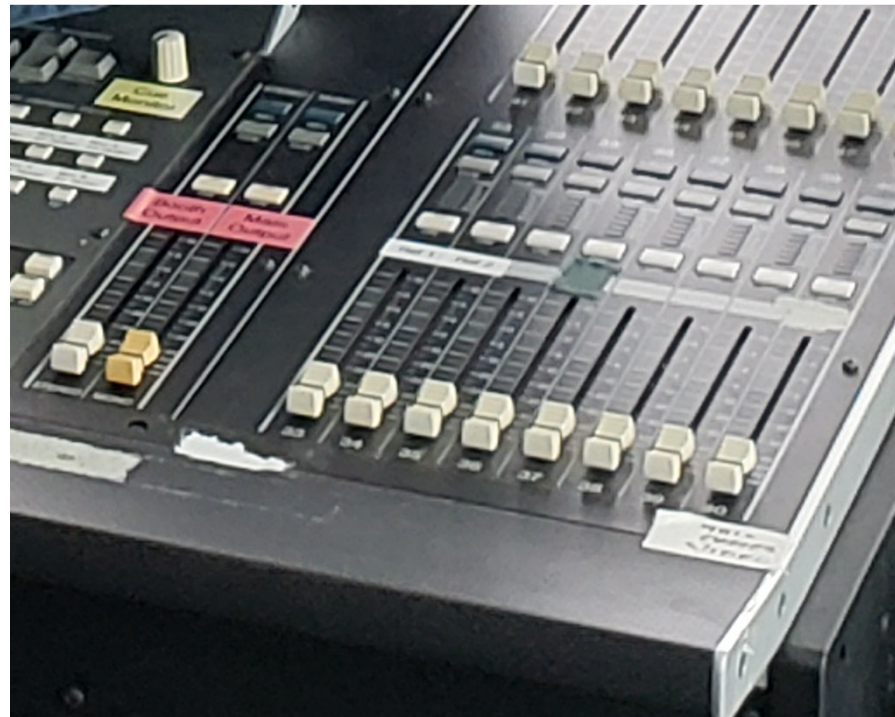
The Yamaha M7 console is about 15 years old, with several unusable/failed channel strips and intermittent main faders. Service parts may not be available past 2025.

Yamaha M7 mixer – example channel modules

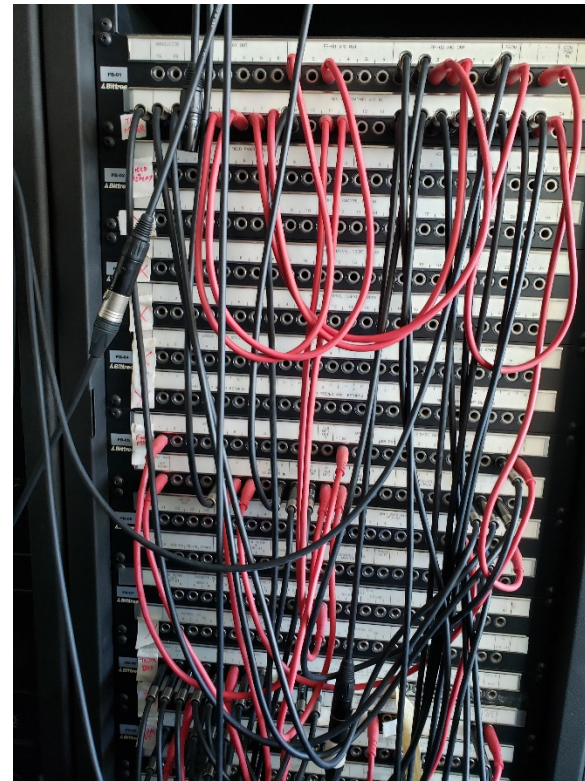
The audio patch frame has development significant signal crosstalk, making sections of it unreliable.

Aging audio patch frame

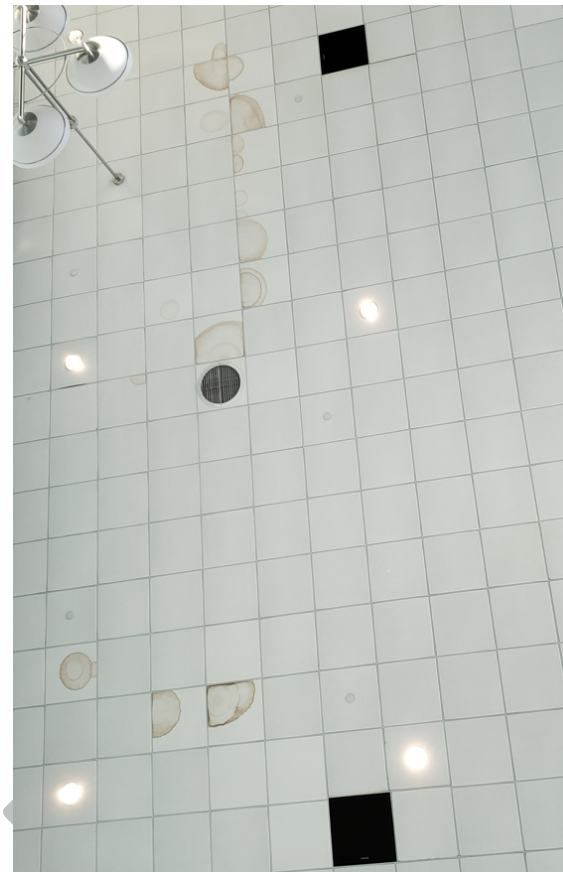
In the main club room, the three large ceiling speakers provide clear speech and good music quality but aesthetically don't blend with the ceiling. There are a series of water-stained ceiling tiles near the loudspeakers. We were unable to inspect the loudspeaker enclosures for any water damage.

Club room ceiling speakers and water damaged tiles

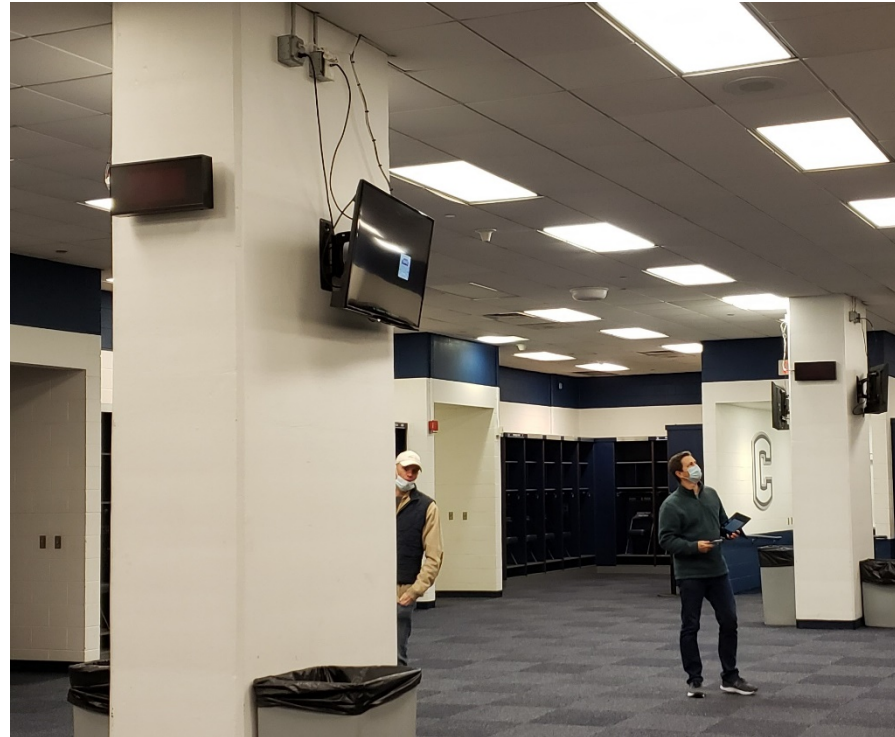
The home locker room television system is in very poor condition, with older televisions, intermittent cable TV reception, and unsightly installation of power and cable connections.

Home locker room televisions

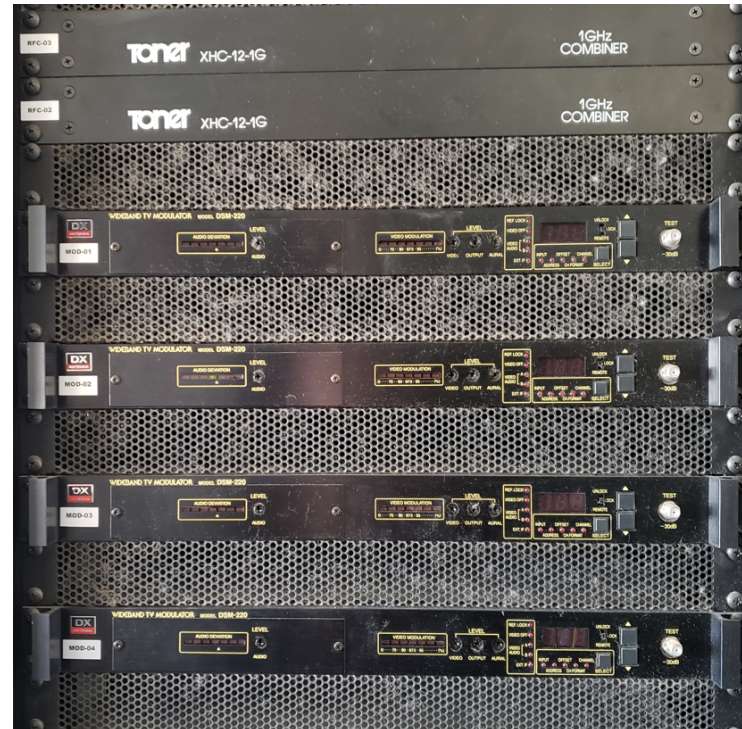
The RF/Coax system is original to the building and in severe decline; reception at some televisions is very poor.

Deteriorating RF components

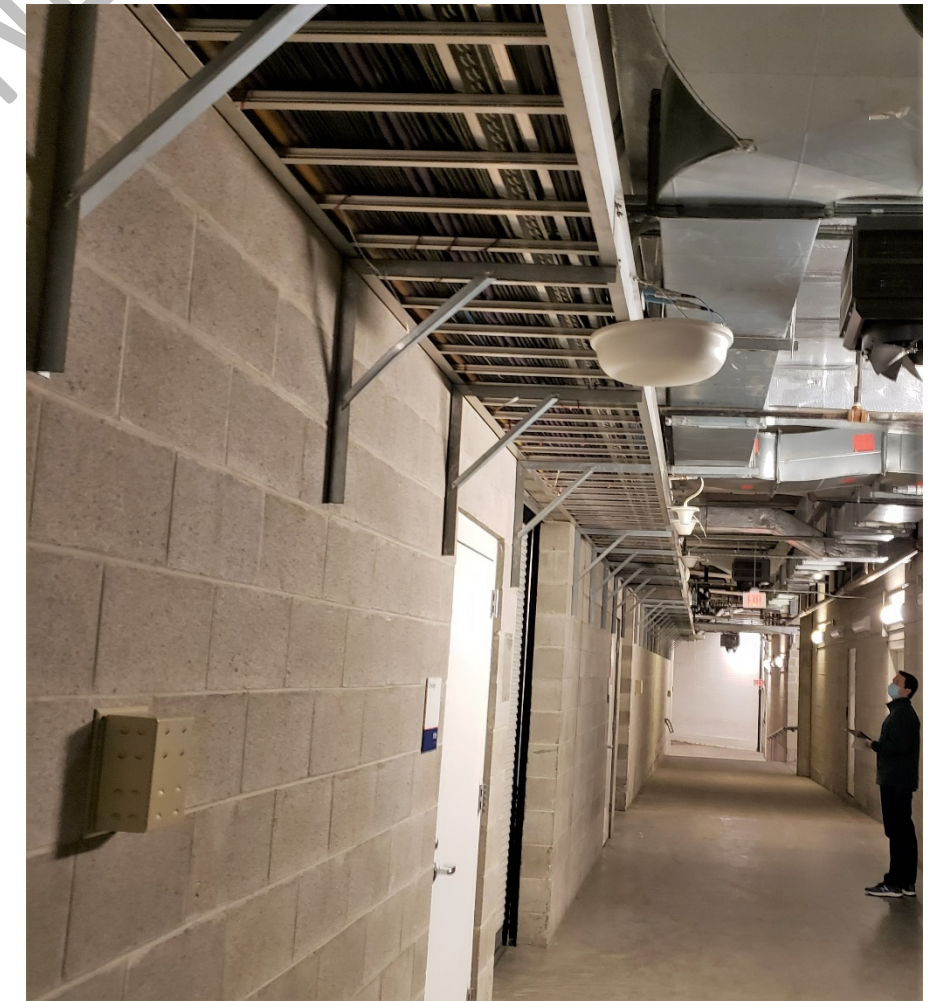
During our walk on the event level, we noticed numerous Wi-Fi & DAS antenna and transmission devices located directly under or adjacent to the low voltage cable tray. The operator believes these to be the source of various “gremlins” in the systems which have cabling in these trays.

Event Level cable tray with DAS antennas mounted to it

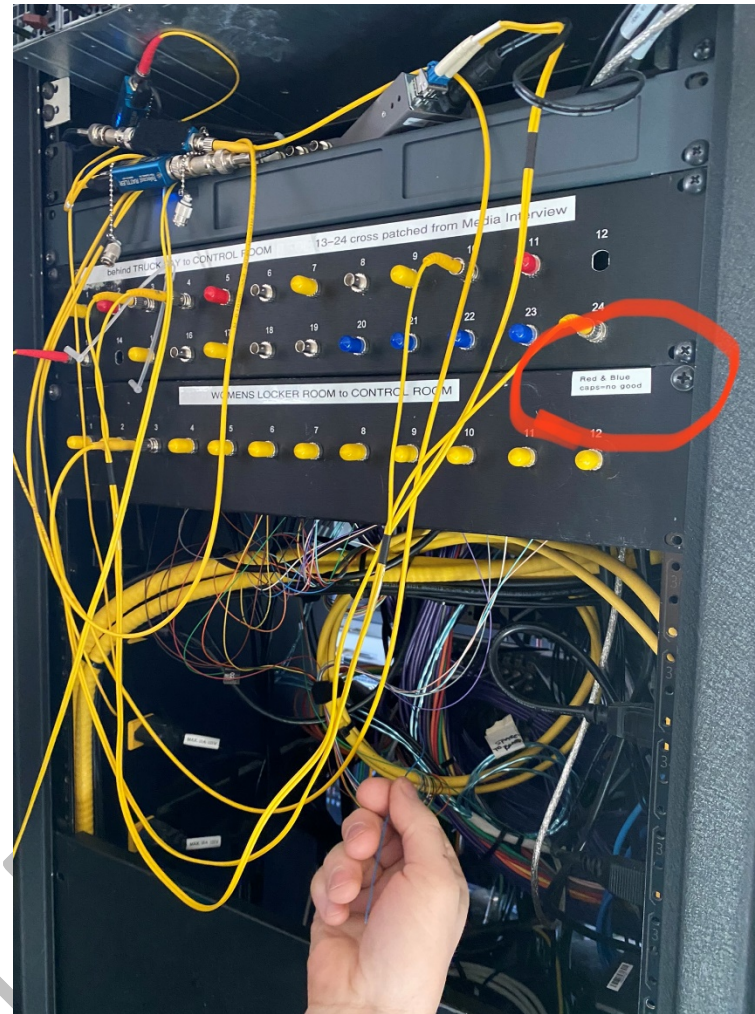
- The Blackmagic router is unreliable as it has broken inputs and outputs and patches become unconnected.
- Not all the fiber patch lines are functional.

Unusable fiber connections with blue and red caps

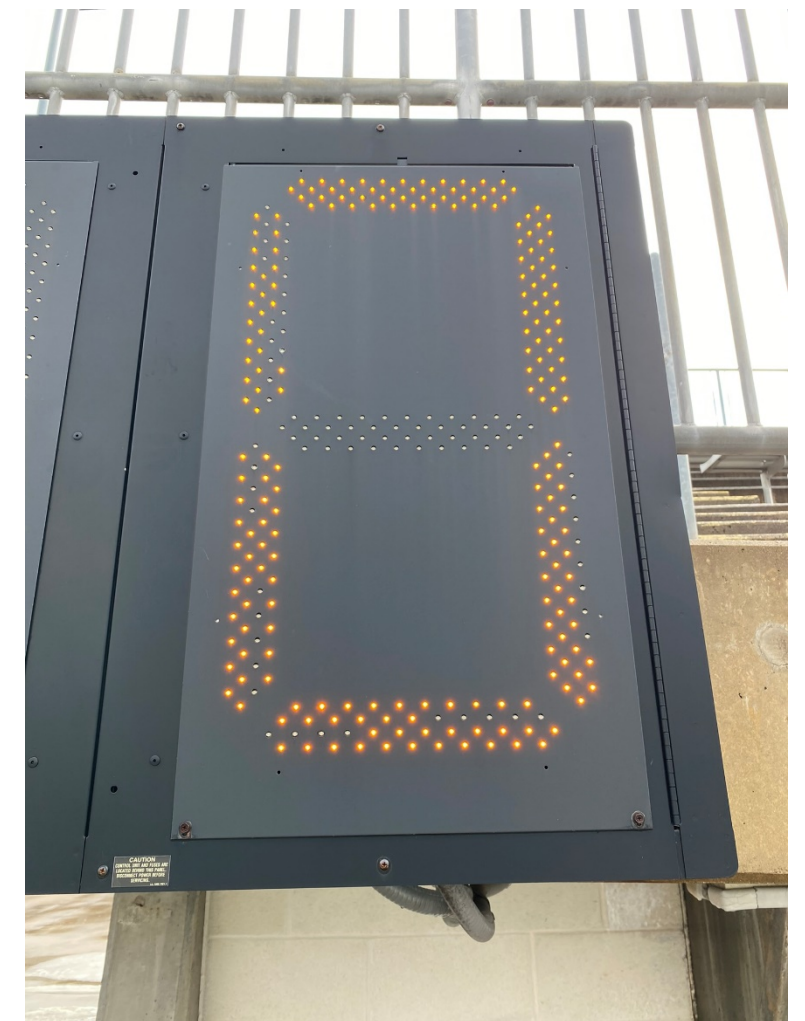
- There are three LED ribbon boards – (2) 2' x 210' and (1) 2' x 73' 20mm products which are showing uniformity issues in several modules around the various lengths/locations. Dark and light modules is apparent throughout the ribbons.
- The play clocks are exhibiting nonfunctioning LEDs within the segments. The numbers from the field are perceivable, but these clocks are slowly losing pixels.

Play Clock losing LEDs in segments

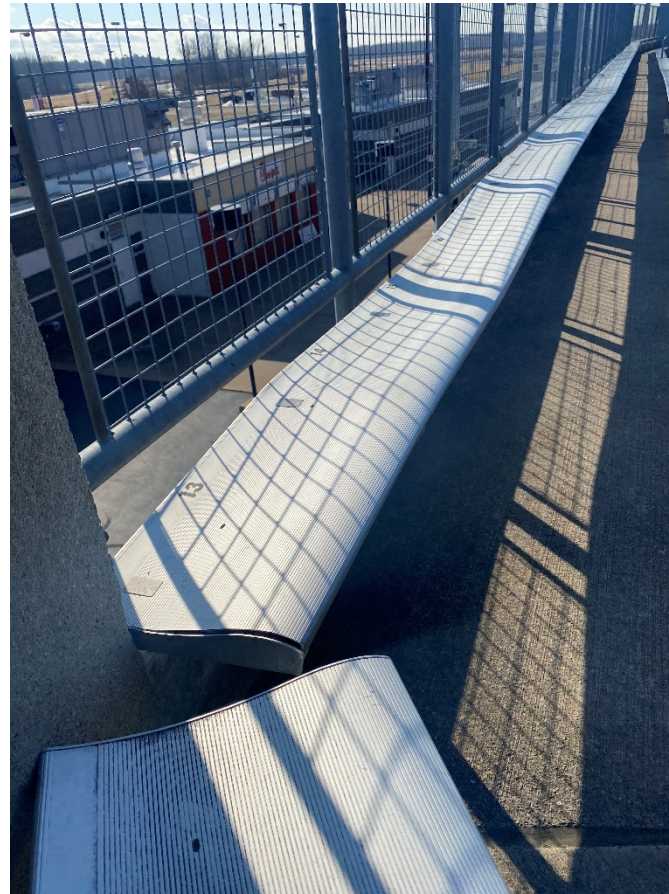
Bench seating is bent and damaged
