Civil and Exterior Assessment

Rentschler Field at Pratt & Whitney Stadium

September 7, 2022
DRAFT FOR
DISCUSSION ONLY

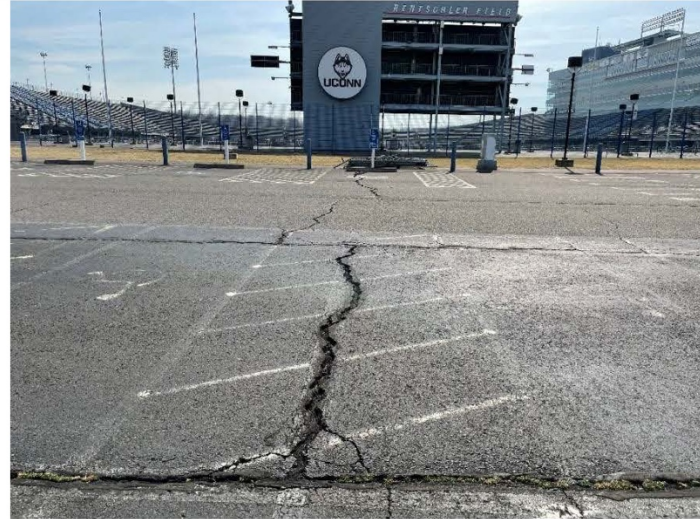
Lot	Pavement Condition	Pavement Notes	Curbing Notes	Pavement Marking/Signage Notes	Representative Photograph
Lot 2	Serious	<ul style="list-style-type: none"> - Longitudinal cracking apparent throughout entire lot, spaced approximately 15' apart, apparently at the interface between paving courses. Cracking appears up to 4" wide and 1-2 inches deep - Transverse Cracks throughout entire lot, up to 3" wide and 1-2 inches deep. - There is evidence of previous crack sealing throughout the lot. At this time, however, the cracks are of sufficient width that the crack sealing is no longer functioning effectively. - Minor alligator cracking noted in isolated areas near joint cracks. Due to the loss of pavement integrity at the corners created by the longitudinal and transvers cracks, loading of the pavement in these areas caused the corners to break off. (See representative photo) 	<ul style="list-style-type: none"> - No curbing present in lot. 	<ul style="list-style-type: none"> - Pavement markings are severely faded and in need of replacement. - Original lot striping was sealed over and replaced with accessible parking striping. The pavement sealing has deteriorated overtime and the original striping is now starting to show through, confusing the striping configuration. - Cross walk striping is severely faded. - One section of Striping (4 spaces) have been replaced in the north portion of this lot. - Only the accessible parking immediately adjacent to the stadium contains signage. The signage does not meet code. Refer to the code section of this report for further information.

<p>Lot 2: Longitudinal and Transverse Cracks greater than 3" wide.</p>

In those instances where the cracking is excessive and some subgrade may be compromised (Lot 2, lot 4), Reclaim-in-place is a viable option, where the existing pavement is ground directly into the base layer, creating a very stable base layer to overlay new pavement over. This would be the second most affordable improvement option over the mill and overly. Curbs would also be replaced.

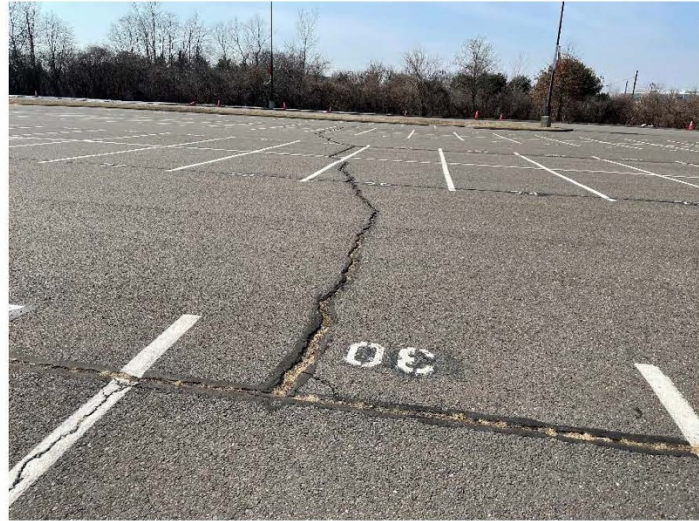
Lot 3	Poor	<ul style="list-style-type: none"> - Longitudinal cracking apparent throughout entire lot, apparently at the interface between paving courses. Cracks up to 3" wide and 1" deep - Numerous 2" wide transverse cracks noted along length of handicapped parking area - Transverse cracking, ranging between 2" to 3" in width, noted in several locations of main parking area . - There is evidence of previous crack sealing throughout the lot. At this time, however, the cracks are of sufficient width that the crack sealing is no longer functioning effectively. 	<ul style="list-style-type: none"> - Two areas of fractured curbing noted in the accessible parking area of lot. 	<ul style="list-style-type: none"> - Pavement markings are severely faded in the accessible parking and are in need of replacement - The accessible Parking was sealed over and replaced with new striping. The pavement sealing has deteriorated overtime and the original striping is now starting to show through, confusing the striping configuration. - The remaining portions of lot 3 striping (non-accessible) are in satisfactory condition. - Crosswalk striping is severely faded ns in need of replacement - Only 11 of the accessible spaces include signs. The signage does not meet code. Refer to the code section of this report for further information.

<p>Lot 3: Longitudinal and Transverse Cracks greater than 2" wide.</p>

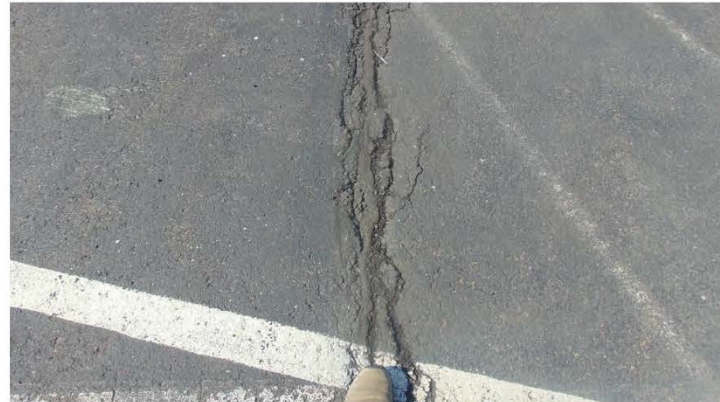
Lot	Pavement Condition	Pavement Notes	Curbing Notes	Pavement Marking/Signage Notes	Representative Photograph
Lot 4	Serious	<ul style="list-style-type: none"> - Longitudinal cracking apparent throughout entire lot, apparently at the interface between paving courses. Cracks are up to 6" wide in some areas with instances of pavement separation (see representative photo). - Transverse Cracks throughout entire lot, up to 2" wide and 1" deep. - Alligator cracking observed in isolated areas. - There is some evidence of previous crack sealing throughout the lot. At this time, however, the cracks are of sufficient width that the crack sealing is no longer functioning effectively. There is also evidence of new cracking with no sealing. - Minor alligator cracking noted in isolated areas near joint cracks. Due to the loss of pavement integrity at the corners created by the longitudinal and transverse cracks, loading of the pavement in these areas caused the corners to break off. (See representative photo) 	<ul style="list-style-type: none"> - Large section of damaged curbing noted in northeast portion of lot. 	<ul style="list-style-type: none"> - Pavement markings are in satisfactory condition. - Crosswalks are in satisfactory condition. - There are no signs for the accessible spaces.

<p><i>Lot 4: Longitudinal Cracks greater than 6" wide, with evidence of pavement separation.</i></p>

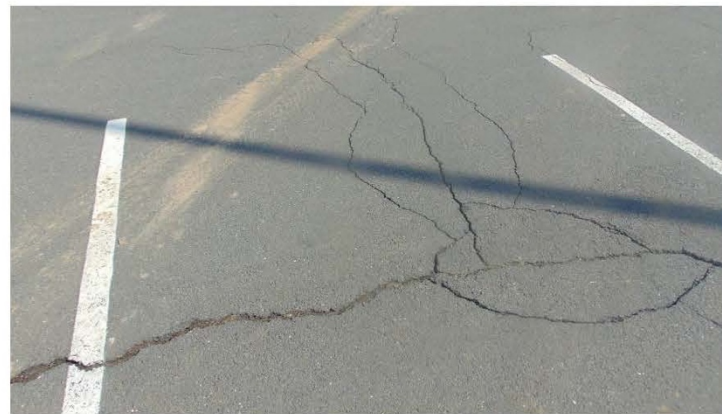
<p><i>Lot 4: Evidence of Alligator Cracking.</i></p>

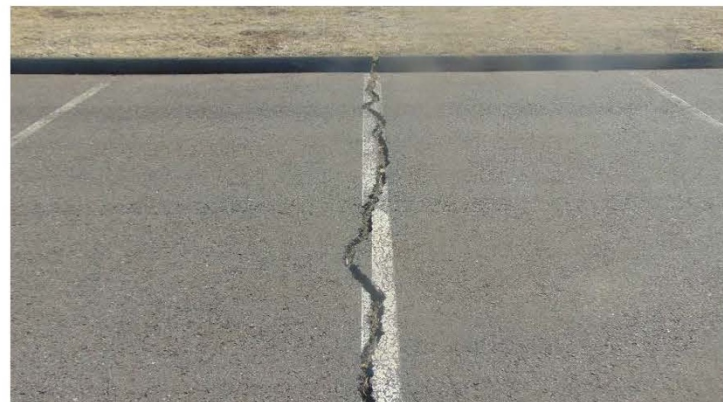
Lot 5	Poor	<ul style="list-style-type: none"> - Longitudinal cracking apparent throughout entire lot, apparently at the interface between paving courses. - Transverse cracking, 2"-3" wide, is noted in regular intervals of around 20 feet. - There is some evidence of previous crack sealing throughout the lot. At this time, however, the cracks are of sufficient width that the crack sealing is no longer functioning effectively. There is also evidence of new cracking with no sealing. - Minor alligator cracking just starting in select areas. 	<ul style="list-style-type: none"> - Curbing is tending to crack in the same location as the transvers crack locations. 	<ul style="list-style-type: none"> - Pavement markings are severely faded in the accessible parking area and in need of replacement. - Original, non-accessible striping was eradicated and replaced with accessible striping, but the paint is severely faded. - The remaining original striping is in satisfactory condition. - There are signposts erected for accessible signage, but the signs do not exist.

<p><i>Lot 5: Evidence of Transverse Cracking and Shrinkage Separation (note translation of parking stripe).</i></p>

Lot 5 is the only parking area with deficient accessible parking, being 1 space shy of the code compliant 5 spaces. Investigation of the area appears to show an additional 8 feet of striping area (4 feet on either end) not being utilized correctly for parking. We recommend this area be restriped, shifting the spaces down by 4 feet and effectively creating room for a fifth accessible space.

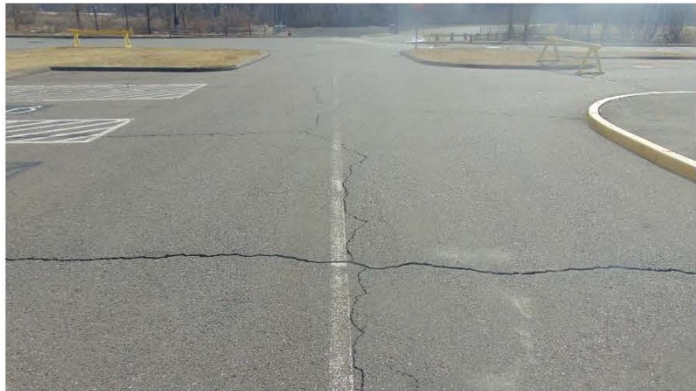
Lot	Pavement Condition	Pavement Notes	Curbing Notes	Pavement Marking/Signage Notes	Representative Photograph
Lot 7	Poor	<ul style="list-style-type: none"> - Block cracking apparent throughout the extents of this lot. The separation cracks range anywhere from 0.5" to 2.5" wide and the blocks are approximately 20-30 feet square. - Paving course joint separation noted in some areas as well. - Limited crack sealing has occurred. 	<ul style="list-style-type: none"> - Curbing fractured in multiple locations and beginning to be displaced. 	<ul style="list-style-type: none"> - Pavement markings are in satisfactory condition. - Original, accessible striping was eradicated (painted over) and replaced with new striping in a different orientation. - The accessible spaces include signs, but they do not meet code. Refer to the code section of this report for further information.

<p><i>Lot 7: Evidence of Block Cracking.</i></p>

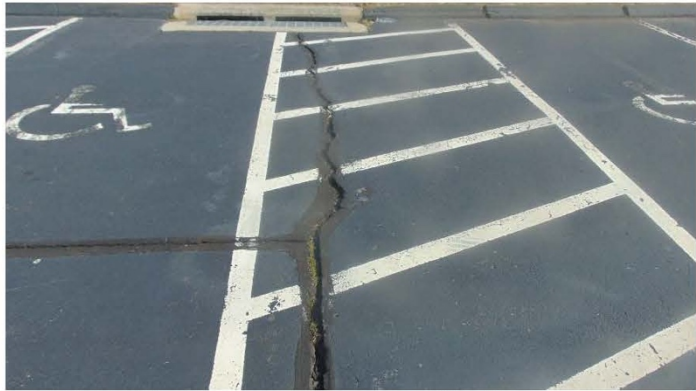
Lot 8	Poor	<ul style="list-style-type: none"> - Longitudinal cracking apparent throughout entire lot, apparently at the interface between paving courses, ranging between 0.5" to 2" in width. - Transverse Cracks throughout entire lot, from 0.5" to 2" wide and up to 1" deep in some areas - There is some evidence of previous crack sealing throughout the lot. At this time, however, the cracks are of sufficient width that the crack sealing is no longer functioning effectively. - The accessible parking space area was sealed entirely with pavement sealer at one point, but that sealer is no longer functioning effectively. - There appears to be some minor evidence of alligator cracking in very select areas. 	<ul style="list-style-type: none"> - Curbing fractured in multiple locations and beginning to be displaced. 	<ul style="list-style-type: none"> - Pavement markings are in satisfactory condition. - Original striping was sealed over and replaced with the new accessible striping. - There are no signs for the accessible spaces. - Crosswalk striping is severely faded and in need of replacement

<p><i>Lot 8: Evidence of minor Transverse Cracking.</i></p>

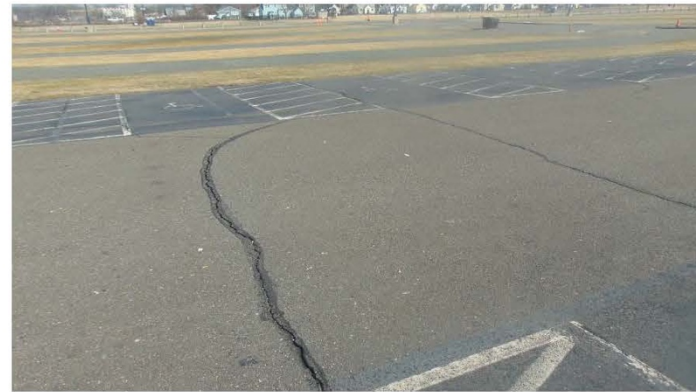
Lot 12	Poor	<ul style="list-style-type: none"> - Longitudinal cracking apparent throughout entire lot, apparently at the interface between paving courses, ranging between 0.5" to 2" in width. - Transverse Cracks throughout entire lot, from 0.5" to 2" wide and up to 1" deep in some areas - Minor alligator cracking noted in some areas. Cracks were sealed at one point, but the sealing has failed, and the cracking continues to worsen. - The accessible parking space area was sealed entirely with pavement sealer at one point, but that sealer is no longer functioning effectively. - Paving course joint separation noted in some areas as well. 	<ul style="list-style-type: none"> - Curbing is tending to crack in the same location as the transvers crack locations. - Section of Curb are also starting to displace. 	<ul style="list-style-type: none"> - Pavement markings are severely faded in the accessible parking are and in need of replacement. - Original striping was sealed over and replaced with the new accessible striping. - There are no signs for the accessible spaces. - There is no crosswalk.

<p><i>Lot 12: Evidence of Transverse Cracking.</i></p>

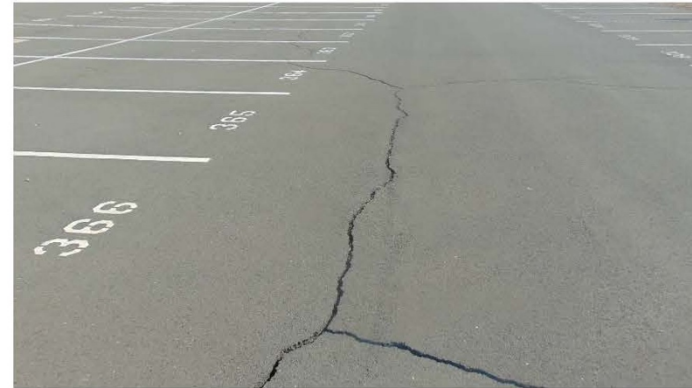
Lot	Pavement Condition	Pavement Notes	Curbing Notes	Pavement Marking/Signage Notes	Representative Photograph
Lot A	Fair	<ul style="list-style-type: none"> - Longitudinal cracking apparent throughout entire lot, apparently at the interface between paving courses and in other random areas, ranging between 1" and 2" in width. - There appears to be a 10' x 10' pavement repair in the center of the lot, however the repair contains a portion of uneven, depressed pavement with evidence of water retention. - Random transverse and diagonal cracking observed throughout the lot with little apparent cause. - There does not appear to be any crack or pavement sealing evident 	- No curbing present in lot.	- Pavement markings are in satisfactory condition.

<p><i>Lot A: Longitudinal and Transverse Cracks.</i></p>

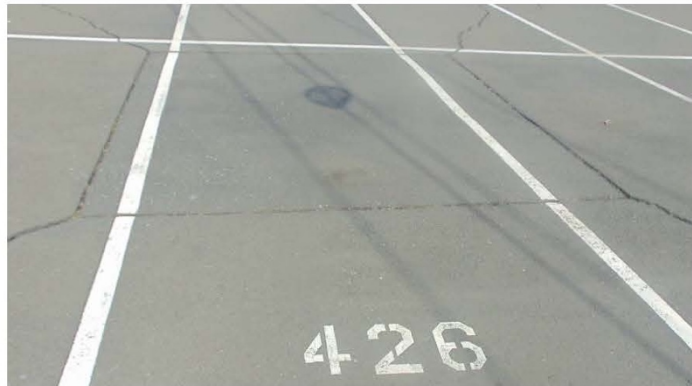
<p><i>Lot A: Block Cracking with Depression of pavement noted.</i></p>

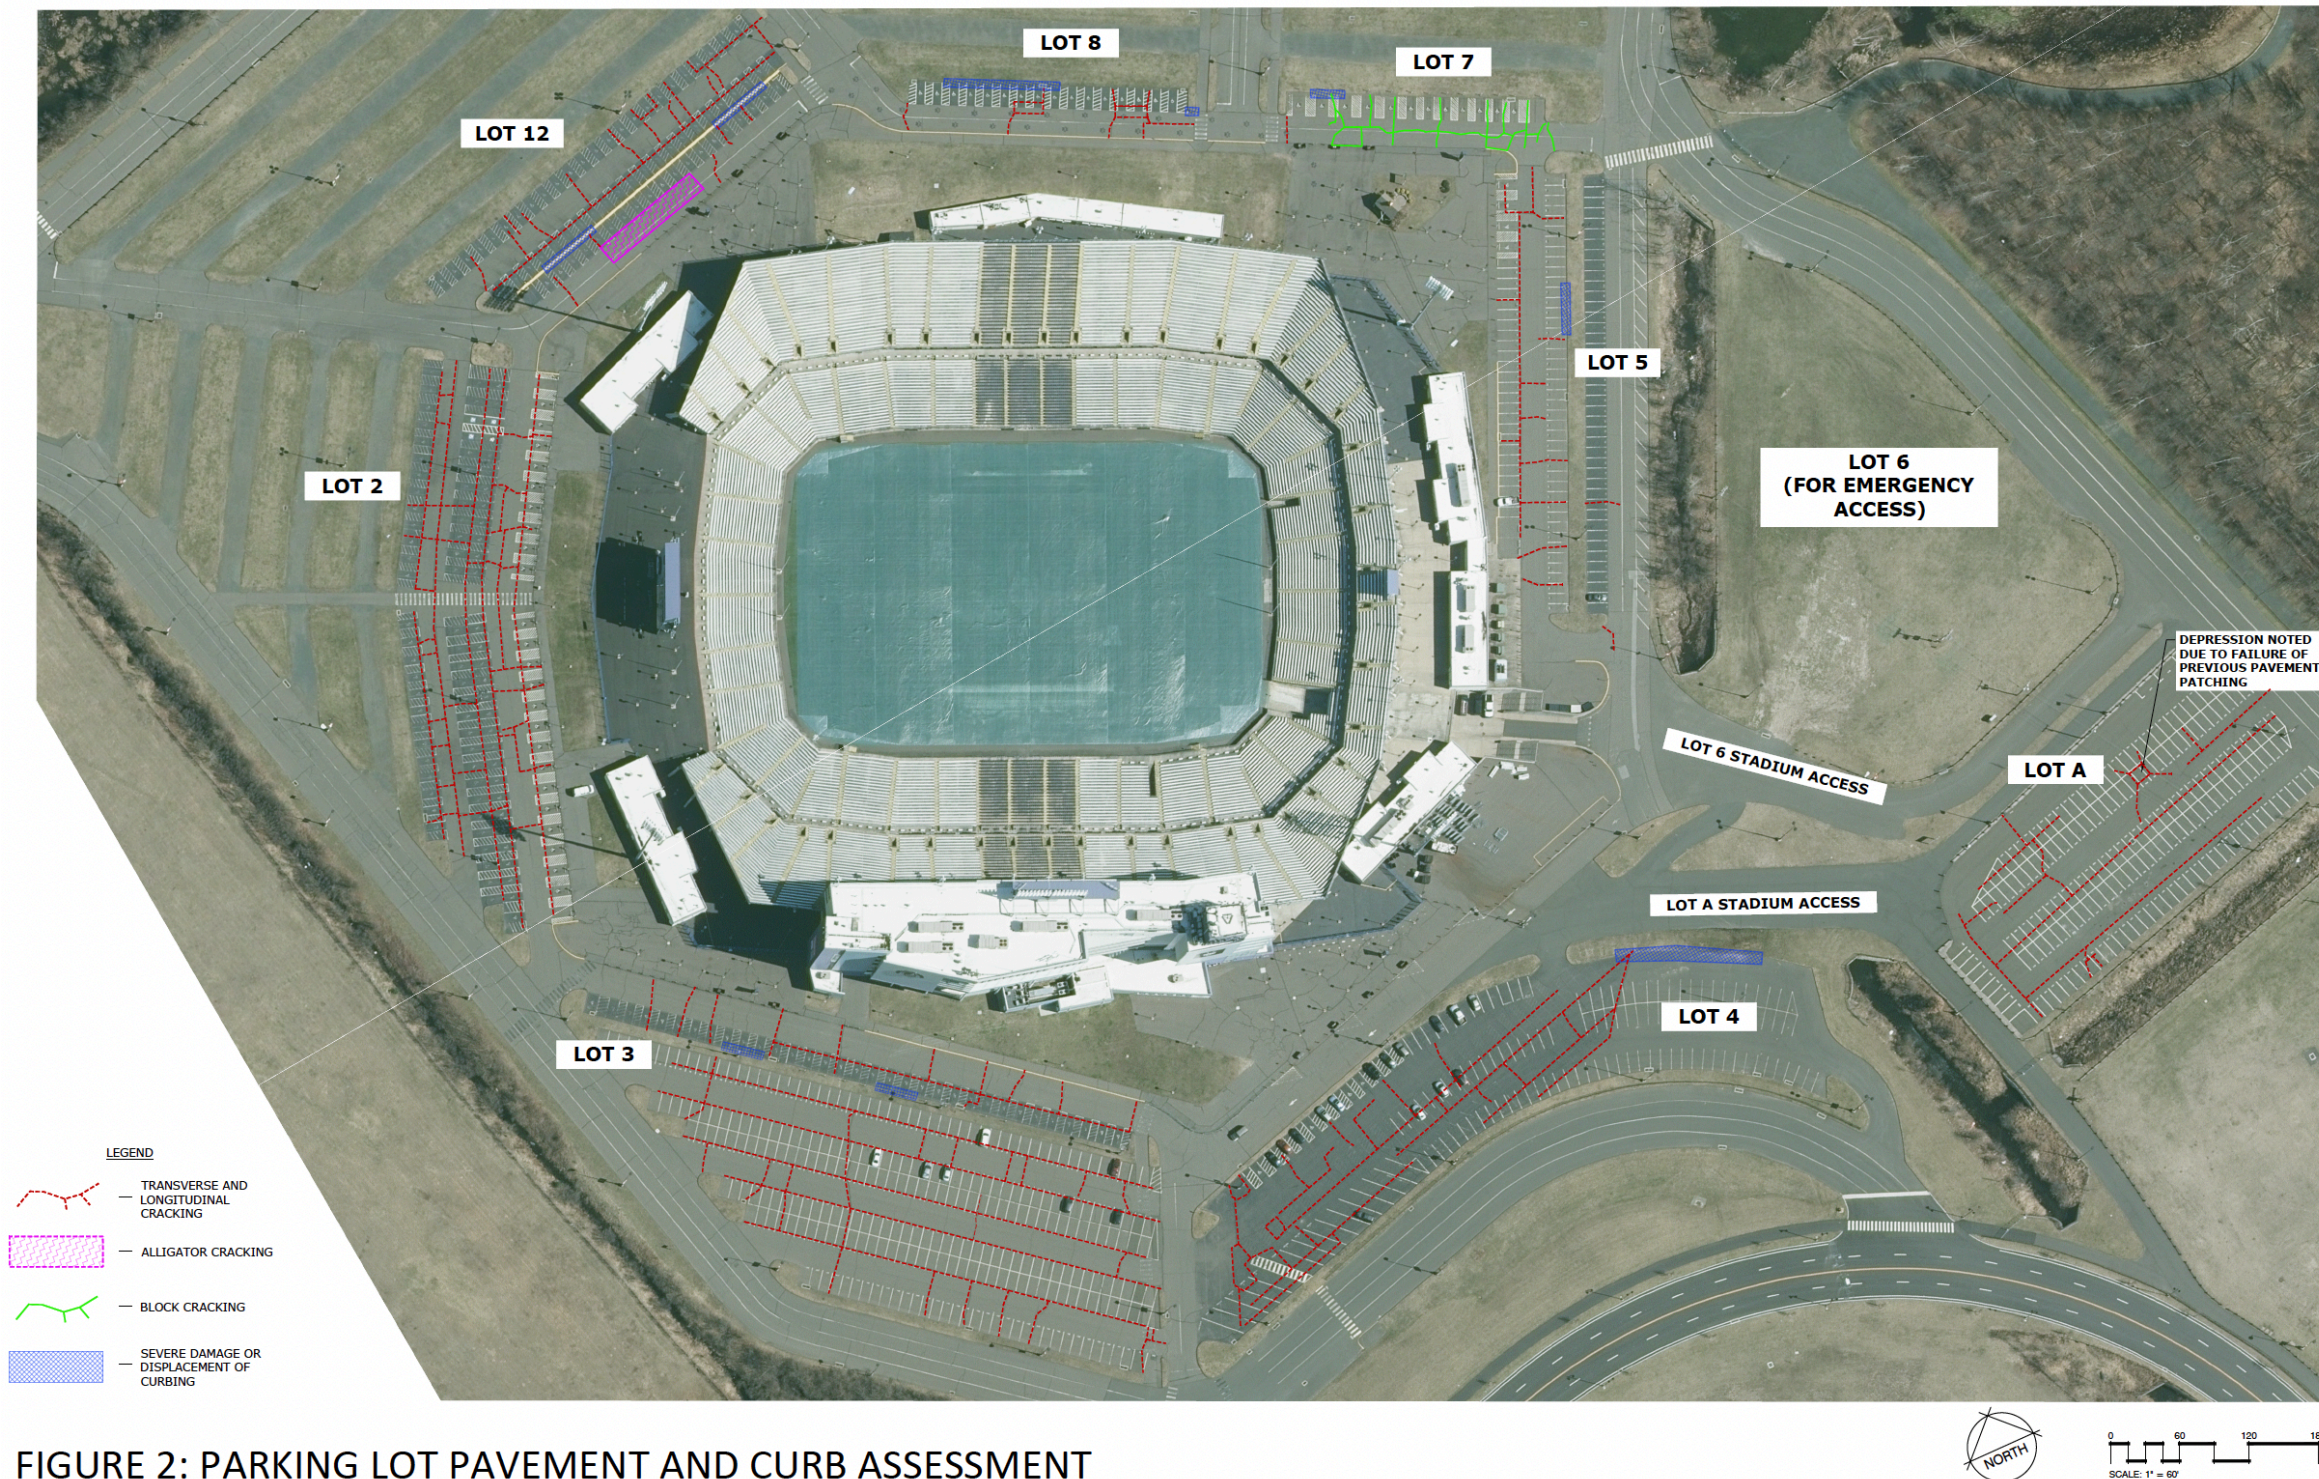
FIGURE 2: PARKING LOT PAVEMENT AND CURB ASSESSMENT
PRATT & WHITNEY STADIUM FACILITY ASSESSMENT

The parking lot pavement and curbs ranged from fair condition to serious, with many instances of alligator, longitudinal, and transverse cracking. The pavement markings were generally in fair (acceptable) condition with only a few exceptions.

Though there appears to be a substantial amount of longitudinal and transverse cracking throughout all parking areas around the stadium, there is a much smaller amount of the other deterioration factors that were identified earlier in this report. This evidence points less to issues associate with the subbase material failing, but more to the failure of the pavement course due to its age. The pavement, at the end of its useful life, has lost all flexibility and has started to shrink in all directions, causing the observed cracking. Therefore, a reasonable recommendation for the majority of the pavement areas would be a Mill and Overlay.

A mill and overlay would remove the aged pavement either partially, or fully, via mechanical methods, while the subbase would remain relatively intact. The area would then be overlain with new pavement. This is also the cheapest improvement option that were generate a new pavement condition. The curbs surrounding these parking areas would also be replaced.

Please refer to Figure 2 (page 22) for information on the location of pavement and curb deficiencies.

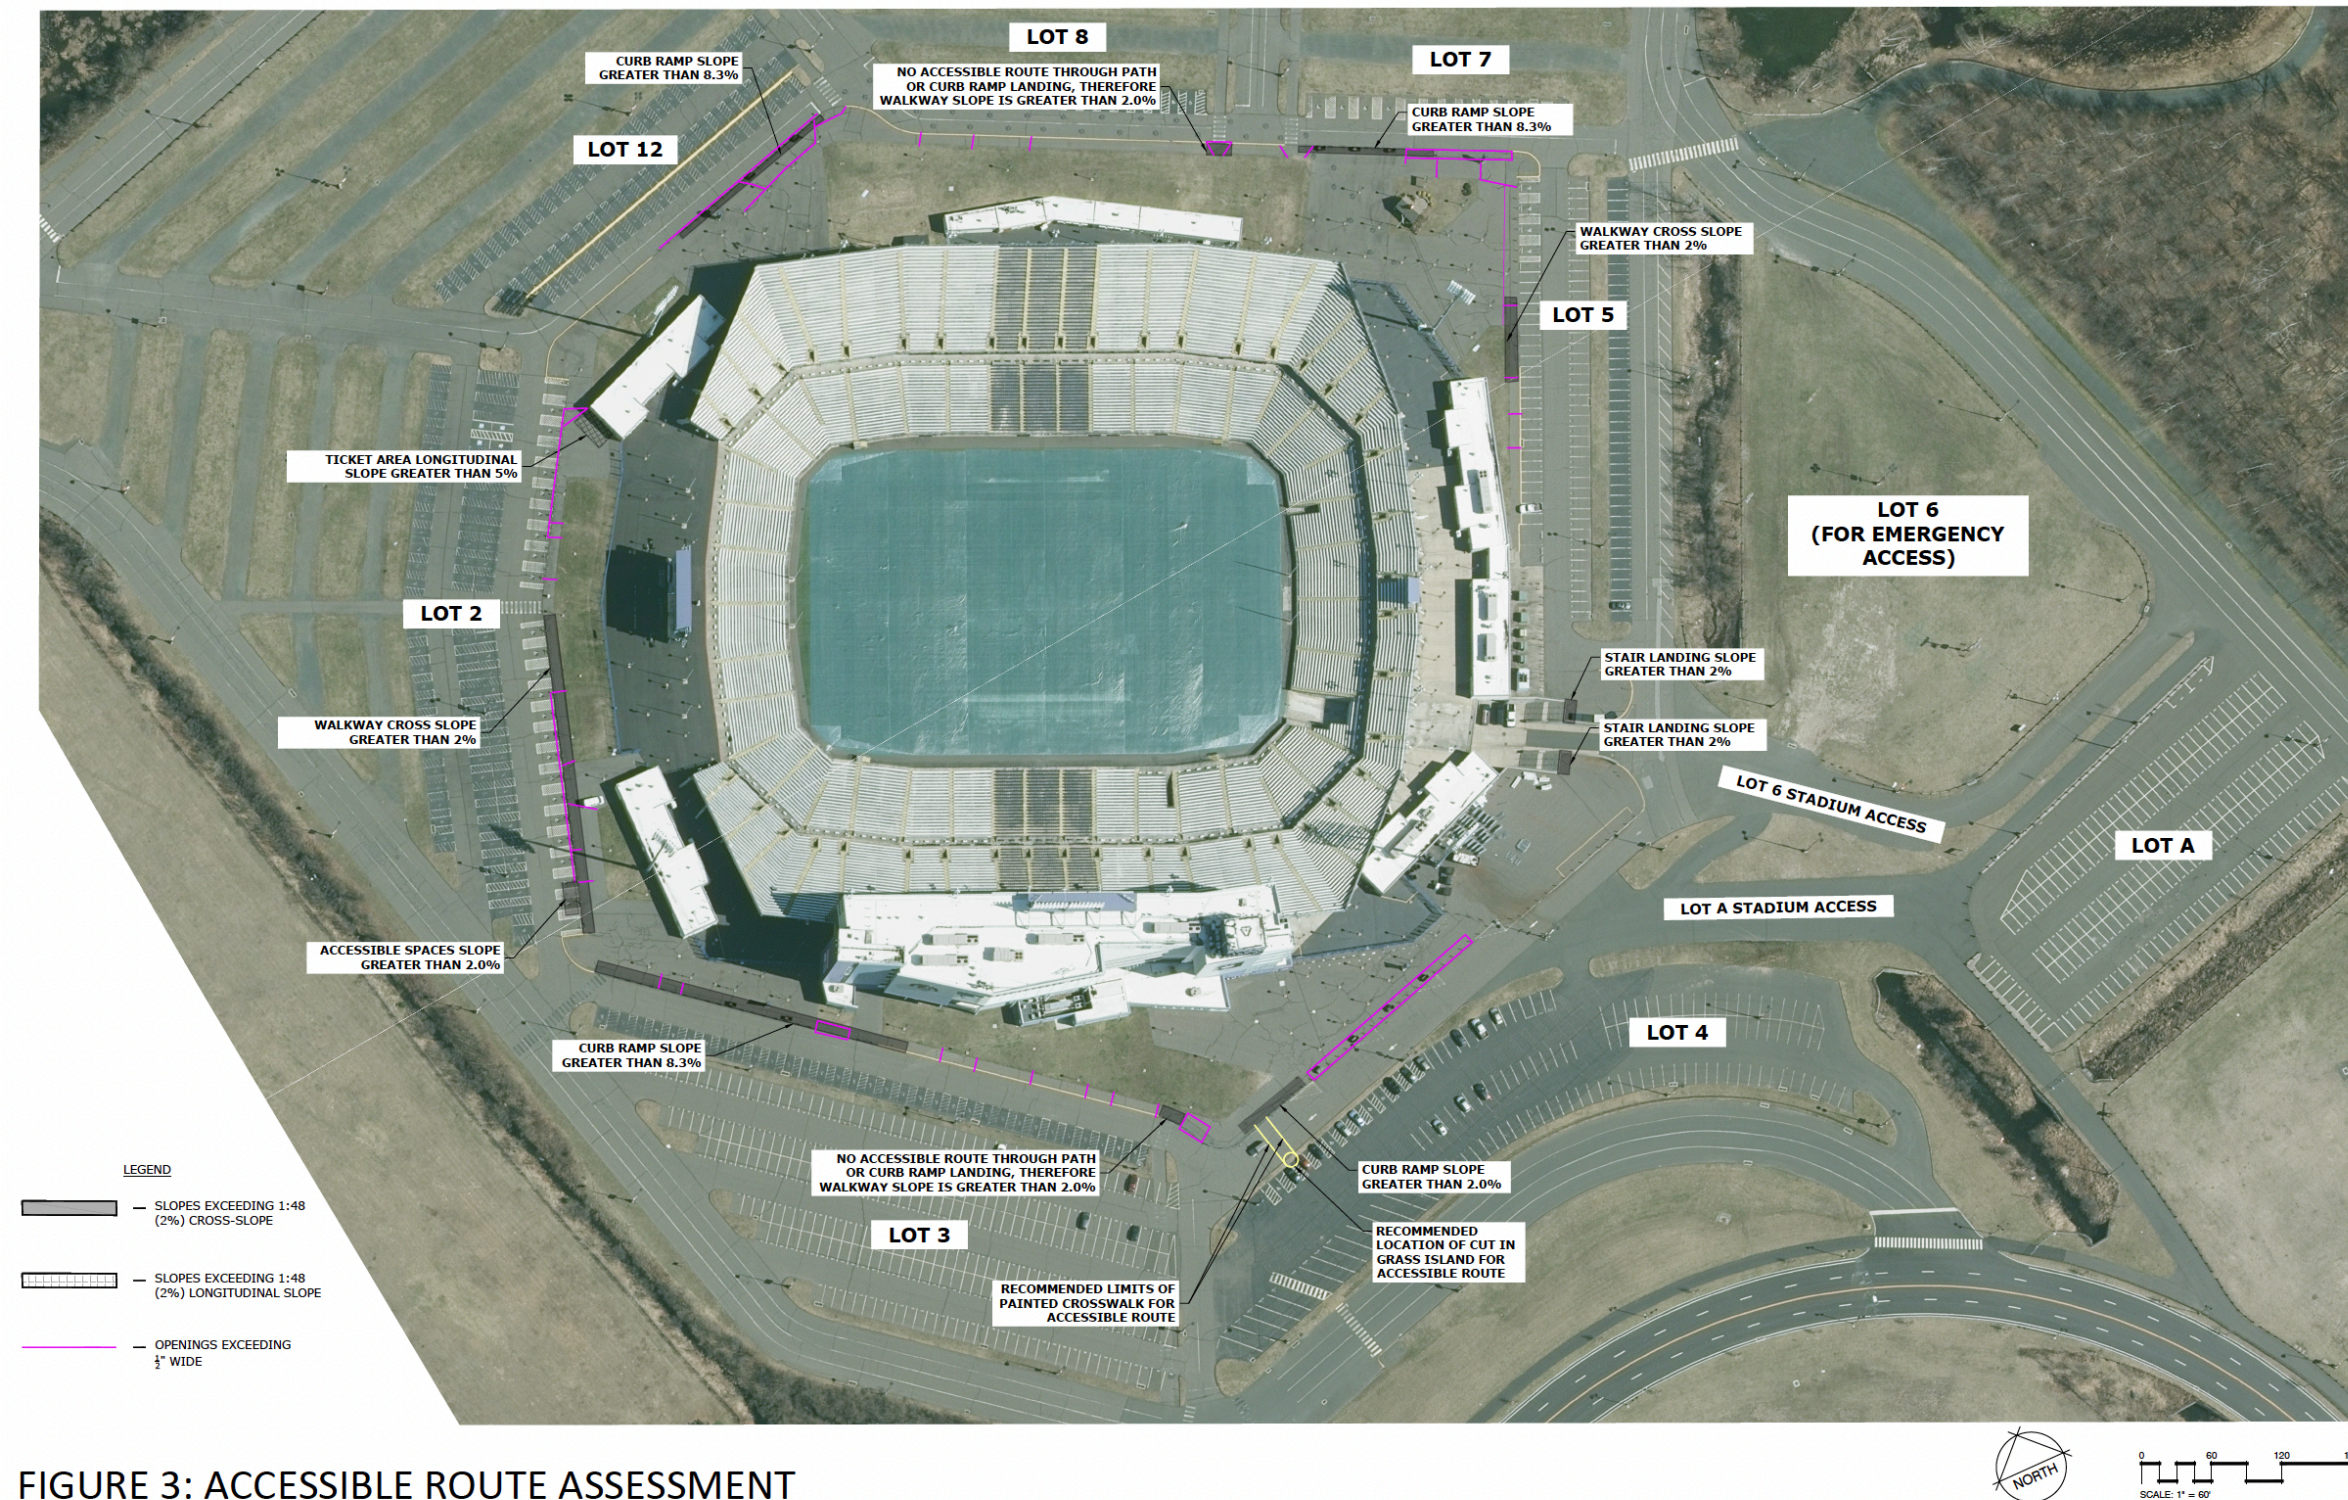
For further clarification, a diagram identifying the approximate location of any observed issues is included as Figure 3 - "Accessible Route Assessment" (page 23).

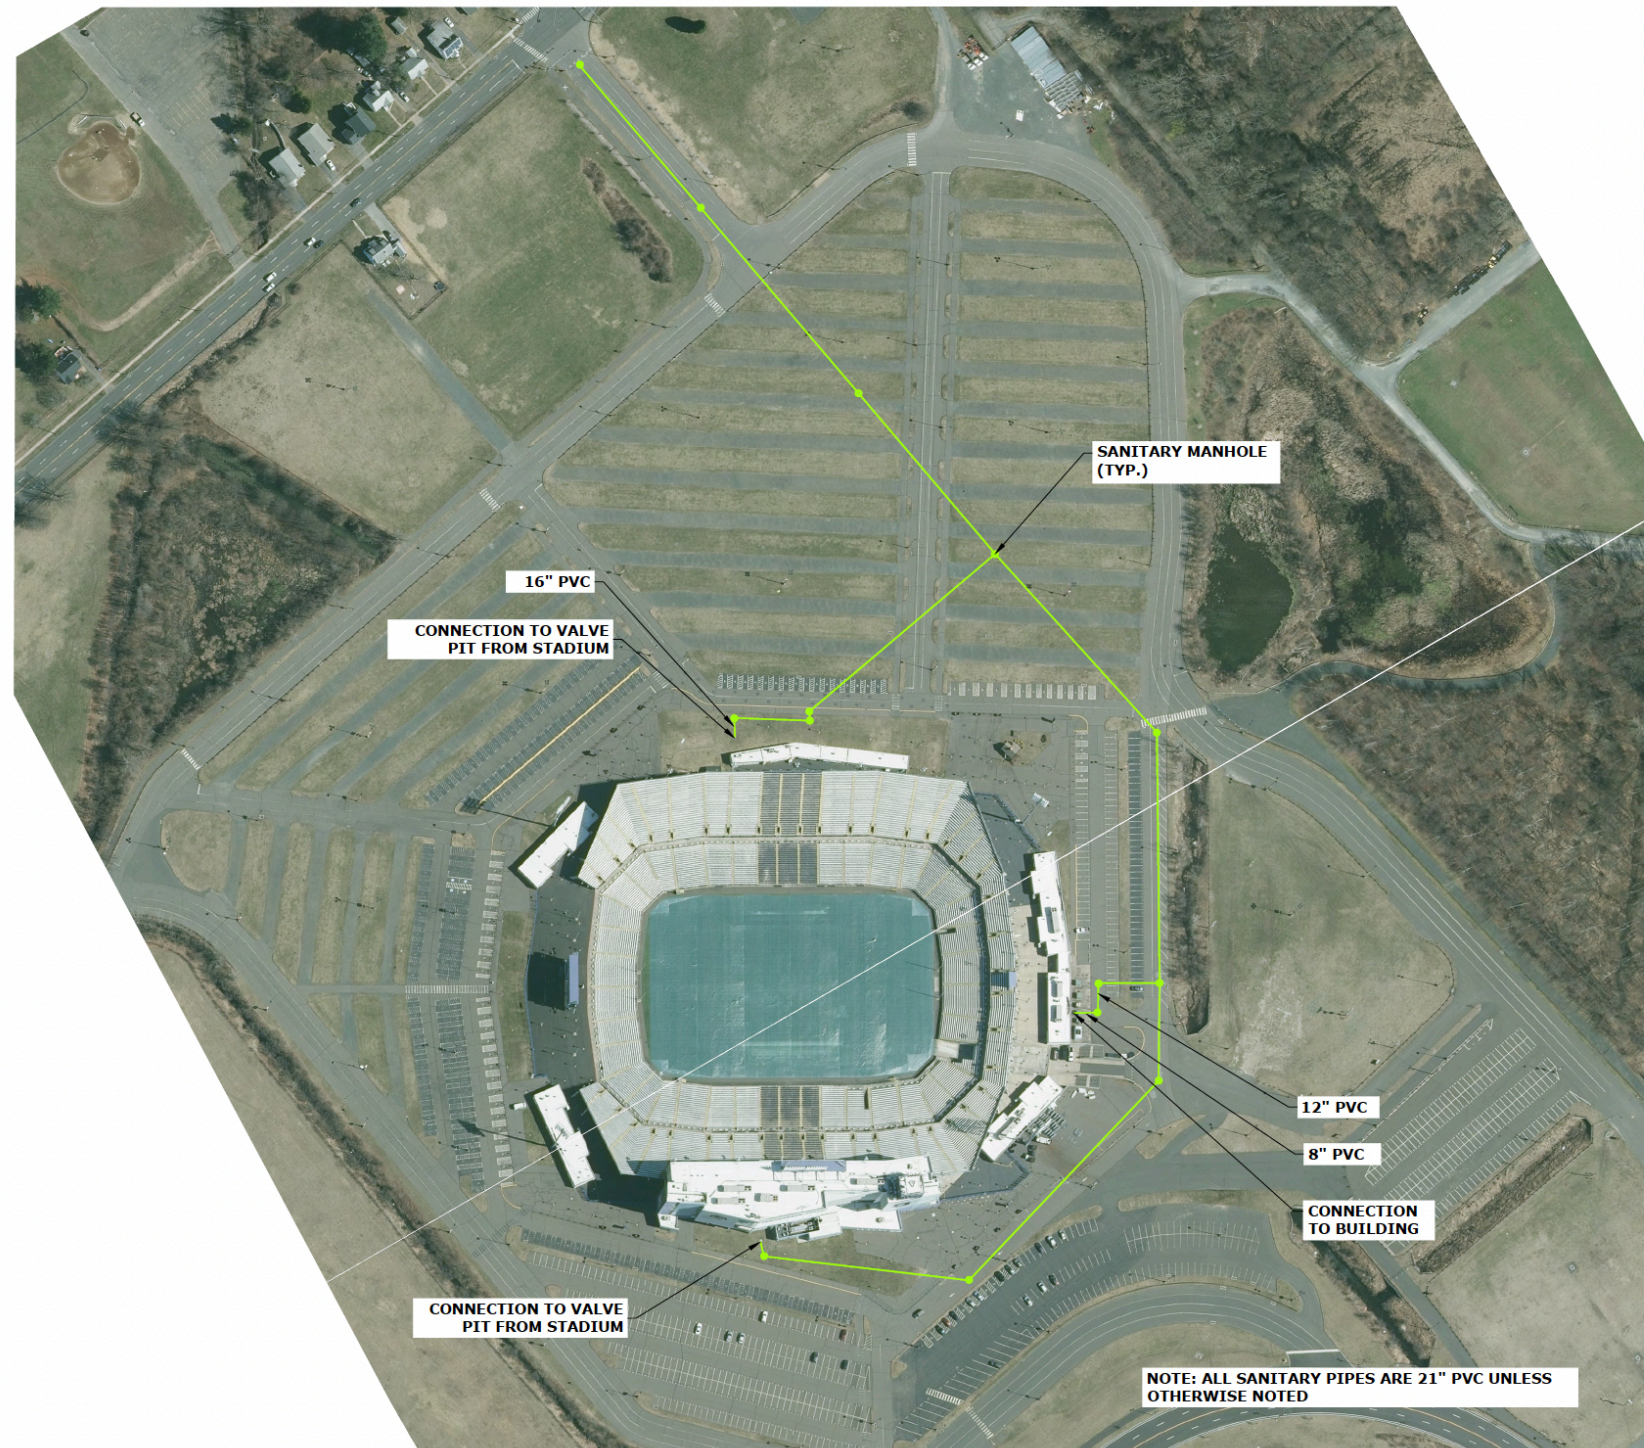
FIGURE 4: SANITARY SEWER SYSTEM PIPING INSPECTION
PRATT & WHITNEY STADIUM FACILITY ASSESSMENT

Beneficially, there were no deficiencies, blockages, collapses, or any other detrimental issues observed in any of the sanitary piping throughout the inspection.

(There are no recommendations proposed for the sanitary piping.)

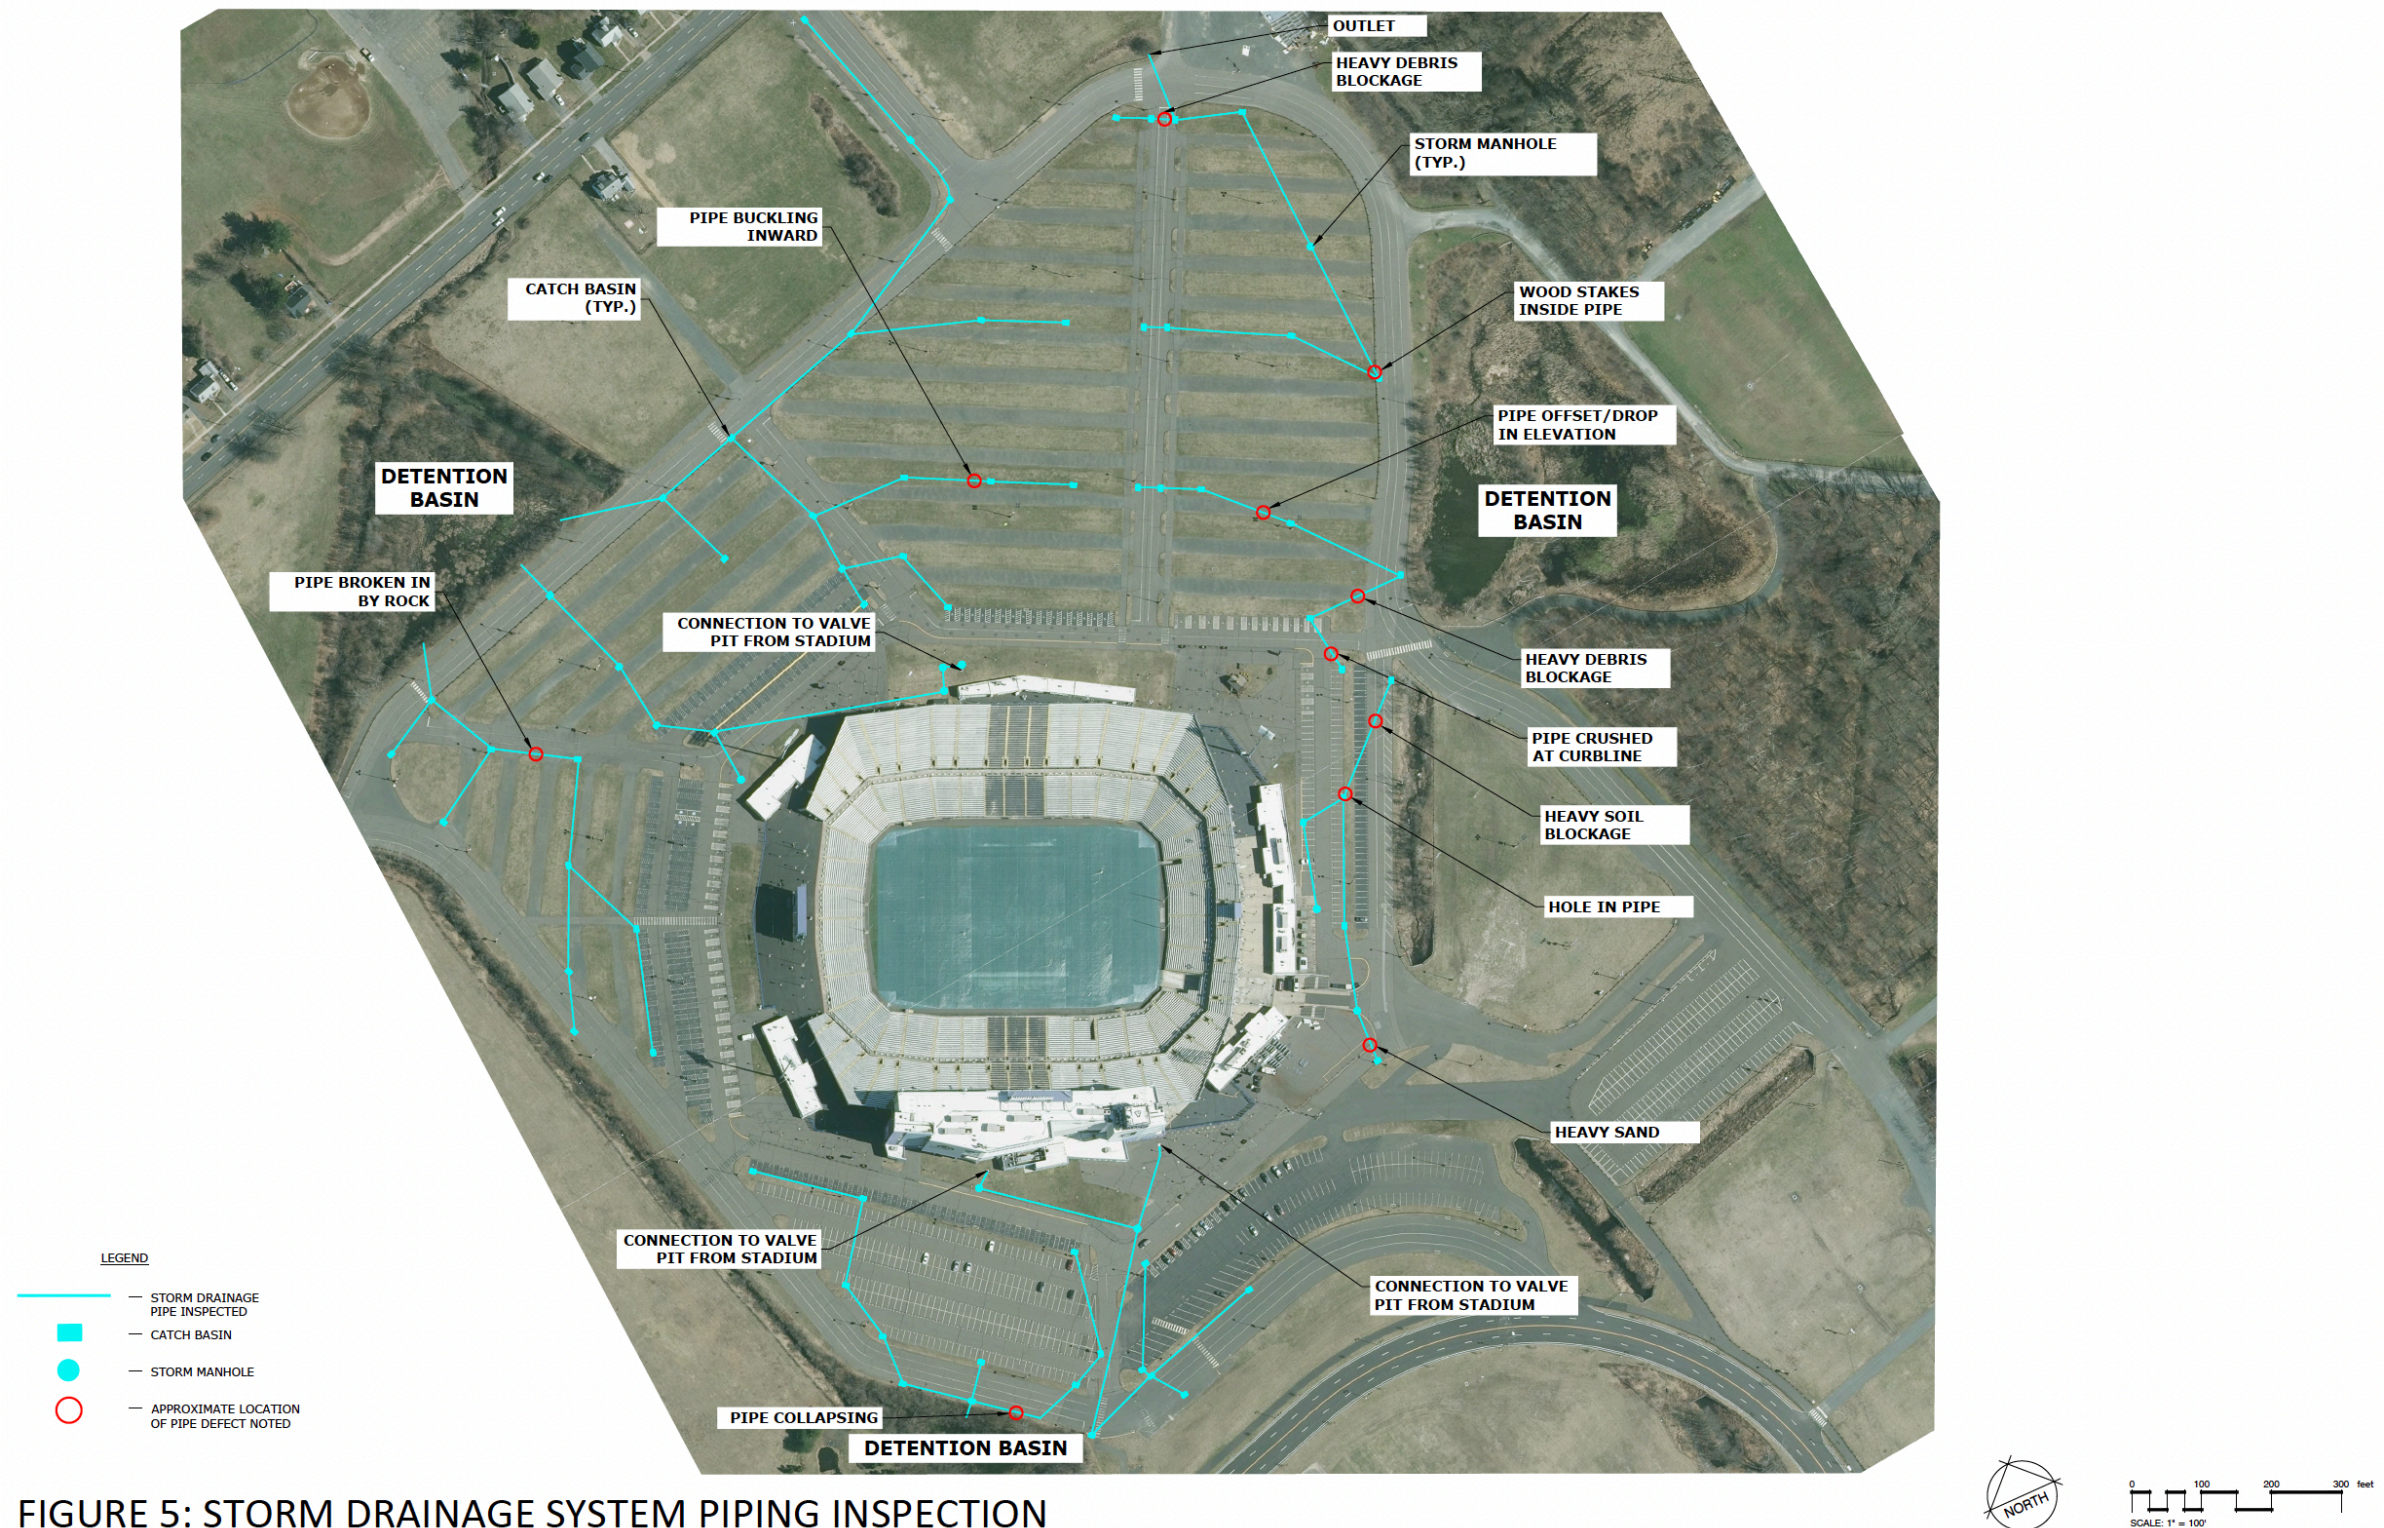
FIGURE 5: STORM DRAINAGE SYSTEM PIPING INSPECTION
PRATT & WHITNEY STADIUM FACILITY ASSESSMENT

Upon completion of the inspections, it was determined that there are 11 locations in the drainage system where deficiencies were observed, including heavy siltation, foreign debris blockage, crushed pipes, and broken pipes. Please see Figure 5 - "Storm Drainage System Piping inspection" (page 25), which documents the drainage lines that were inspected and the locations where obstructions or deficiencies were observed.

We recommend consulting a storm drainage cleaning service to clean heavily silted piping. These services may also have the ability to clear piping obstructed with foreign debris.

We recommend the damaged piping as indicated in the inspection reports be assessed on a case-by-case bases for replacement. These damaged individual sections of piping should be capable of replacement of the immediate pipe section, not the entire piping run.

Please refer to Figure 5 (page 25) for a graphical representation of the Storm piping that was inspected in this assessment, and for the locations of the defects observed.
