# **Comprehensive Building Assessment** Rentschler Field at Pratt & Whitney Stadium

Capital Region Development Authority

Populous was engaged by the Capital Regional Development Authority (CRDA) to provide a comprehensive building system assessment for Pratt & Whitney Stadium at Rentschler Field that benchmarks the current condition of the facility. As part of the assessment, Venue Solutions Group, in partnership with the consultant team, has developed a 20-year capital expense matrix to assist the CRDA in establishing priorities for major repairs, potential upgrades and maintaining the facility in a professional manner. The ability to plan and maintain the stadium as it transitions from years 19 to 30 is crucial in extending the life of the facility as well as its relevance in the competitive and ever evolving regional and national marketplace.

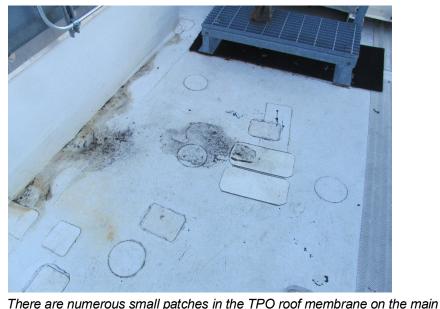
Tower Building: The existing low-slope TPO single-ply membrane roof covering systems generally appear to be in very poor condition. There are active moisture leaks into the building interior that, we were informed, have not yet been addressed. We understand that the TPO roofing/flashing membrane has previously sustained burns/damage/leakage in many places, resulting from pyrotechnics/fireworks that were previously launched from the roofs. There are numerous patches/repaired areas throughout the Tower Building roofs. It was also noted that the membrane base flashings surrounding an equipment curb (west penthouse roof) are delaminated from the field roof membrane, and nonwatertight. Based upon a visual examination of the roof covering system, it is evident that there is substantial moisture saturation of the roof insulation and roof deck substrate beneath the roof membrane, and it is very likely that an extensive portion of the roof insulation/underlayments and the concrete roof deck are moisture-saturated.

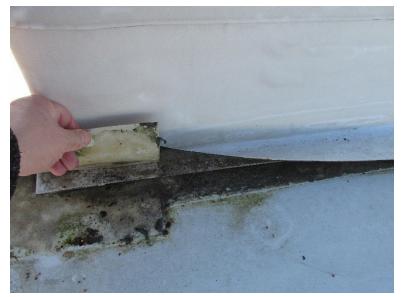
TPO membrane base flashings surrounding an equipment curb are delaminated from the roof membrane, and non-watertight.

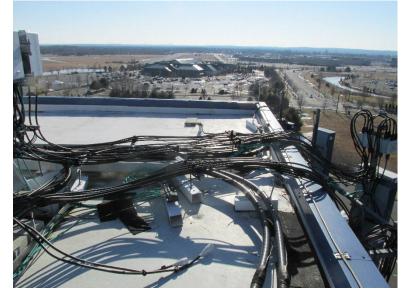
Much of the west stair/elevator penthouse roof is covered with telecom equipment/antennae/cabling.

Numerous telecom cables are extended from equipment atop the west stair/elevator penthouse roof, over the roof edge, and downward to connect with other equipment installed in other areas of the building and/or grounds.

2. Tower Building: Coordinate with all telecom carriers with equipment/cabling on the roofs, for temporary removal/reinstallation of their equipment from the roofs, so as to provide full access to all areas of the roofs, for removal/replacement of the roof covering systems. Completely remove the existing roof covering systems, including all membrane, insulation/underlayments, sheet metal flashings, etc., down to the concrete roof deck. Make all necessary repairs to any damaged/deteriorated roof deck/ substrates. Allow the concrete roof deck to properly dry, prior to applying new insulation/roofing materials. Make repairs to the existing drainage elements or remove/replace the roof drains/overflow drains. Install a new roof insulation assembly, to meet current codes for thermal efficiency and wind uplift. Install a new single-ply membrane roof covering system that is fully-adhered to the roof insulation assembly/substrate, and to comply with current wind uplift requirements. Install all new prefinished sheet metal flashings associated with the roof replacement. Design and install new fall protection equipment (that may also include reinstallation of exiting equipment, to meet current codes/safety requirements. Install safety/fall protection equipment, to comply with current codes/regulations.

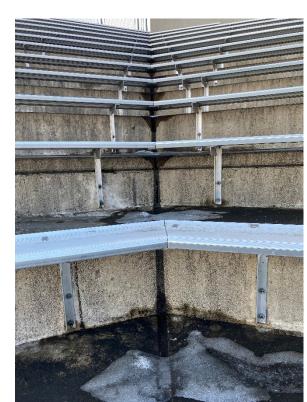
Sealant maintenance/replacement required

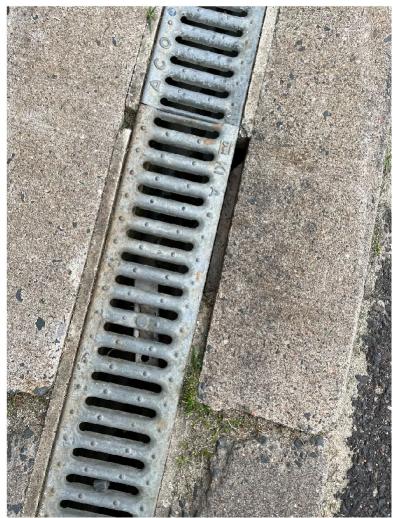
The perimeter trench drains are significantly damaged, displaying broken drain edges and damaged grates. Additionally, the installed grates do not appear to be rated for truck traffic at the field access tunnel.

Broken trench drain edge

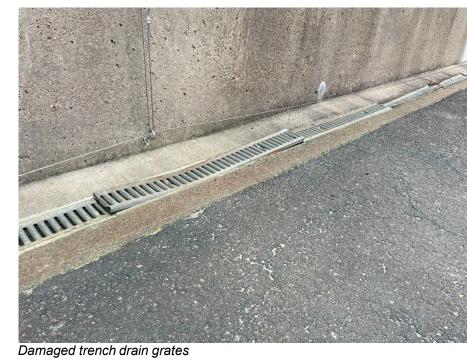
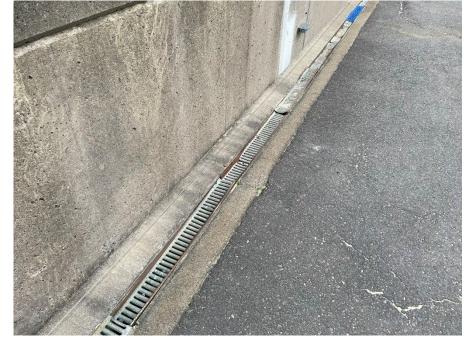
Damaged trench drain grates

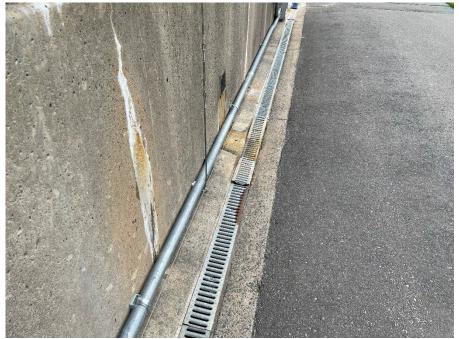
Damaged trench drain grates

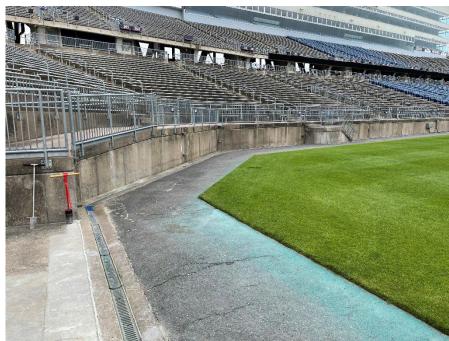
Perimeter track at Service Tunnel

The Perimeter Track displays significant cracking. There are significant gaps in the pavement where it has been cut out for the installation of conduits.

The perimeter track should be replaced with concrete or heavy-duty asphalt within its current extents and be expanded as noted in Appendix A to allow the passage of maintenance equipment/vehicles without impeding on the turf area. It is recommended that the pavement be covered with a synthetic running track material along the sidelines where soccer player benches will reside as to prevent slippage of players wearing cleats. The track should slope from the field edge to the field wall to accommodate drainage.

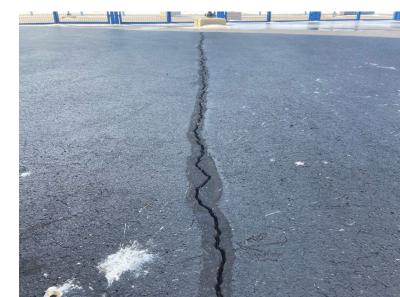
Flexible pavement cracking on Main Concourse

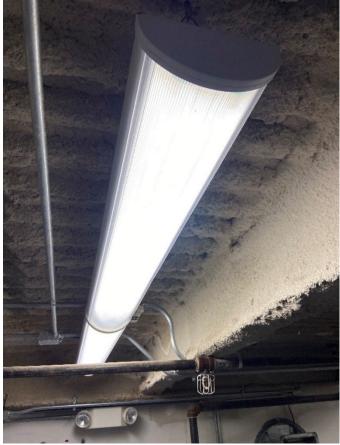
A majority of existing interior luminaires feature fluorescent lamps, which have a shorter lifespan and lower energy efficiency than equivalent LED light sources. As such, lamp replacements are a frequent task for facilities maintenance personnel, requiring time and expense to access light fixtures, remove lensing, and maintain a large stock of spare inventory.

Fluorescent luminaire in back-of-house equipment room

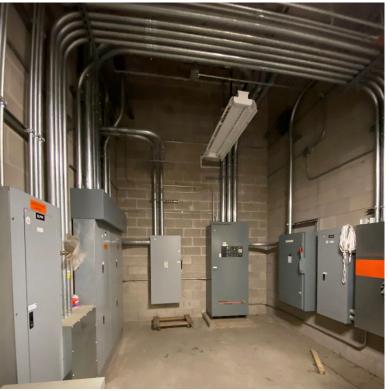
Failed lamps in back-of-house equipment room luminaire

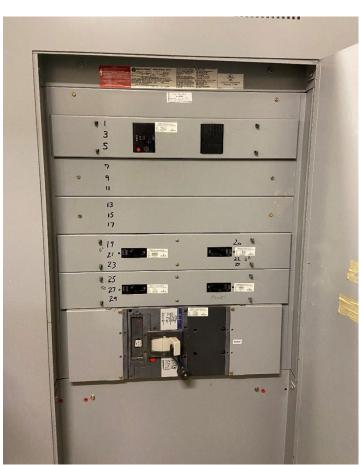
Acknowledging the electrical system panels and overcurrent protection devices original to the building are now 20 years old, it is prudent to comprehensively test them for safe and reliable operation. For example, low voltage molded case circuit breaker (MCCB) interior components such as copper contacts and spring-loaded operating mechanism lubrication can wear down over time, causing delayed trip clearing times and increasing risk of fire from an overload or fault condition. Similar testing and lubrication are recommended for medium voltage power circuit breakers located in unit substations and switchgear throughout the facility, with additional consideration given to replace any worn arcing contacts.

Typical distribution panel with MCCB breakers.

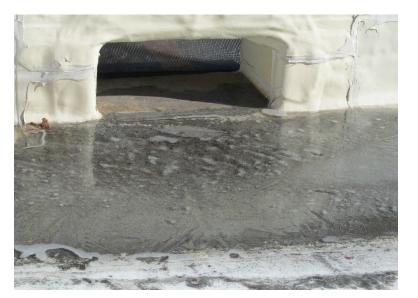
When the overlay roof covering systems were installed in 2020, some deficiencies that existed in the original TPO roof covering system were left in place, and covered over with the new EPDM membrane system, such as through-wall scuppers not being properly sumped below the surface of the roof membrane (photo above). As a result, the roof continues to retain water at the scuppers.

Through-wall scuppers (Buildings 1-7 and 9) are not properly sumped below the roof surface level and, as a result, water is retained (ponding) on the roof at many of the scuppers. This deficiency was not corrected when the new overlay roof membranes were installed on Buildings 1, 3, and 9, and can contribute to premature aging of the roof covering system.

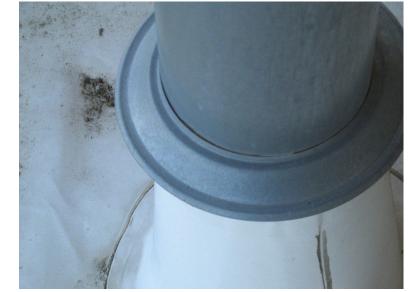
Pipes, conduits, and other round items that penetrate the roof are flashed with a premanufactured TPO flashing boot that is heat-welded to the roof membrane, and terminated at the top with a metal draw band and an application of elastomeric sealant. The existing sealant on some roof penetrations is poorly installed and/or deteriorated, and potentially nonwatertight.

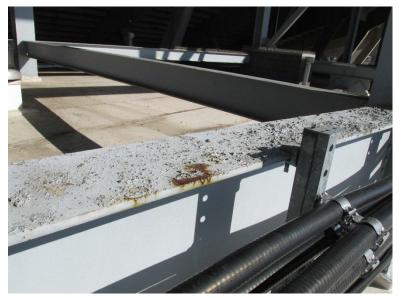
The acidity of bird droppings causes damage to paint/finishes on sheet metal flashings, as well as conduits and steel structural members. Once the paint/coatings on metals/steel are eroded through, bird feces typically will cause corrosion of the underlying metal/steel.

The paint on the top surface of this steel structural member is significantly eroded and, as a result, the steel is rusting. Many exposed steel members are in need of being cleaned, prepared, primed, and painted,

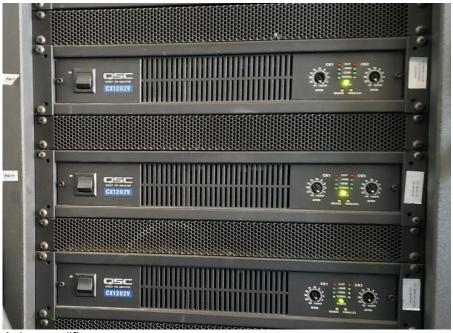
The bowl sound mixing equipment is near or at the end of service life. The QSC CX series amplifiers, while known for very long service life, are likely to require repair or replacement in the next five years. The operator could not confirm whether the various AV closets around the bowl were on emergency power, so as to maintain bowl audio for emergency announcements.

Aging amplifiers

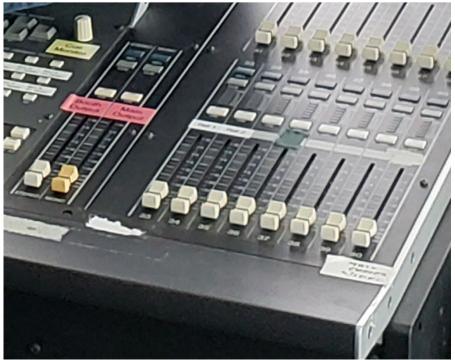
The Yamaha M7 console is about 15 years old, with several unusable/failed channel strips and intermittent main faders. Service parts may not be available past 2025.

Yamaha M7 mixer – example channel modules

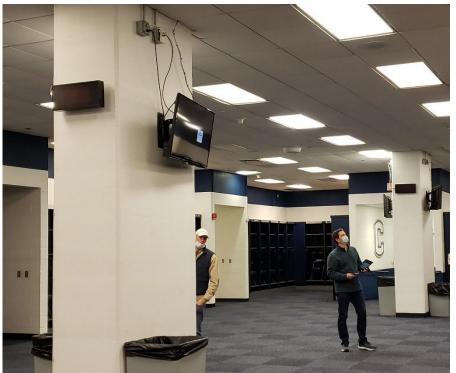
The home locker room television system is in very poor condition, with older televisions, intermittent cable TV reception, and unsightly installation of power and cable connections.

Home locker room televisions

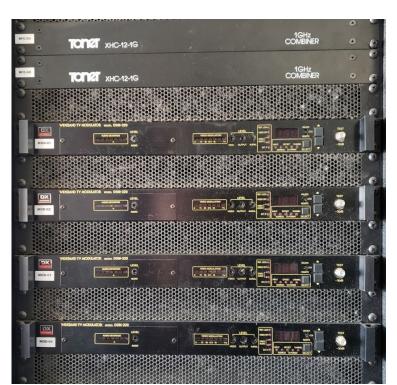
The RF/Coax system is original to the building and in severe decline; reception at some televisions is very poor.

Deteriorating RF components

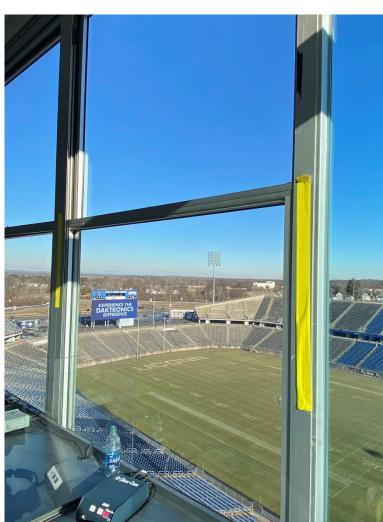
Temporary cable route through press window

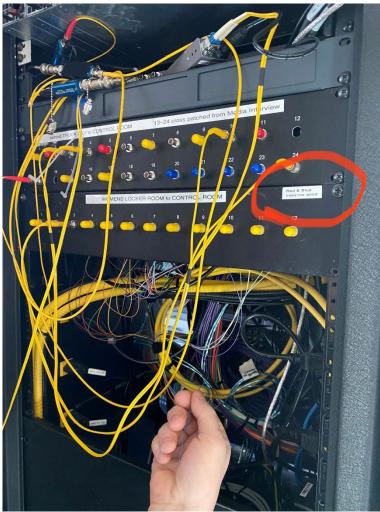
- The Blackmagic router is unreliable as it has broken inputs and outputs and patches become unconnected.
- Not all the fiber patch lines are functional.

Unusable fiber connections with blue and red caps

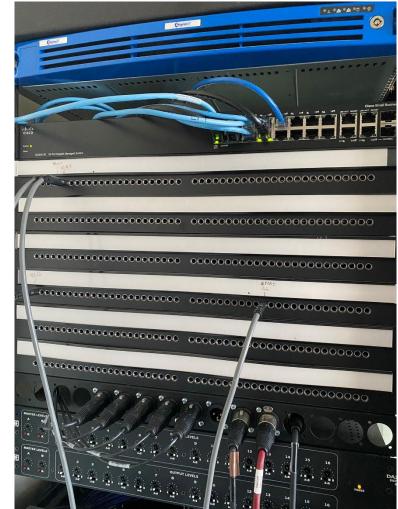
Unlabeled patch bays

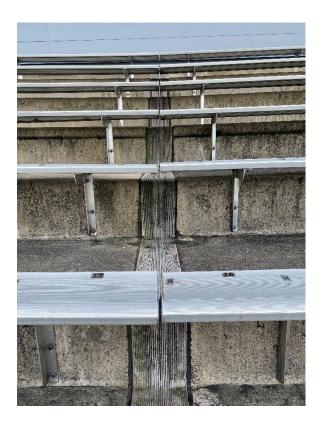
Cracking and separation joints are observed throughout the bowl. These joints were observed on a day when snow was melting. The water is making its way through to the underside of the bowl in areas and should be addressed. Generally, it appears there has been an ongoing maintenance program of exterior sealants.

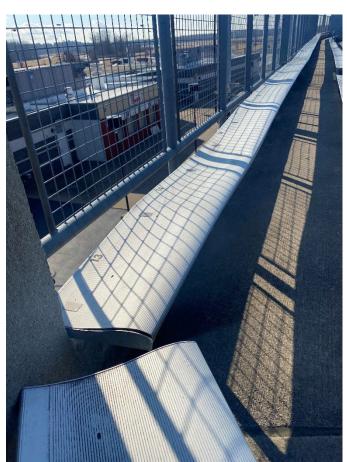
Bench seating is bent and damaged

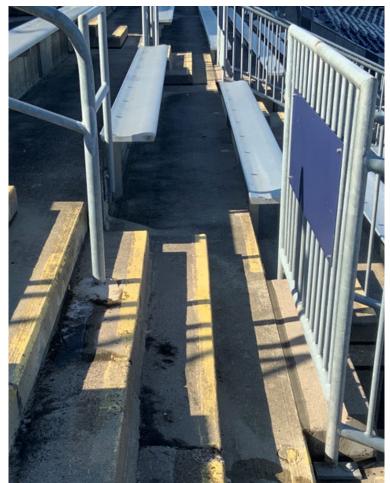
Figure 4: Guard at bottom of aisle/top of vomitory

This is an existing condition and will need to be addressed if a Level 2 or 3 alteration occurs in the area.

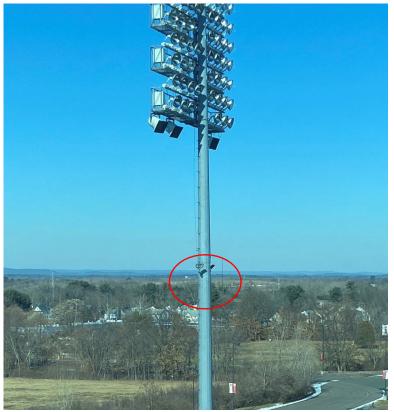
Original metal-halide emergency lights mounted on sports lighting poles.
