# Civil and Exterior Assessment

Rentschler Field at Pratt & Whitney Stadium

September 7, 2022

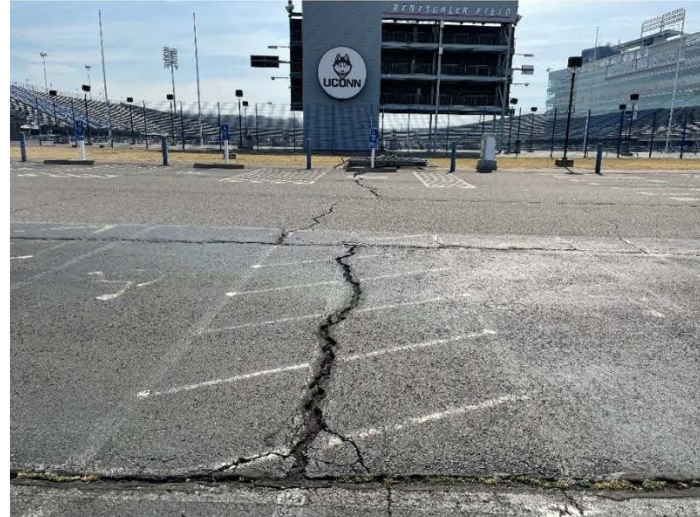
Lot	Pavement Condition	Pavement Notes	Curbing Notes	Pavement Marking/Signage Notes	Representative Photograph
Lot 2	Serious	<ul style="list-style-type: none"> <li>- Longitudinal cracking apparent throughout entire lot, spaced approximately 15' apart, apparently at the interface between paving courses. Cracking appears up to 4" wide and 1-2 inches deep</li> <li>- Transverse Cracks throughout entire lot, up to 3" wide and 1-2 inches deep.</li> <li>- There is evidence of previous crack sealing throughout the lot. At this time, however, the cracks are of sufficient width that the crack sealing is no longer functioning effectively.</li> <li>- Minor alligator cracking noted in isolated areas near joint cracks. Due to the loss of pavement integrity at the corners created by the longitudinal and transverse cracks, loading of the pavement in these areas caused the corners to break off. (See representative photo)</li> </ul>	<ul style="list-style-type: none"> <li>- No curbing present in lot.</li> </ul>	<ul style="list-style-type: none"> <li>- Pavement markings are severely faded and in need of replacement.</li> <li>- Original lot striping was sealed over and replaced with accessible parking striping. The pavement sealing has deteriorated overtime and the original striping is now starting to show through, confusing the striping configuration.</li> <li>- Cross walk striping is severely faded.</li> <li>- One section of Striping (4 spaces) have been replaced in the north portion of this lot.</li> <li>- Only the accessible parking immediately adjacent to the stadium contains signage. The signage does not meet code. Refer to the code section of this report for further information.</li> </ul>

<p><i>Lot 2: Longitudinal and Transverse Cracks greater than 3" wide.</i></p>

In those instances where the cracking is excessive and some subgrade may be compromised (Lot 2, lot 4), Reclaim-in-place is a viable option, where the existing pavement is ground directly into the base layer, creating a very stable base layer to overlay new pavement over. This would be the second most affordable improvement option over the mill and overly. Curbs would also be replaced.

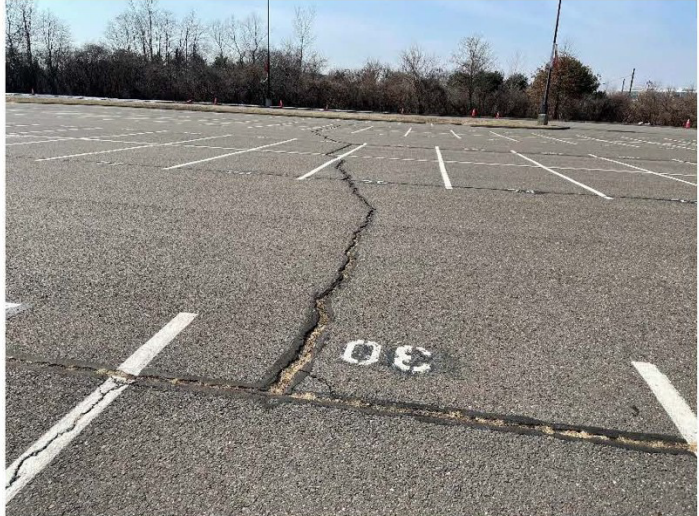
Lot 3	Poor	<ul style="list-style-type: none"> <li>- Longitudinal cracking apparent throughout entire lot, apparently at the interface between paving courses. Cracks up to 3" wide and 1" deep</li> <li>- Numerous 2" wide transverse cracks noted along length of handicapped parking area</li> <li>- Transverse cracking, ranging between 2" to 3" in width, noted in several locations of main parking area .</li> <li>- There is evidence of previous crack sealing throughout the lot. At this time, however, the cracks are of sufficient width that the crack sealing is no longer functioning effectively.</li> </ul>	<ul style="list-style-type: none"> <li>- Two areas of fractured curbing noted in the accessible parking area of lot.</li> </ul>	<ul style="list-style-type: none"> <li>- Pavement markings are severely faded in the accessible parking and are in need of replacement</li> <li>- The accessible Parking was sealed over and replaced with new striping. The pavement sealing has deteriorated overtime and the original striping is now starting to show through, confusing the striping configuration.</li> <li>- The remaining portions of lot 3 striping (non-accessible) are in satisfactory condition.</li> <li>- Crosswalk striping is severely faded ns in need of replacement</li> <li>- Only 11 of the accessible spaces include signs. The signage does not meet code. Refer to the code section of this report for further information.</li> </ul>

<p><i>Lot 3: Longitudinal and Transverse Cracks greater than 2" wide.</i></p>

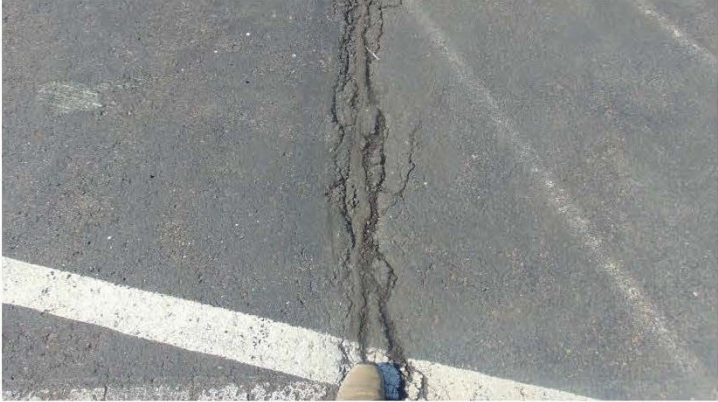
Lot	Pavement Condition	Pavement Notes	Curbing Notes	Pavement Marking/Signage Notes	Representative Photograph
Lot 4	Serious	<ul style="list-style-type: none"> <li>- Longitudinal cracking apparent throughout entire lot, apparently at the interface between paving courses. Cracks are up to 6" wide in some areas with instances of pavement separation (see representative photo).</li> <li>- Transverse Cracks throughout entire lot, up to 2" wide and 1" deep.</li> <li>- Alligator cracking observed in isolated areas.</li> <li>- There is some evidence of previous crack sealing throughout the lot. At this time, however, the cracks are of sufficient width that the crack sealing is no longer functioning effectively. There is also evidence of new cracking with no sealing.</li> <li>- Minor alligator cracking noted in isolated areas near joint cracks. Due to the loss of pavement integrity at the corners created by the longitudinal and transverse cracks, loading of the pavement in these areas caused the corners to break off. (See representative photo)</li> </ul>	<ul style="list-style-type: none"> <li>- Large section of damaged curbing noted in northeast portion of lot.</li> </ul>	<ul style="list-style-type: none"> <li>- Pavement markings are in satisfactory condition.</li> <li>- Crosswalks are in satisfactory condition.</li> <li>- There are no signs for the accessible spaces.</li> </ul>

<p data-bbox="1936 808 2620 862"><i>Lot 4: Longitudinal Cracks greater than 6" wide, with evidence of pavement separation.</i></p>

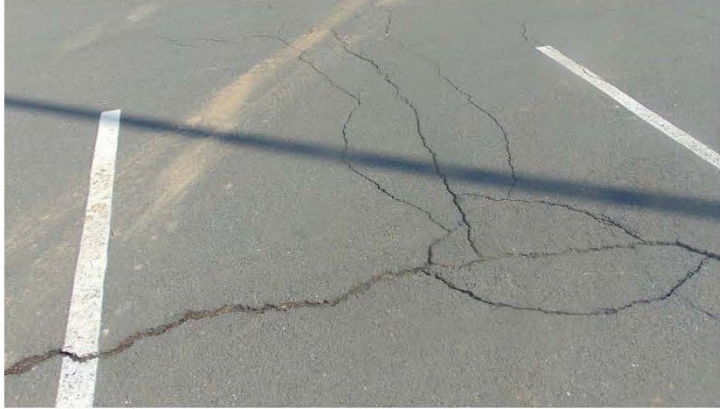
<p data-bbox="1936 1276 2324 1302"><i>Lot 4: Evidence of Alligator Cracking.</i></p>

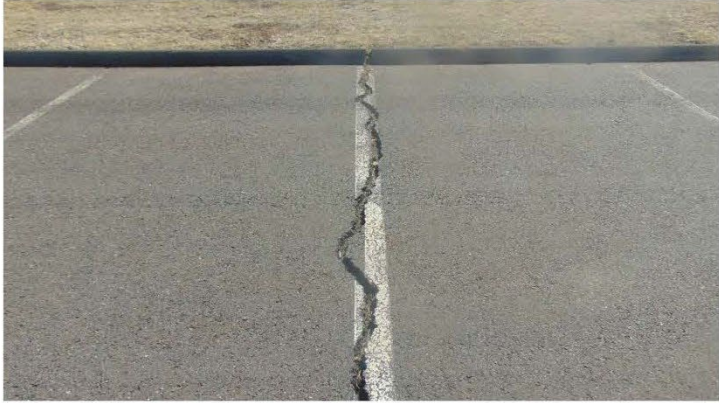
Lot 5	Poor	<ul style="list-style-type: none"> <li>- Longitudinal cracking apparent throughout entire lot, apparently at the interface between paving courses.</li> <li>- Transverse cracking, 2"-3" wide, is noted in regular intervals of around 20 feet.</li> <li>- There is some evidence of previous crack sealing throughout the lot. At this time, however, the cracks are of sufficient width that the crack sealing is no longer functioning effectively. There is also evidence of new cracking with no sealing.</li> <li>- Minor alligator cracking just starting in select areas.</li> </ul>	<ul style="list-style-type: none"> <li>- Curbing is tending to crack in the same location as the transvers crack locations.</li> </ul>	<ul style="list-style-type: none"> <li>- Pavement markings are severely faded in the accessible parking area and in need of replacement.</li> <li>- Original, non-accessible striping was eradicated and replaced with accessible striping, but the paint is severely faded.</li> <li>- The remaining original striping is in satisfactory condition.</li> <li>- There are signposts erected for accessible signage, but the signs do not exist.</li> </ul>

<p data-bbox="1936 1770 2635 1824"><i>Lot 5: Evidence of Transverse Cracking and Shrinkage Separation (note translation of parking stripe).</i></p>

Lot 5 is the only parking area with deficient accessible parking, being 1 space shy of the code compliant 5 spaces. Investigation of the area appears to show an additional 8 feet of striping area (4 feet on either end) not being utilized correctly for parking. We recommend this area be restriped, shifting the spaces down by 4 feet and effectively creating room for a fifth accessible space.

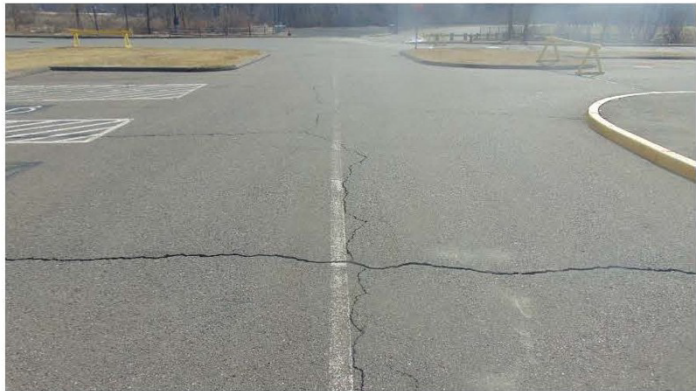
Lot	Pavement Condition	Pavement Notes	Curbing Notes	Pavement Marking/Signage Notes	Representative Photograph
Lot 7	Poor	<ul style="list-style-type: none"> <li>- Block cracking apparent throughout the extents of this lot. The separation cracks range anywhere from 0.5" to 2.5" wide and the blocks are approximately 20-30 feet square.</li> <li>- Paving course joint separation noted in some areas as well.</li> <li>- Limited crack sealing has occurred.</li> </ul>	<ul style="list-style-type: none"> <li>- Curbing fractured in multiple locations and beginning to be displaced.</li> </ul>	<ul style="list-style-type: none"> <li>- Pavement markings are in satisfactory condition.</li> <li>- Original, accessible striping was eradicated (painted over) and replaced with new striping in a different orientation.</li> <li>- The accessible spaces include signs, but they do not meet code. Refer to the code section of this report for further information.</li> </ul>

<p><i>Lot 7: Evidence of Block Cracking.</i></p>

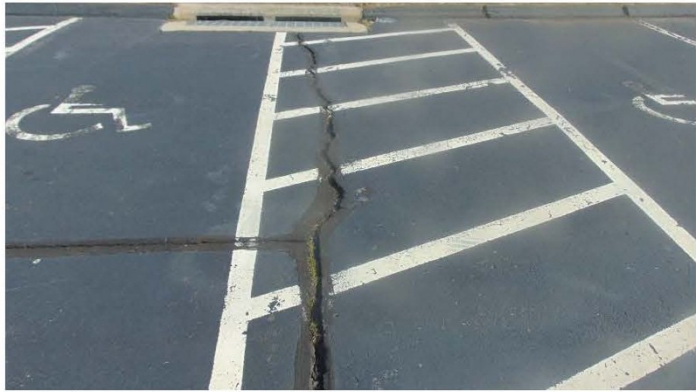
Lot 8	Poor	<ul style="list-style-type: none"> <li>- Longitudinal cracking apparent throughout entire lot, apparently at the interface between paving courses, ranging between 0.5" to 2" in width.</li> <li>- Transverse Cracks throughout entire lot, from 0.5" to 2" wide and up to 1" deep in some areas</li> <li>- There is some evidence of previous crack sealing throughout the lot. At this time, however, the cracks are of sufficient width that the crack sealing is no longer functioning effectively.</li> <li>- The accessible parking space area was sealed entirely with pavement sealer at one point, but that sealer is no longer functioning effectively.</li> <li>- There appears to be some minor evidence of alligator cracking in very select areas.</li> </ul>	<ul style="list-style-type: none"> <li>- Curbing fractured in multiple locations and beginning to be displaced.</li> </ul>	<ul style="list-style-type: none"> <li>- Pavement markings are in satisfactory condition.</li> <li>- Original striping was sealed over and replaced with the new accessible striping.</li> <li>- There are no signs for the accessible spaces.</li> <li>- Crosswalk striping is severely faded and in need of replacement</li> </ul>

<p><i>Lot 8: Evidence of minor Transverse Cracking.</i></p>

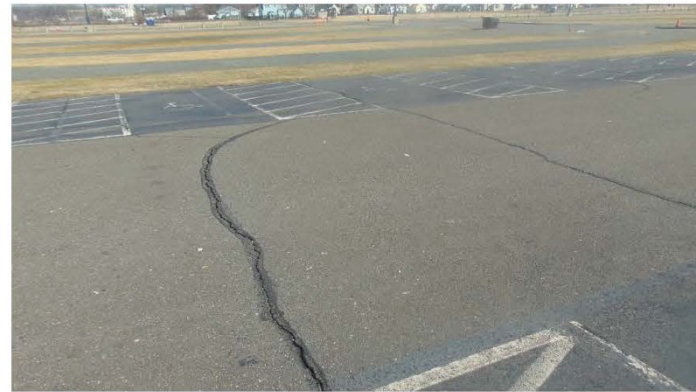
Lot 12	Poor	<ul style="list-style-type: none"> <li>- Longitudinal cracking apparent throughout entire lot, apparently at the interface between paving courses, ranging between 0.5" to 2" in width.</li> <li>- Transverse Cracks throughout entire lot, from 0.5" to 2" wide and up to 1" deep in some areas</li> <li>- Minor alligator cracking noted in some areas. Cracks were sealed at one point, but the sealing has failed, and the cracking continues to worsen.</li> <li>- The accessible parking space area was sealed entirely with pavement sealer at one point, but that sealer is no longer functioning effectively.</li> <li>- Paving course joint separation noted in some areas as well.</li> </ul>	<ul style="list-style-type: none"> <li>- Curbing is tending to crack in the same location as the transvers crack locations.</li> <li>- Section of Curb are also starting to displace.</li> </ul>	<ul style="list-style-type: none"> <li>- Pavement markings are severely faded in the accessible parking area and in need of replacement.</li> <li>- Original striping was sealed over and replaced with the new accessible striping.</li> <li>- There are no signs for the accessible spaces.</li> <li>- There is no crosswalk.</li> </ul>

<p><i>Lot 12: Evidence of Transverse Cracking.</i></p>

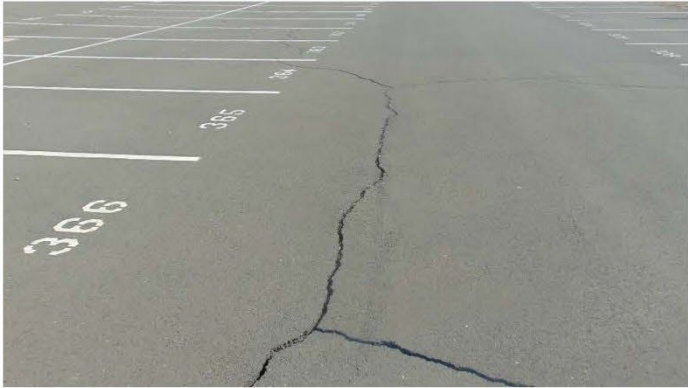
<p data-bbox="1951 798 2402 822"><i>Lot A: Longitudinal and Transverse Cracks.</i></p>

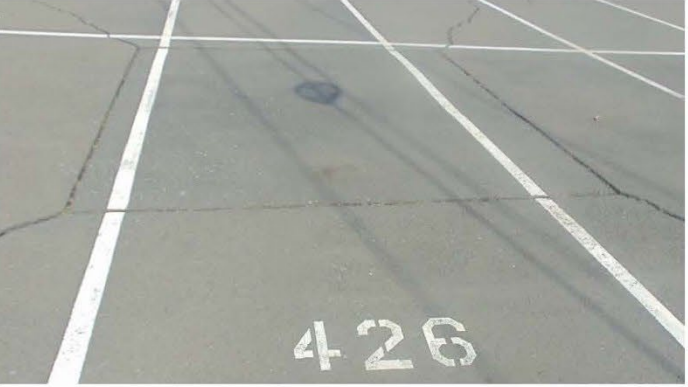
<p data-bbox="1951 1247 2551 1272"><i>Lot A: Block Cracking with Depression of pavement noted.</i></p>

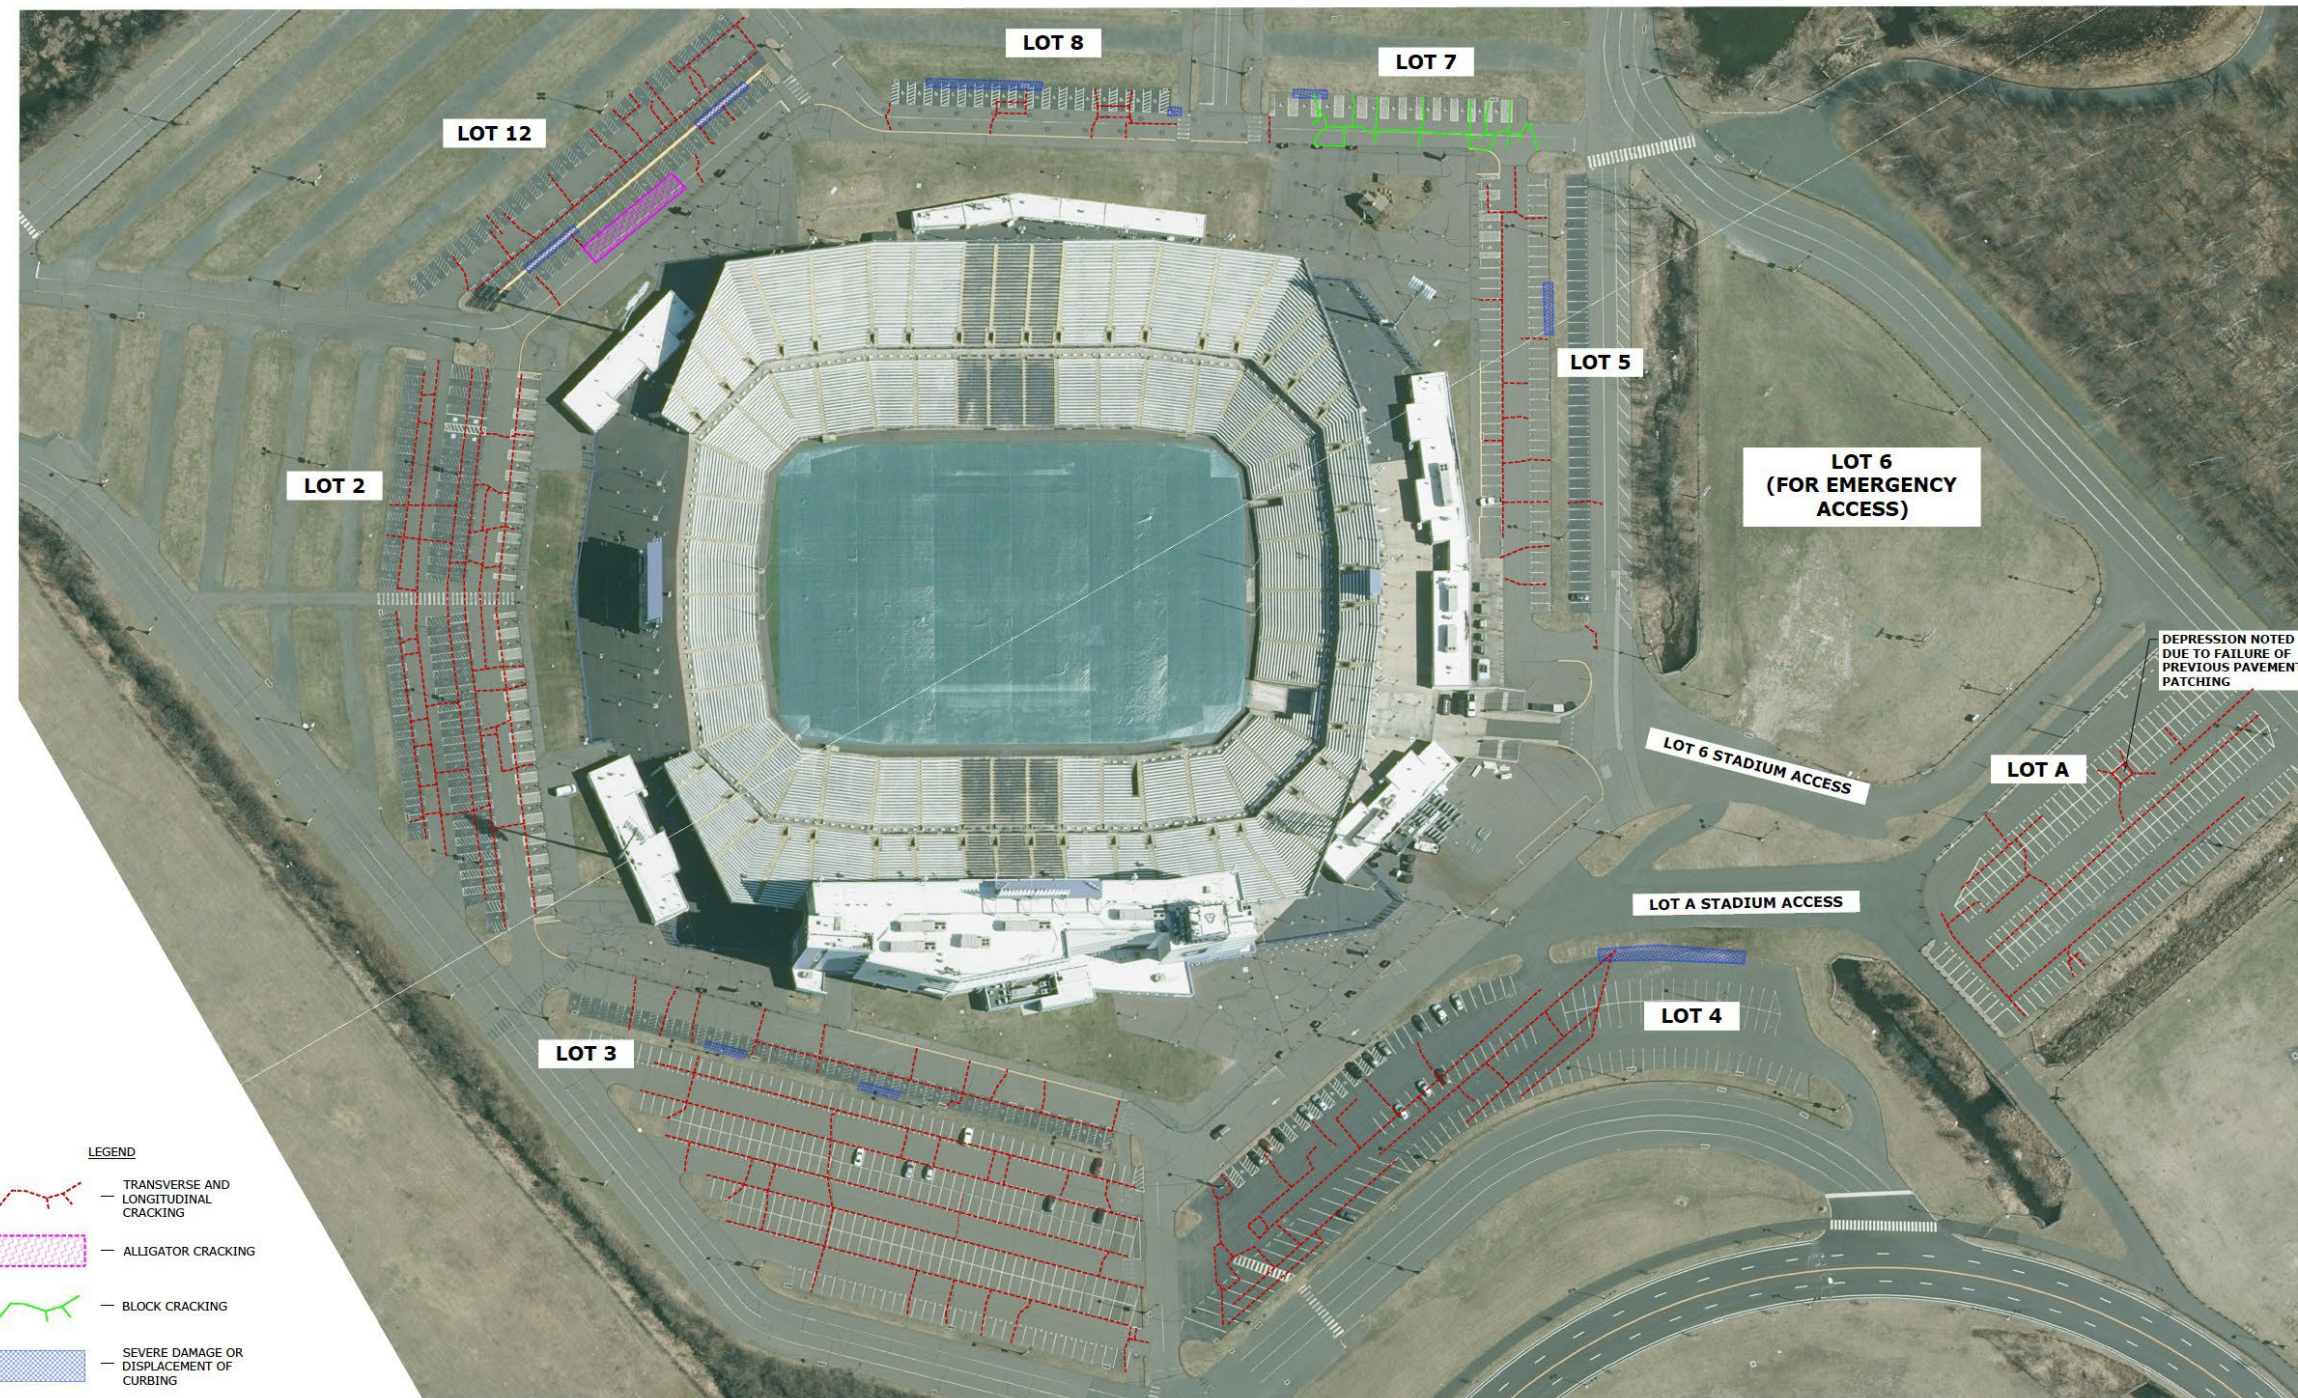
FIGURE 2: PARKING LOT PAVEMENT AND CURB ASSESSMENT  
PRATT & WHITNEY STADIUM FACILITY ASSESSMENT

The parking lot pavement and curbs ranged from fair condition to serious, with many instances of alligator, longitudinal, and transverse cracking. The pavement markings were generally in fair (acceptable) condition with only a few exceptions.

Though there appears to be a substantial amount of longitudinal and transverse cracking throughout all parking areas around the stadium, there is a much smaller amount of the other deterioration factors that were identified earlier in this report. This evidence points less to issues associate with the subbase material failing, but more to the failure of the pavement course due to its age. The pavement, at the end of its useful life, has lost all flexibility and has started to shrink in all directions, causing the observed cracking. Therefore, a reasonable recommendation for the majority of the pavement areas would be a Mill and Overlay.

A mill and overlay would remove the aged pavement either partially, or fully, via mechanical methods, while the subbase would remain relatively intact. The area would then be overlain with new pavement. This is also the cheapest improvement option that were generate a new pavement condition. The curbs surrounding these parking areas would also be replaced.

We do not feel full depth replacement of any entire parking area would be necessary at this time, with the exception of a few limited areas of substantial alligator cracking. In these areas, selective full depth replacement can be investigated.

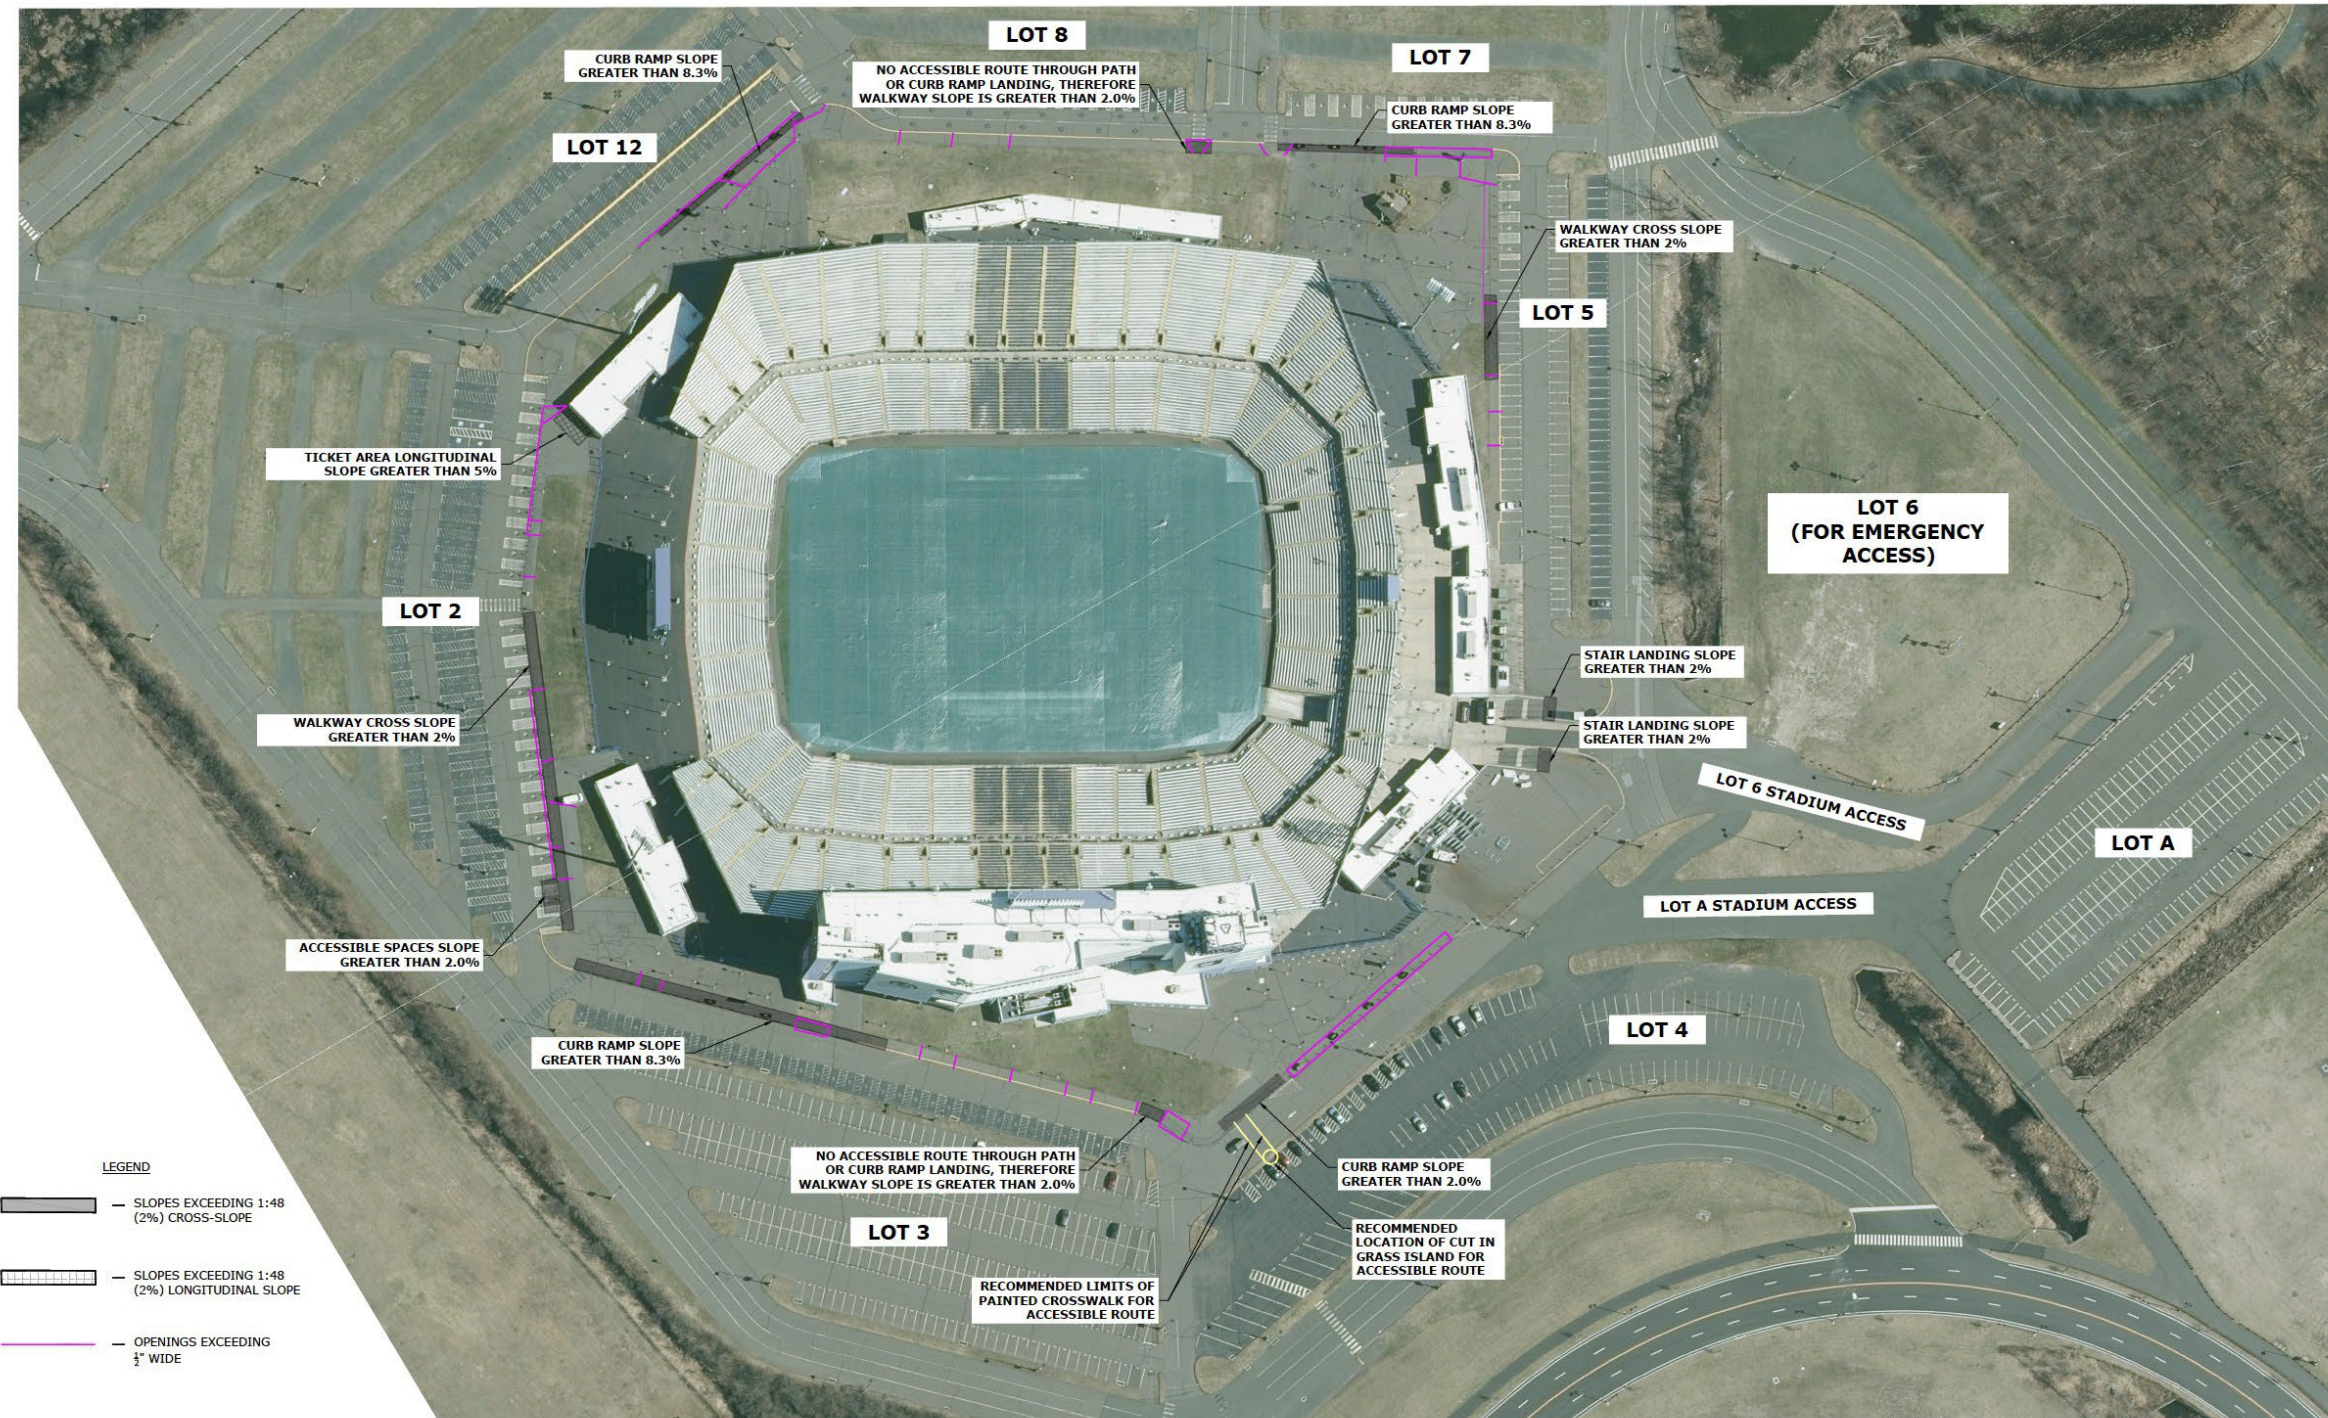
FIGURE 3: ACCESSIBLE ROUTE ASSESSMENT  
PRATT & WHITNEY STADIUM FACILITY ASSESSMENT

The accessible routes from the parking lots had a variety of issues resulting in non-compliance with code, such as observed openings greater than 1/2", changes in level greater than 1/2", longitudinal slope greater than 5.0%, and cross slope greater than 2.0%.

We recommend all cracks ½ or larger in opening width be filled to satisfy code compliance, either by replacement of the entire pavement area, whether parking or walkway, or via crack filling and sealer.

We recommend all changes in level that do not comply with code be reconstructed to be flush, either by replacement of the entire pavement area, whether parking or walkway, or via replacement of the specific deficient area.

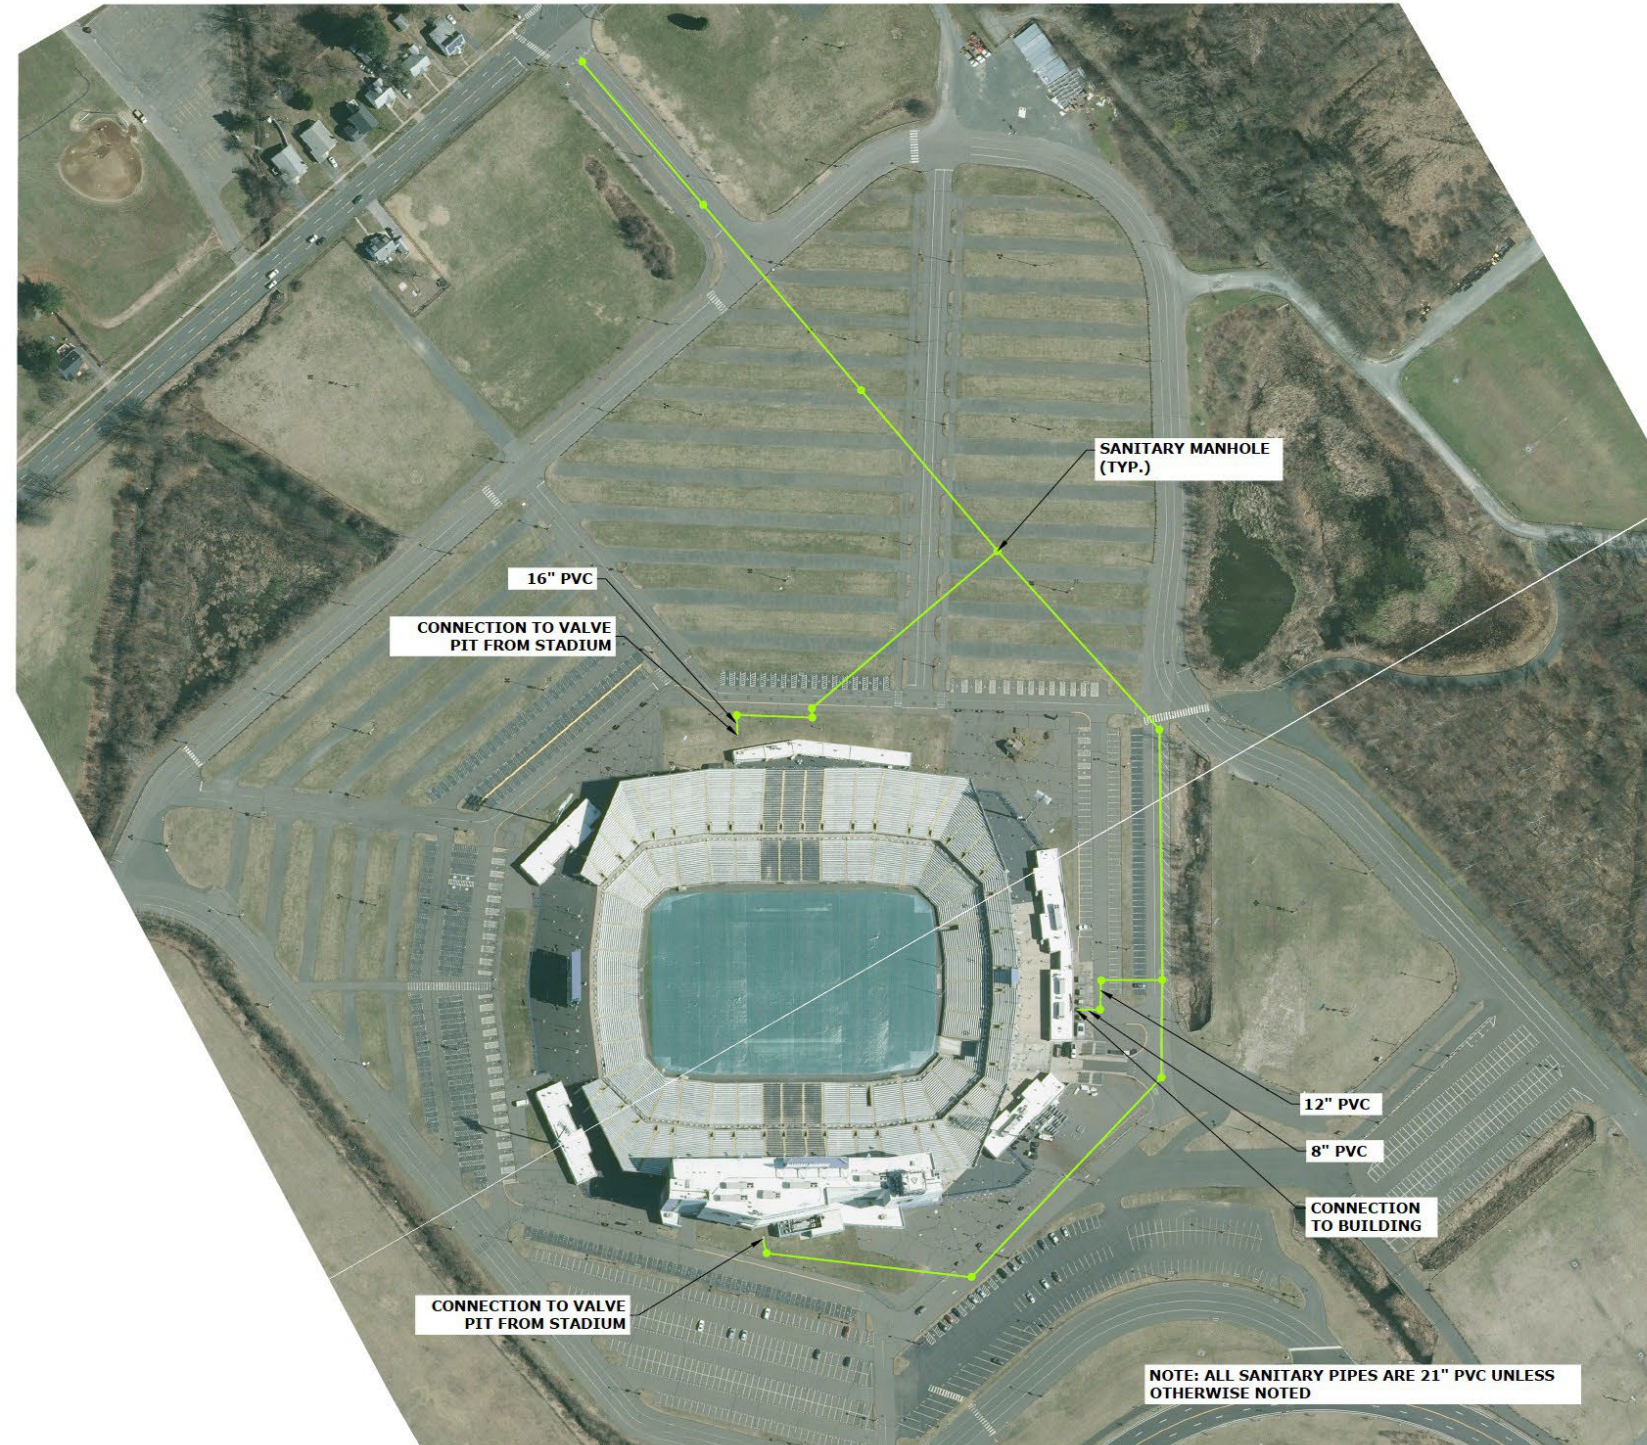
FIGURE 4: SANITARY SEWER SYSTEM PIPING INSPECTION  
 PRATT & WHITNEY STADIUM FACILITY ASSESSMENT

Beneficially, there were no deficiencies, blockages, collapses, or any other detrimental issues observed in any of the sanitary piping throughout the inspection.

*(There are no recommendations proposed for the sanitary piping.)*

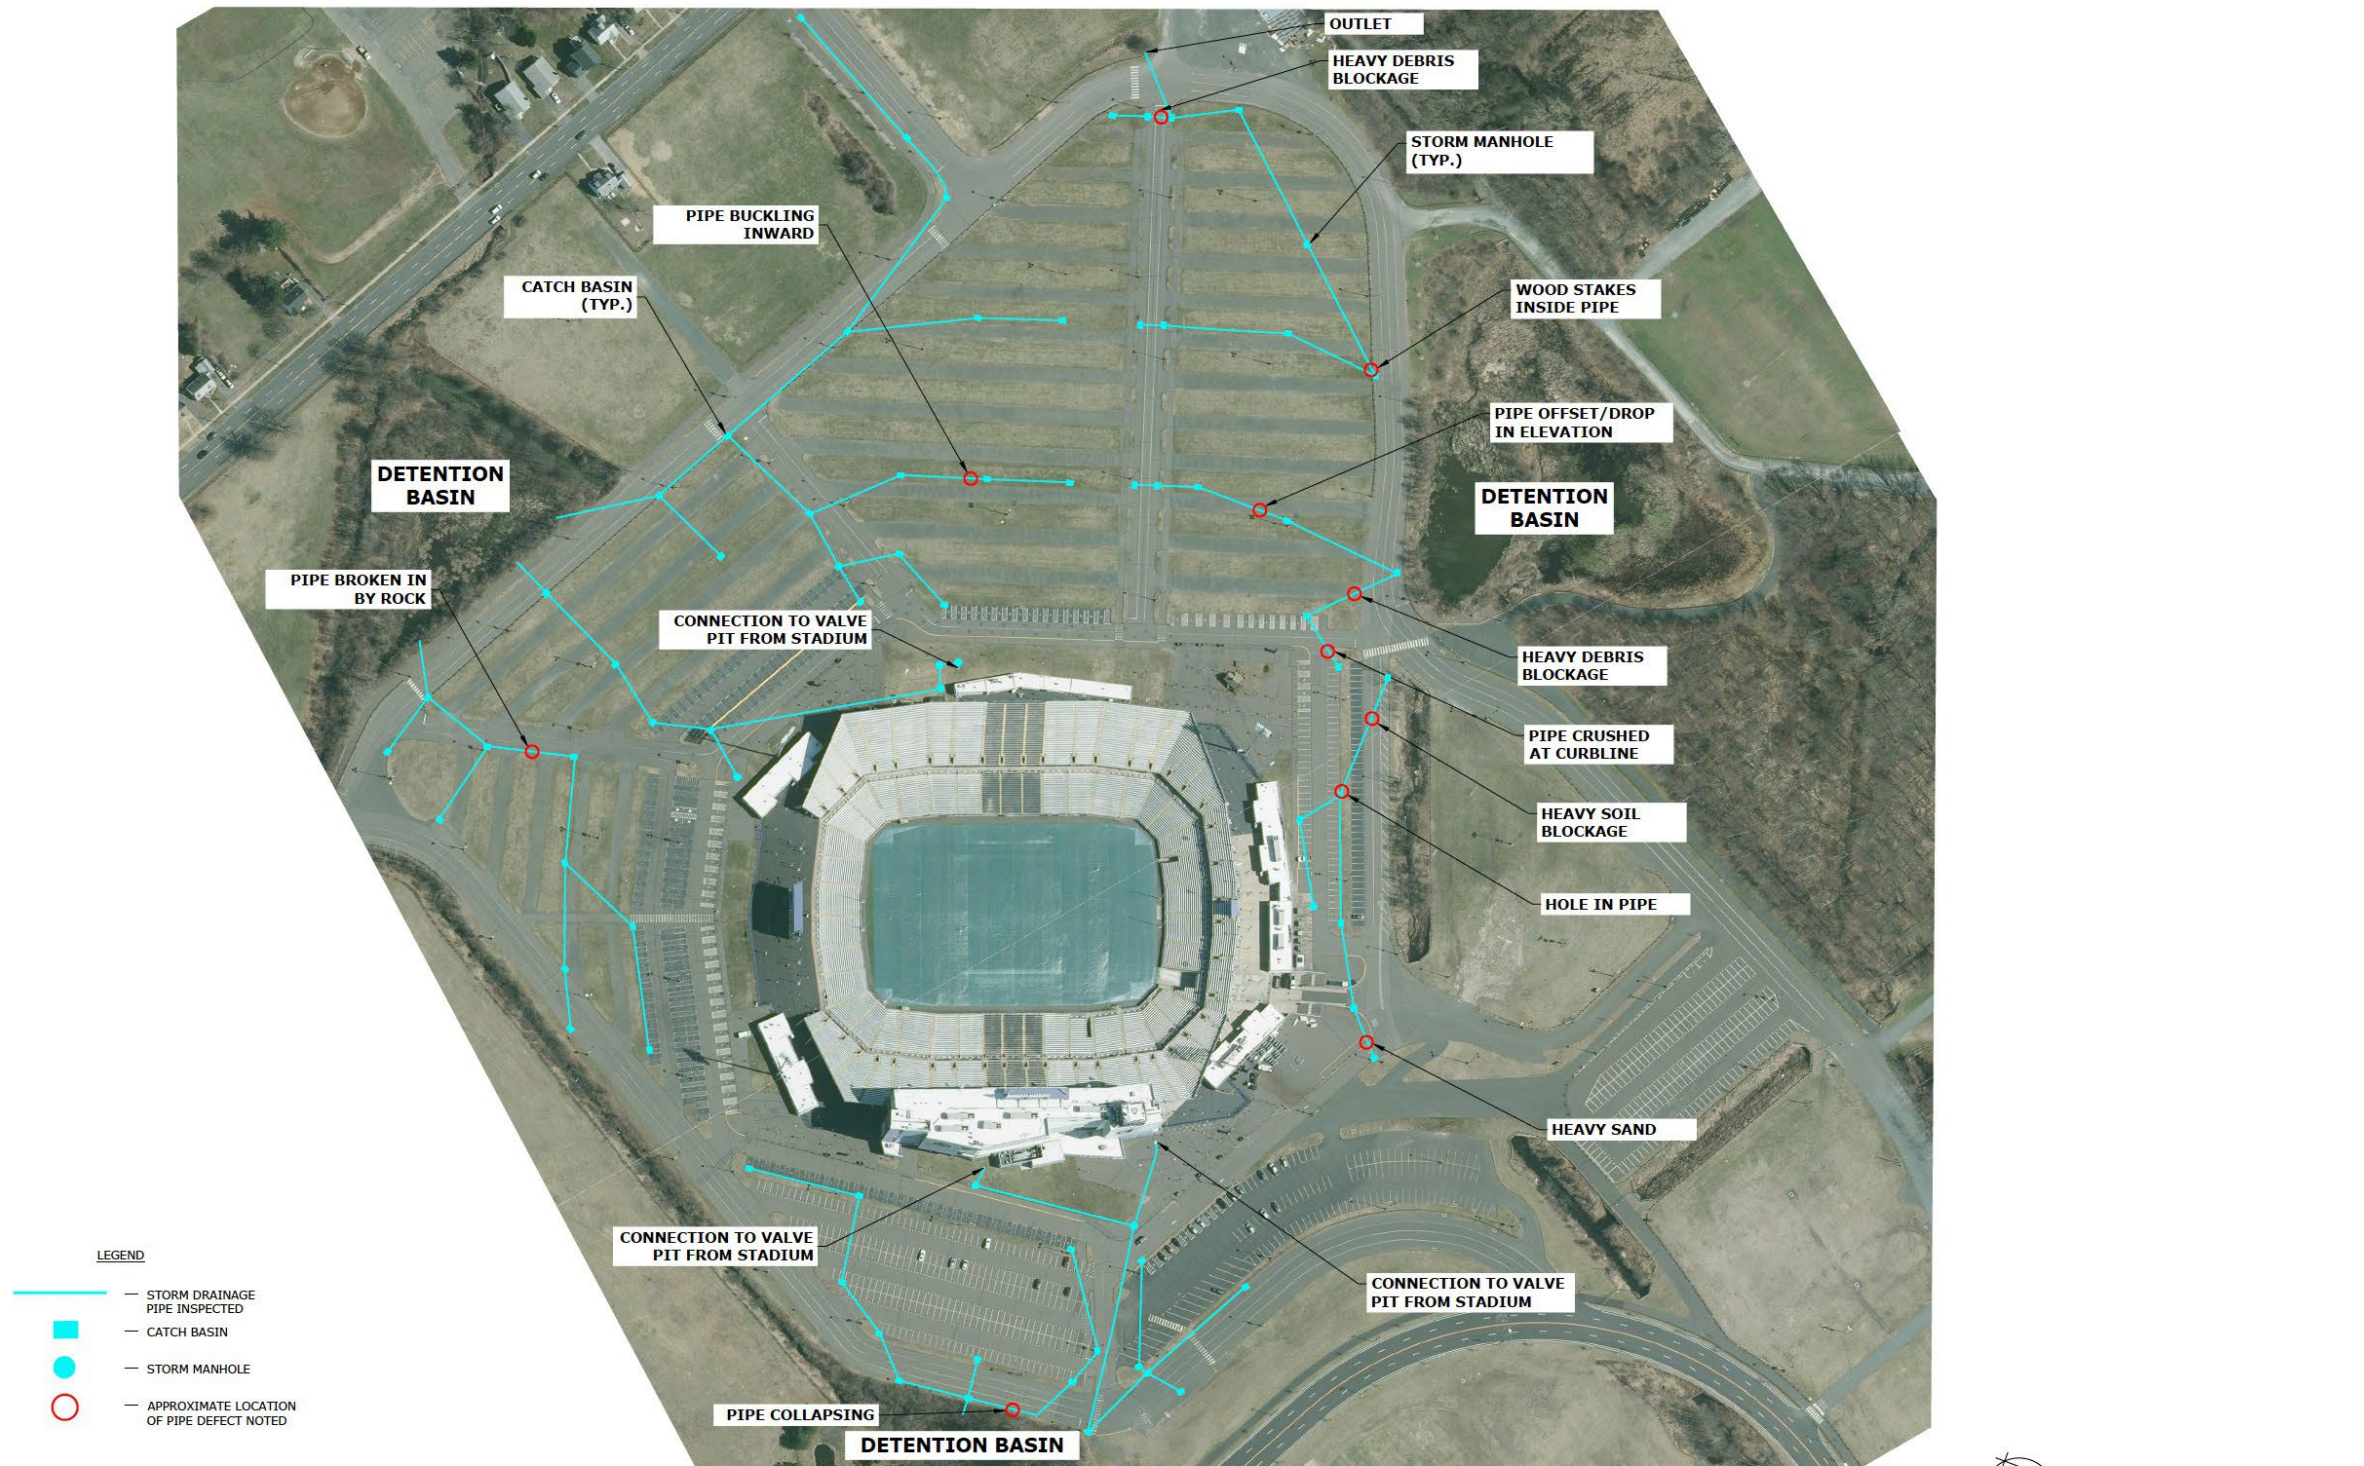
FIGURE 5: STORM DRAINAGE SYSTEM PIPING INSPECTION  
PRATT & WHITNEY STADIUM FACILITY ASSESSMENT

Upon completion of the inspections, it was determined that there are 11 locations in the drainage system where deficiencies were observed, including heavy siltation, foreign debris blockage, crushed pipes, and broken pipes. Please see Figure 5 - "Storm Drainage System Piping inspection" (page 25), which documents the drainage lines that were inspected and the locations where obstructions or deficiencies were observed.

We recommend consulting a storm drainage cleaning service to clean heavily silted piping. These services may also have the ability to clear piping obstructed with foreign debris.

We recommend the damaged piping as indicated in the inspection reports be assessed on a case-by-case bases for replacement. These damaged individual sections of piping should be capable of replacement of the immediate pipe section, not the entire piping run.
