# Asbestos Locations

ORIGINAL BUILDING 1959

# CT DEEP Regulated PCB Containing Materials

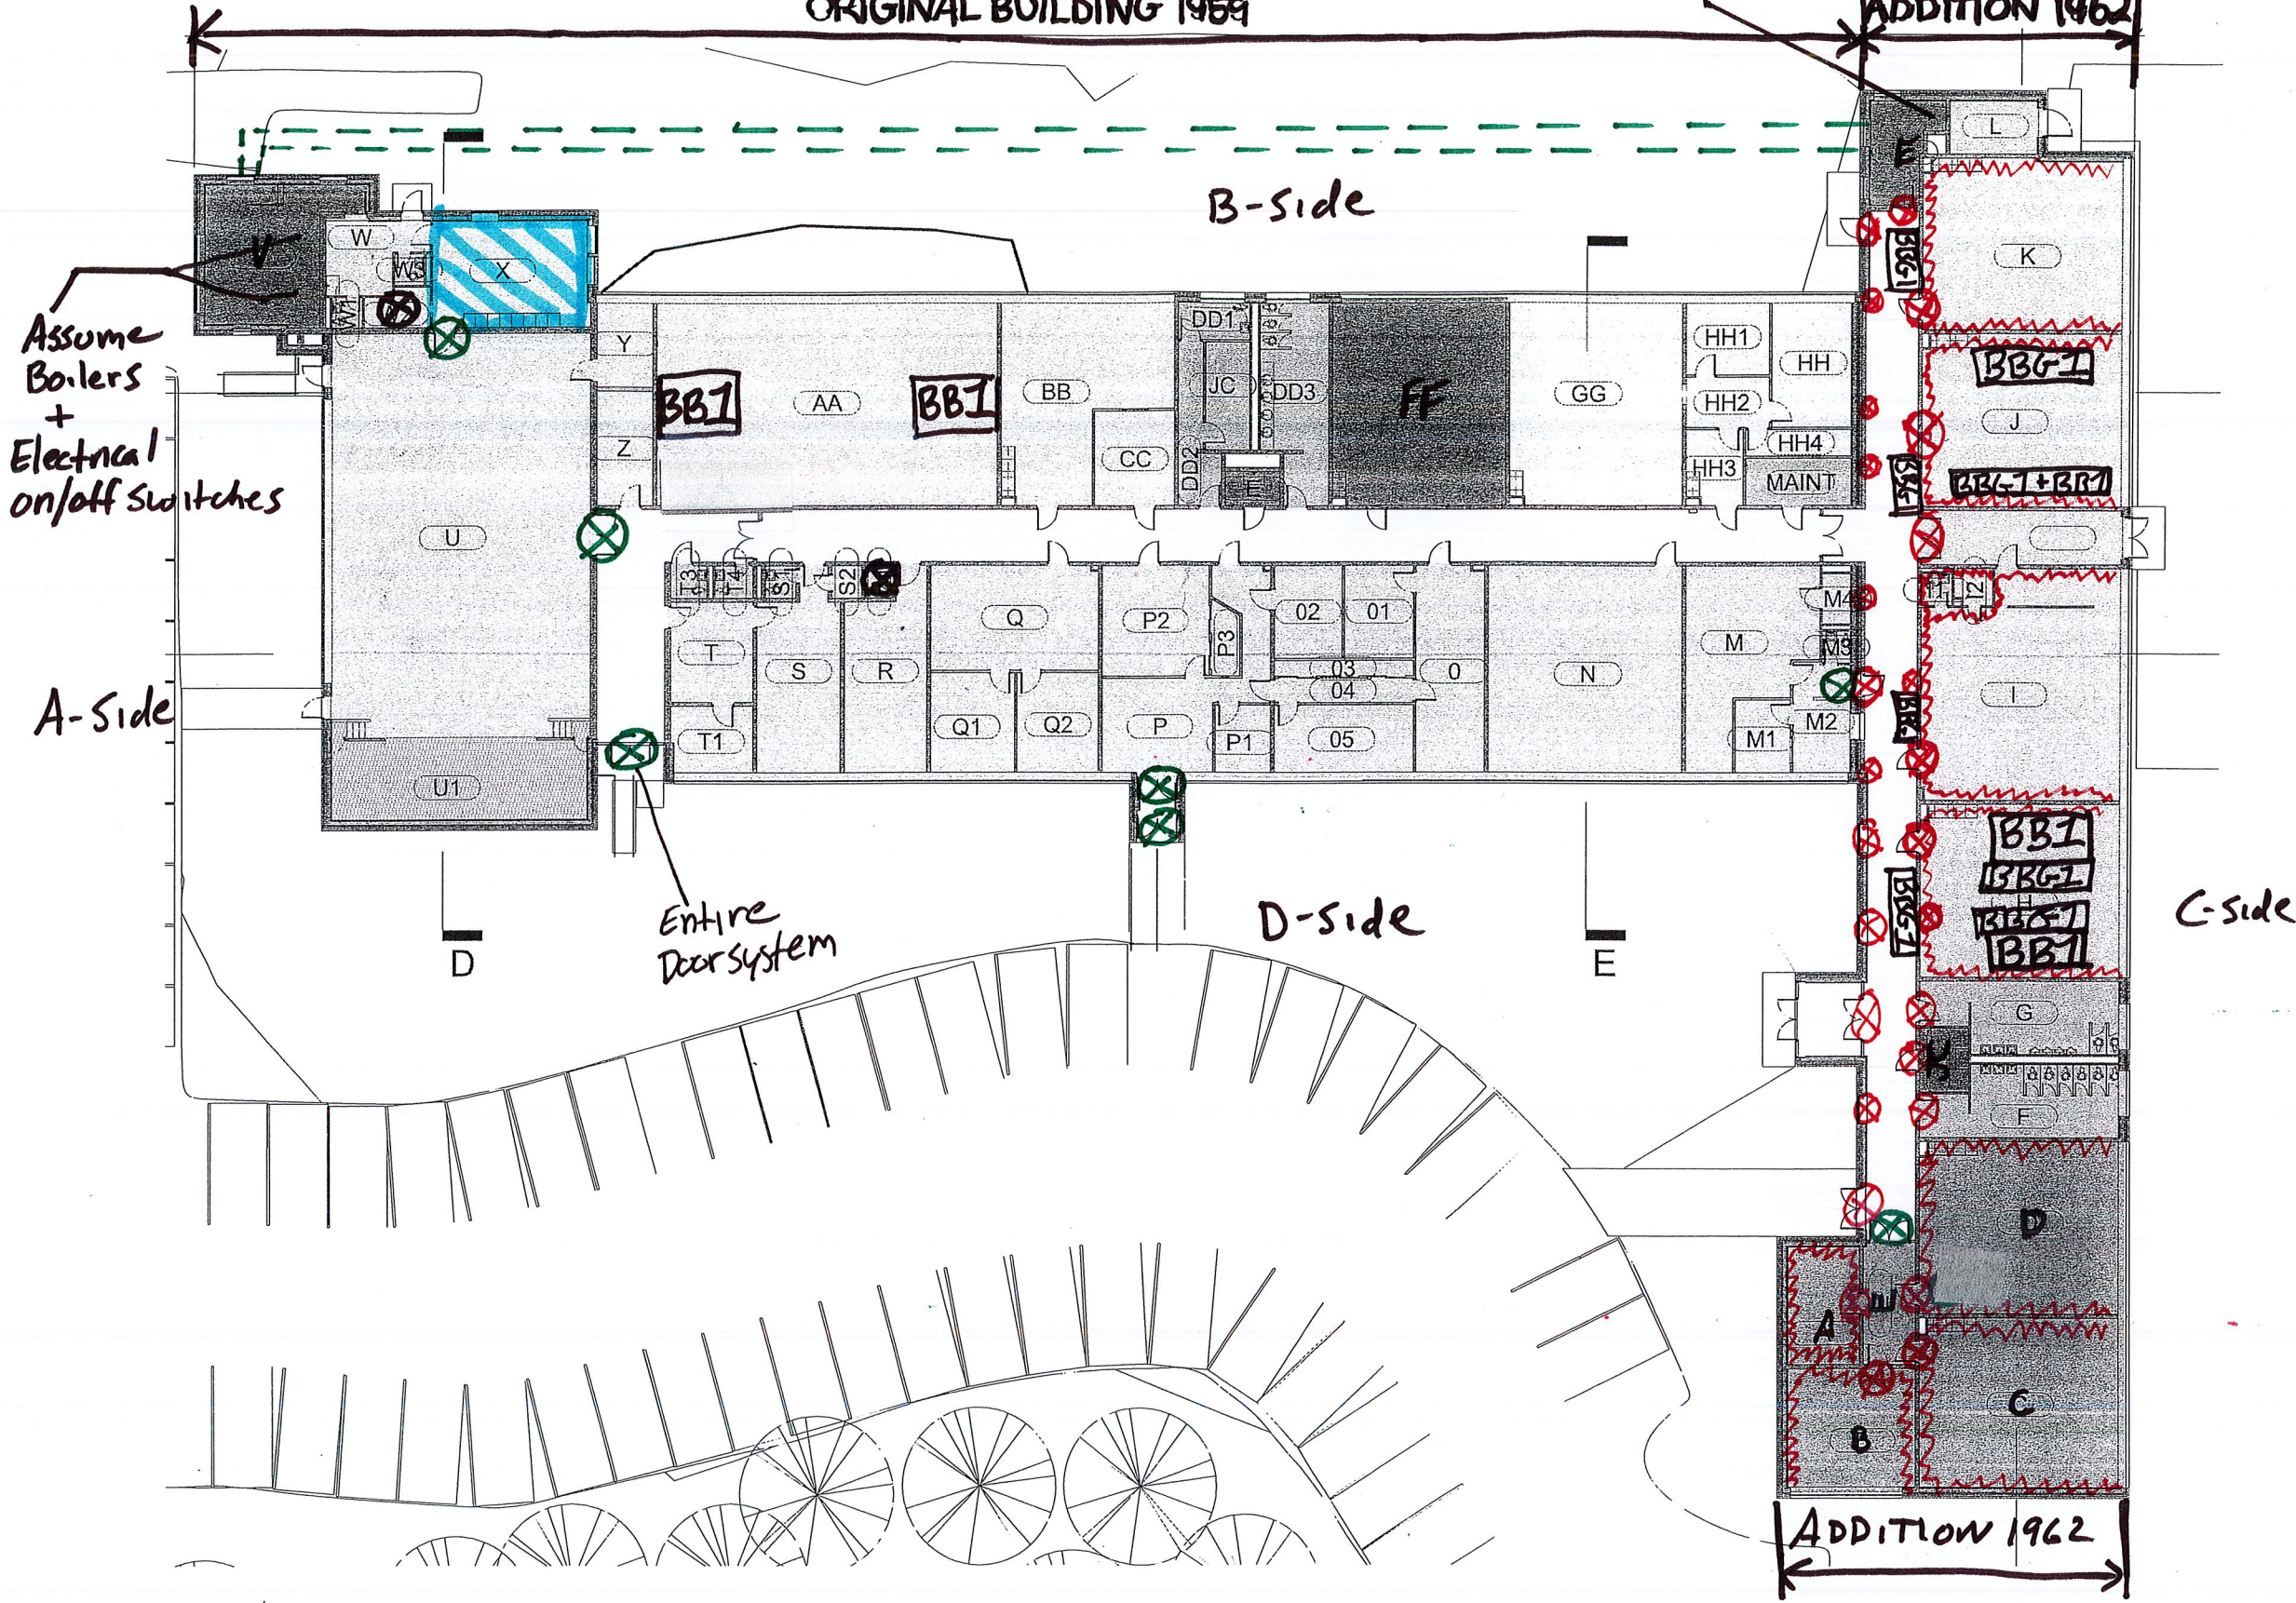
- \* = C2 at top of Wall
- ⊗ = C2 in Expansion Joints
- ⊗ = DWG 1,2,4
- ⊗ = LP1
- ▧ = GD1
- = Assumed buried Pipe insulation
- ▭ = BB1 blackboard glue Dubs
- ▭ = BBG-1 Brown Bulletin Board glue

Note:  
Asbestos Pipe Insulations (PI1, PI2) and associated mudded fittings (MF1) are not shown on the Drawing. They are present above ceilings, in wet walls and chases throughout the 1959 Wing.

\* = C2 is also CT DEEP PCB

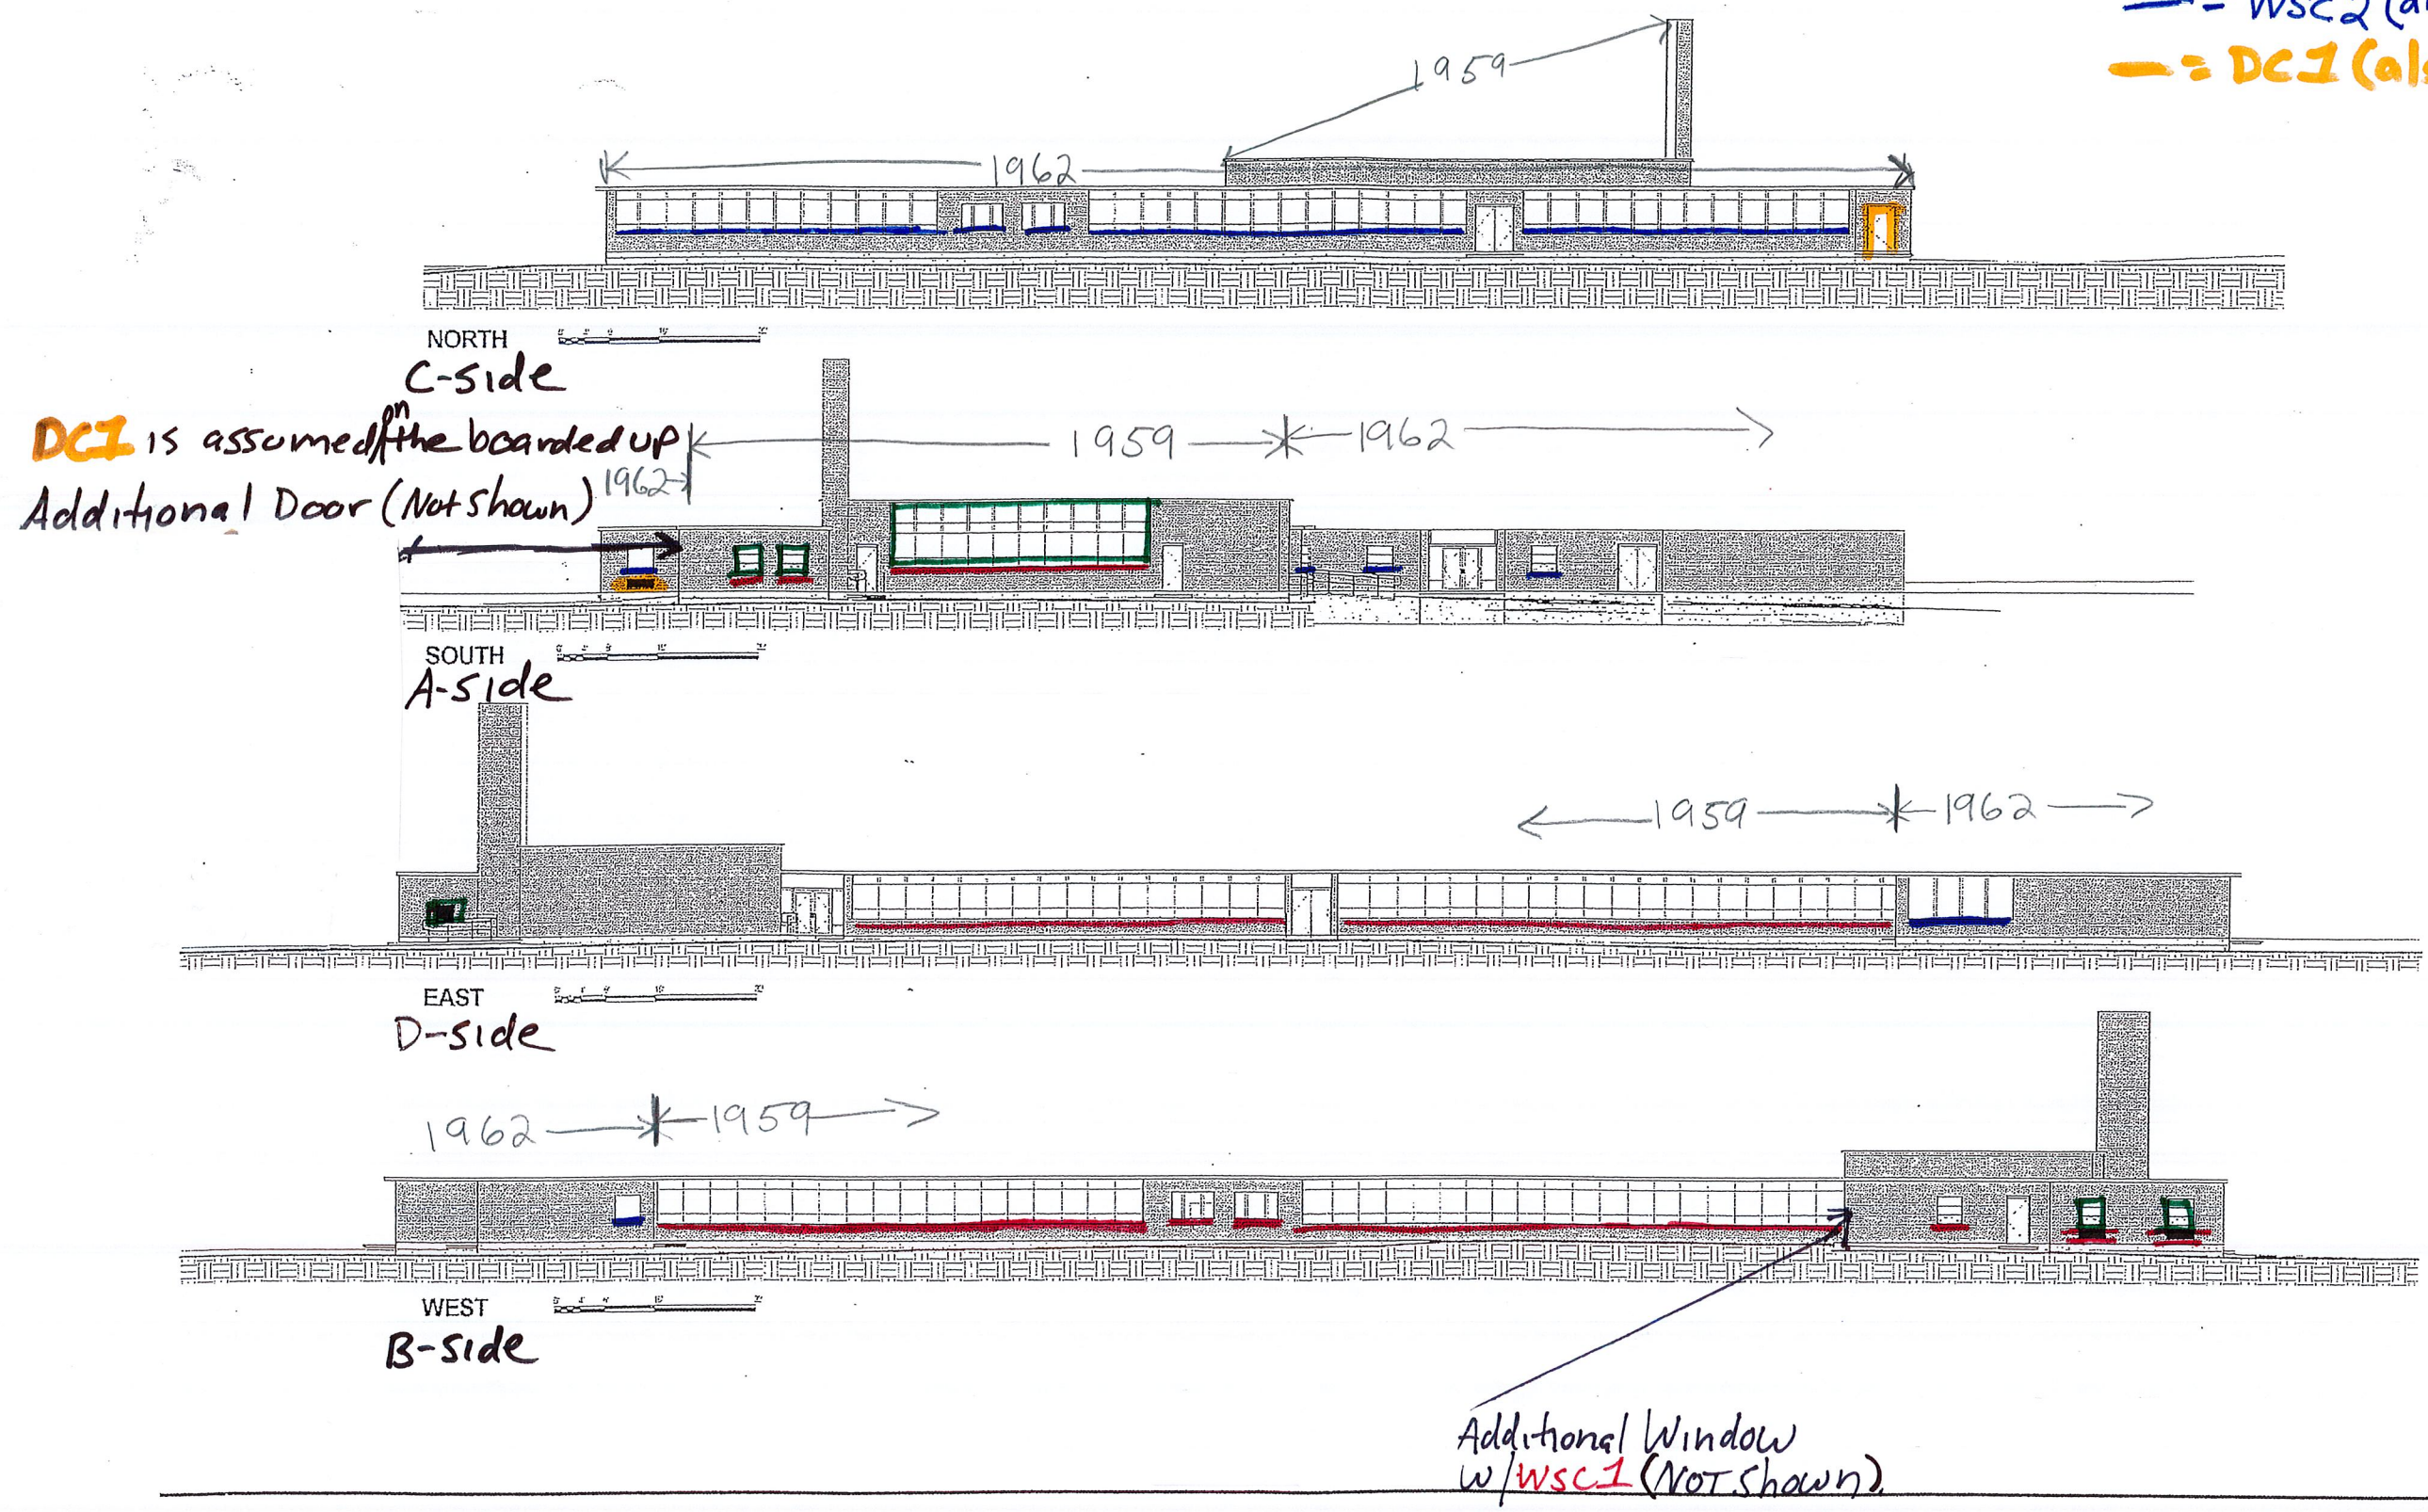
- = WC2
- = WSC1
- = WSC2 (also CTDEEP PCB)
- = DC1 (also CTDEEP PCB)

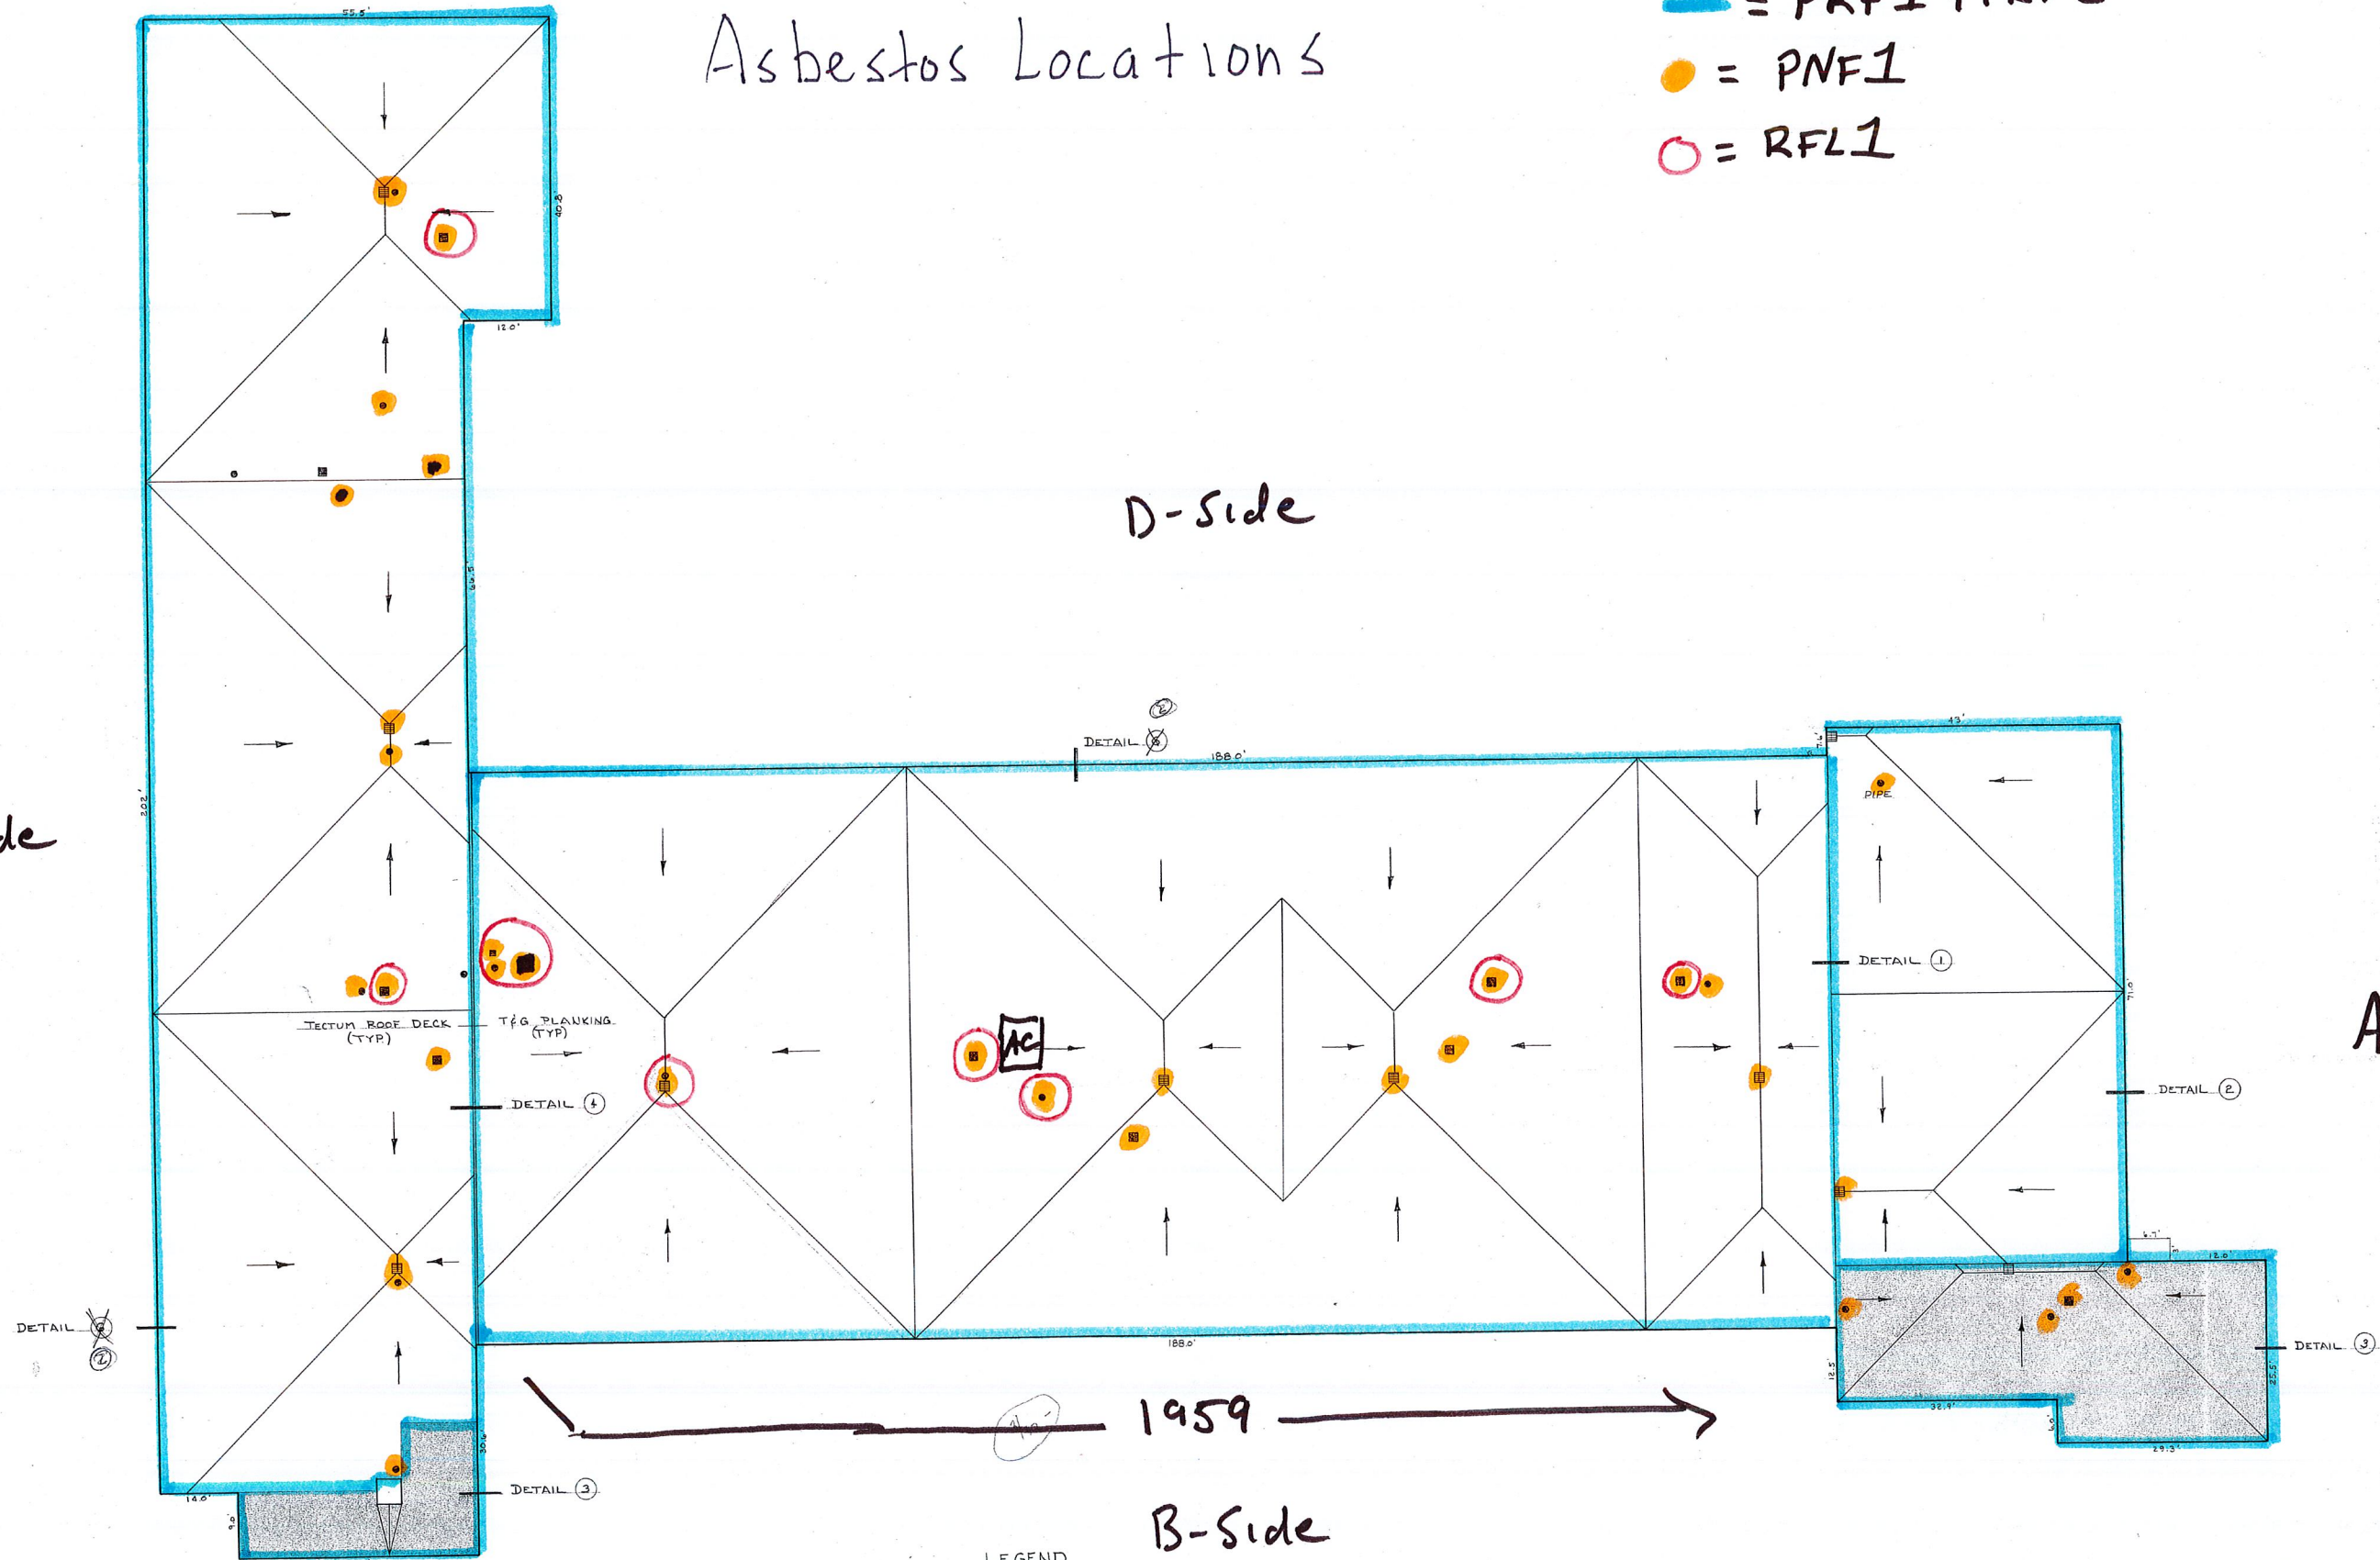
- = PRF1 + PRF2
- = PNF1
- = RFL1

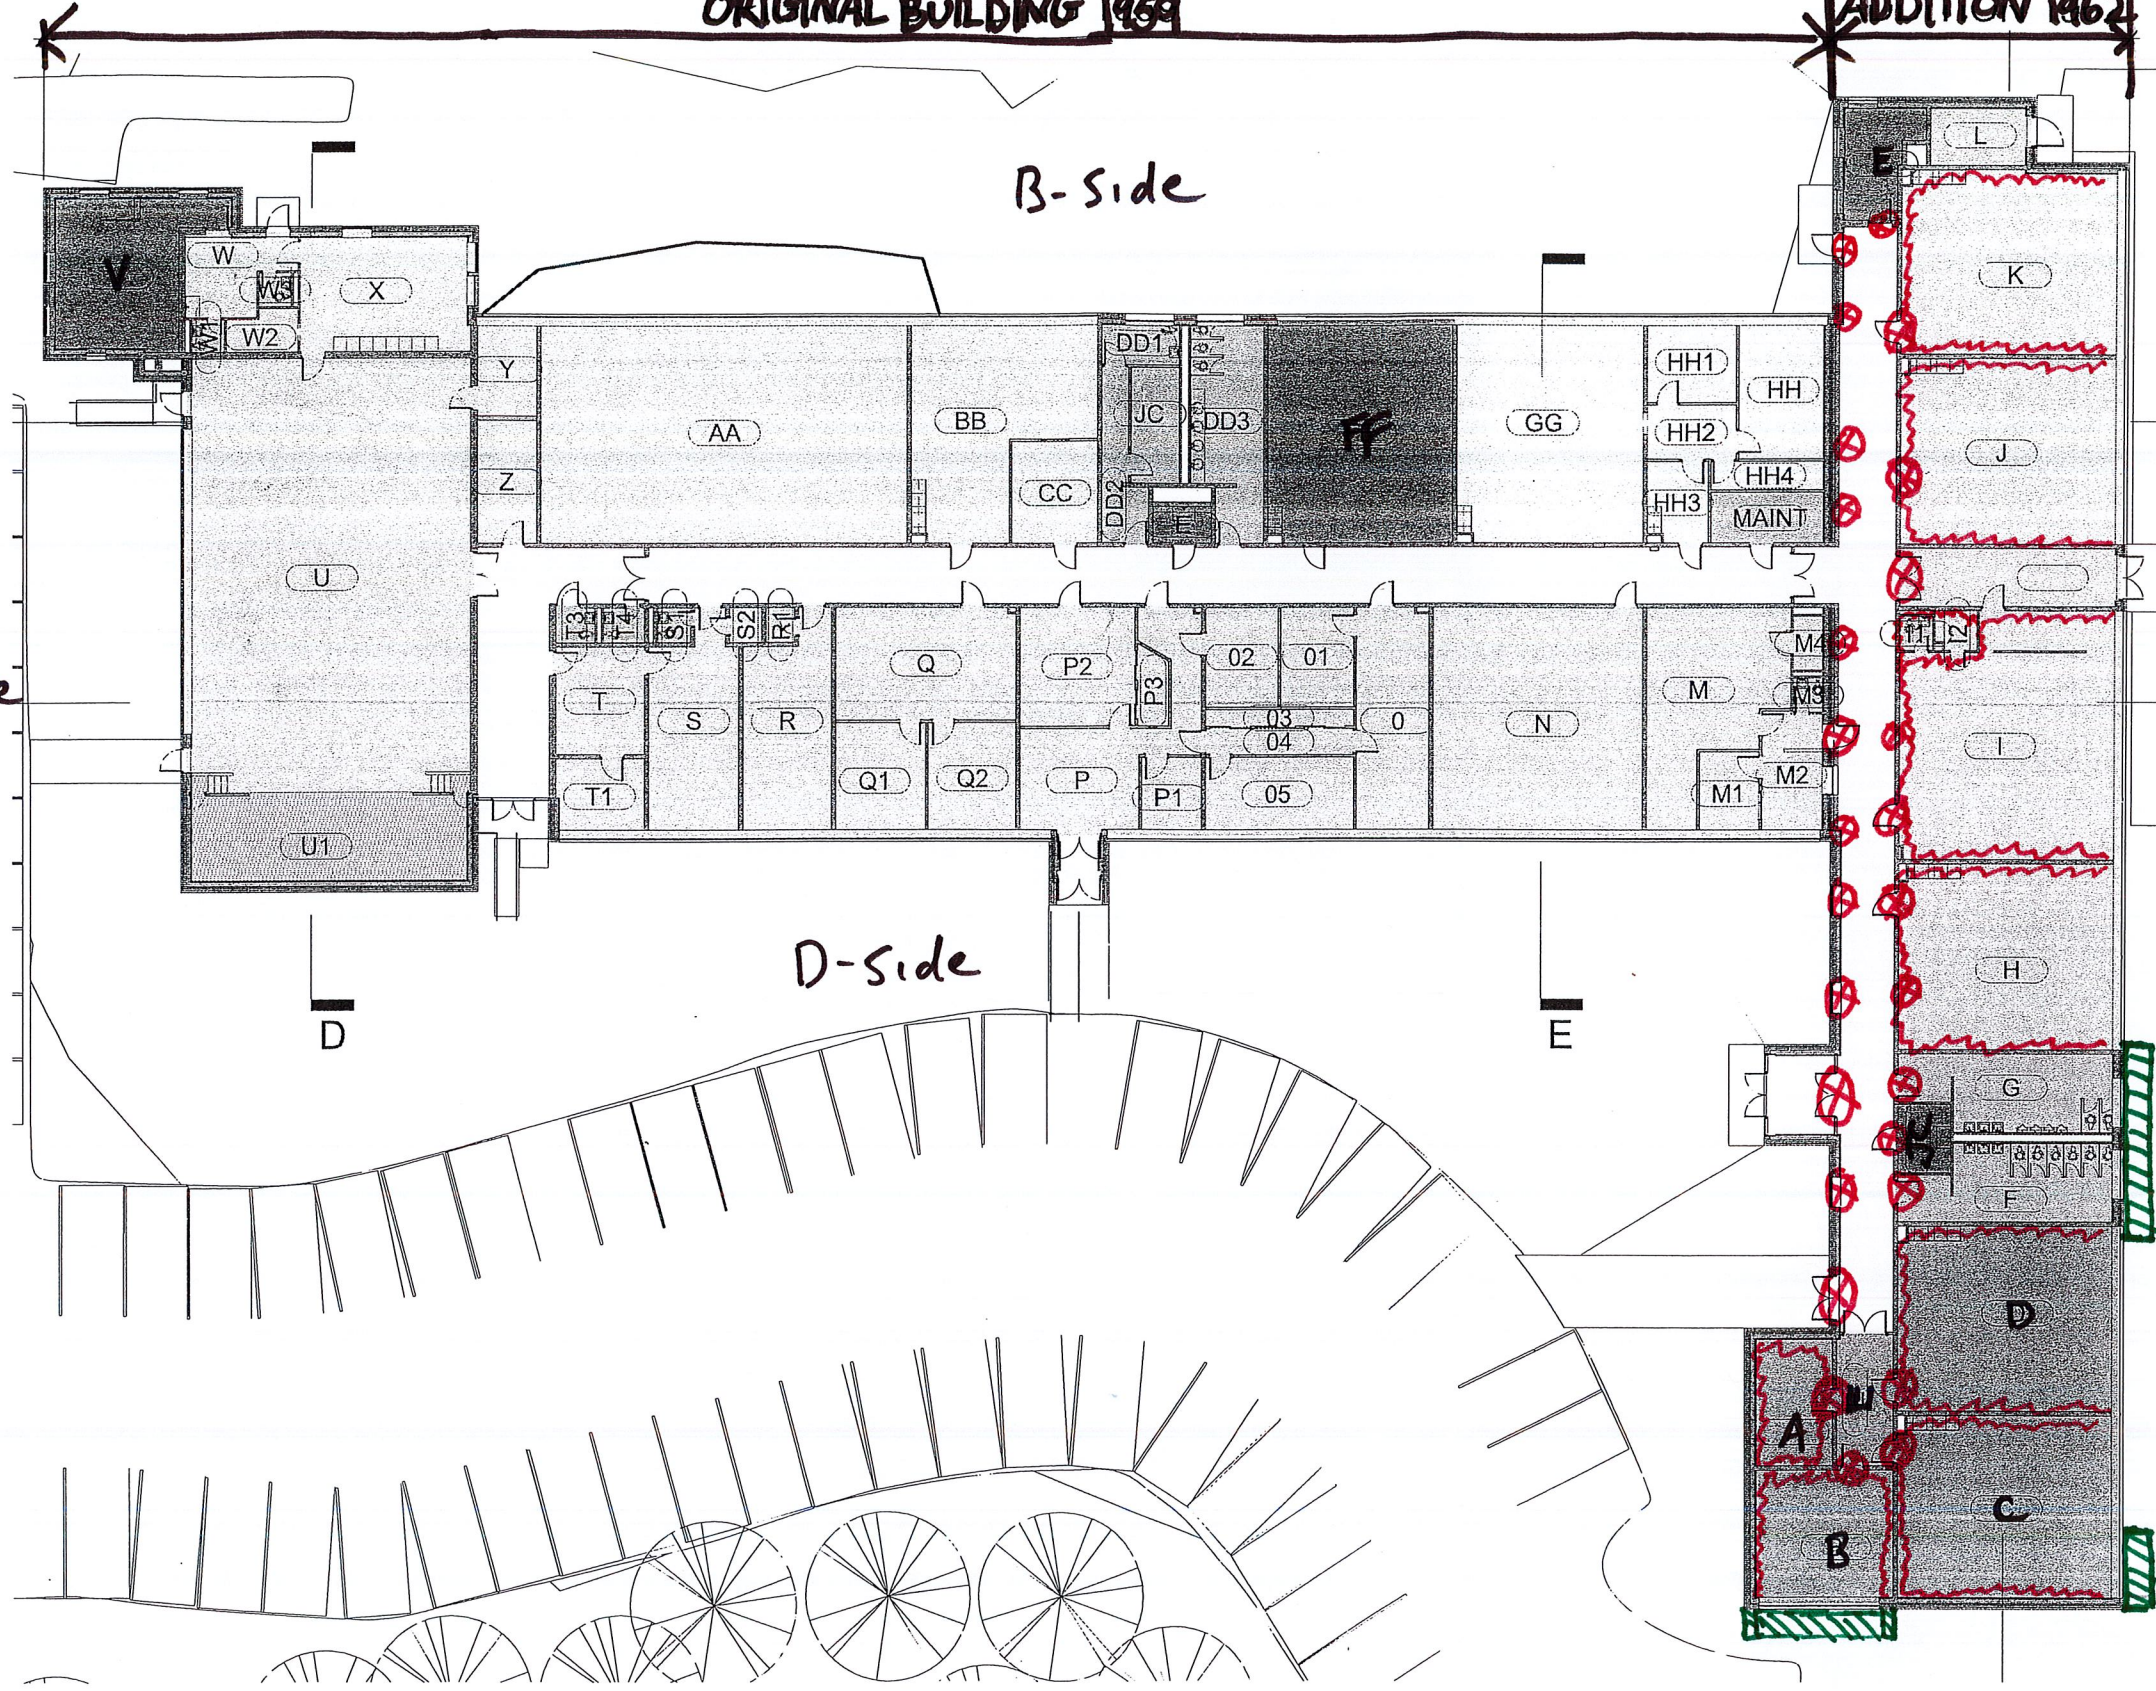
~ = C2 at top of wall (Also AcM)  
⊗ = C2 in Expansion Joints (Also AcM)  
▨ = PCB impacted Soil

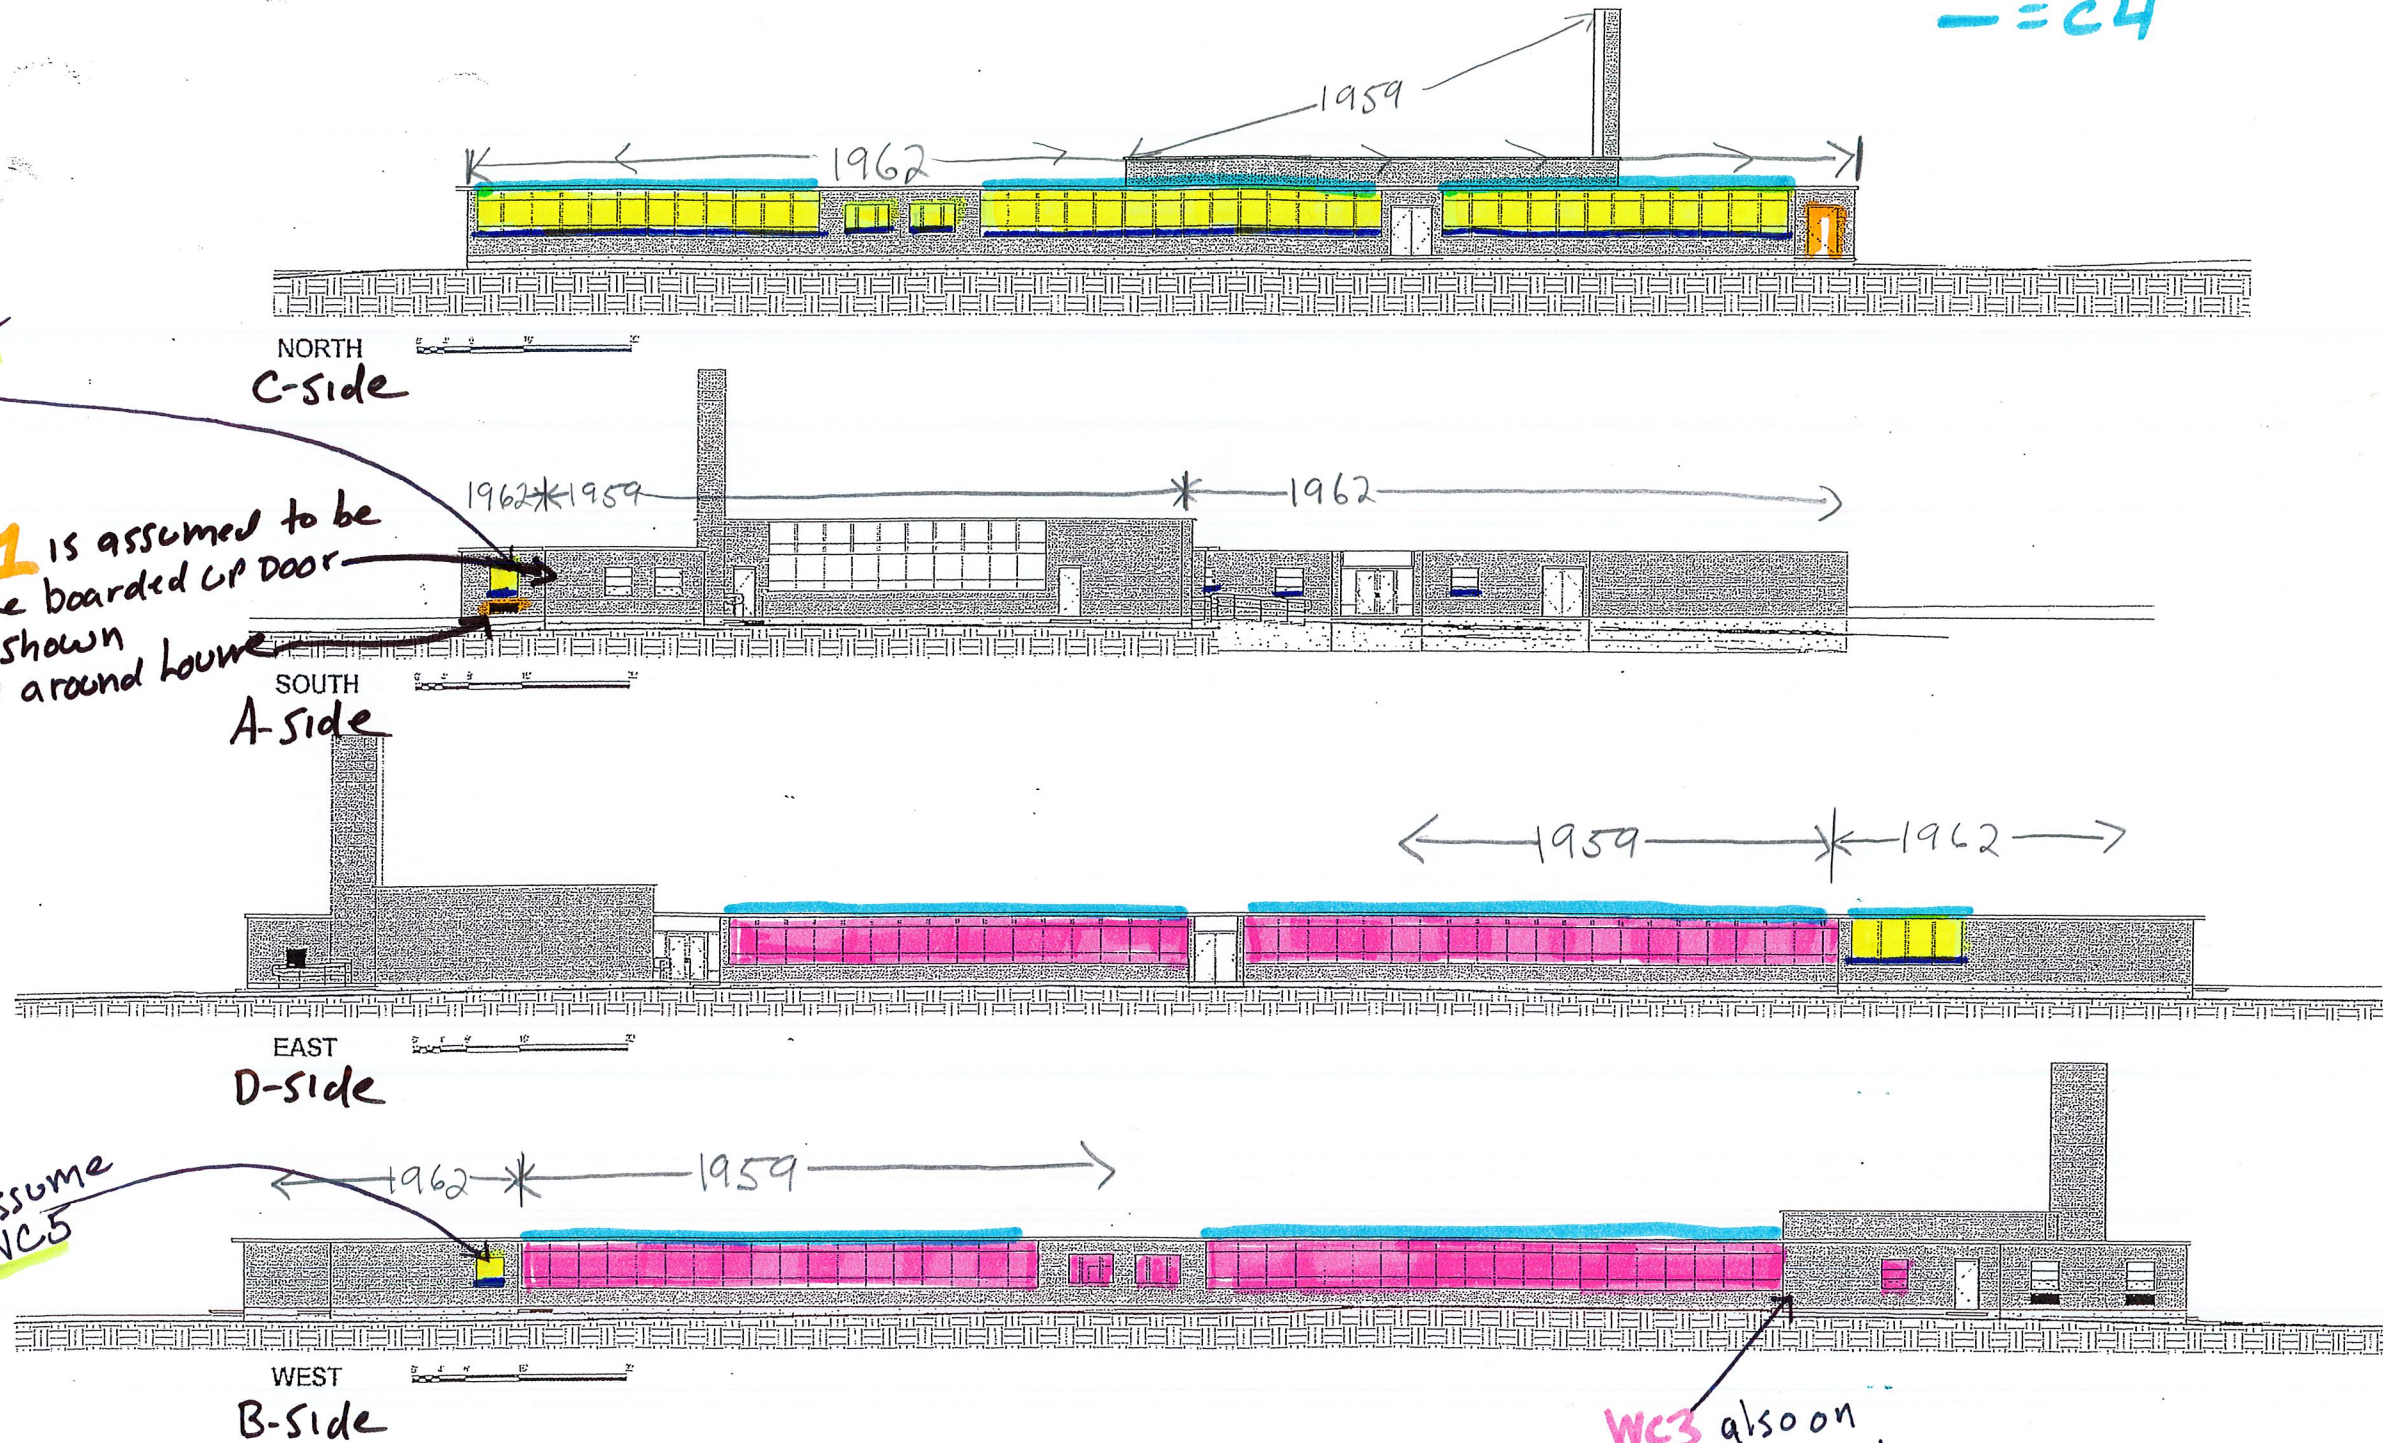
- = DC1 (Also ACM)
- = WSC2 (Also ACM)
- = WC3
- = WC5
- = C4

Assume WC5

DC1 is assumed to be on the boarded up door and around lower

WC3 also on Window Notshown
