BID SPECIFICATIONS  
FOR  
**SILVER LANE PLAZA DEMOLITION**

818-850 SILVER LANE

**CDRA Project #24-015**

**Project:** Silver Lane Plaza Abatement & Demolition  
CRDA Project #24-015

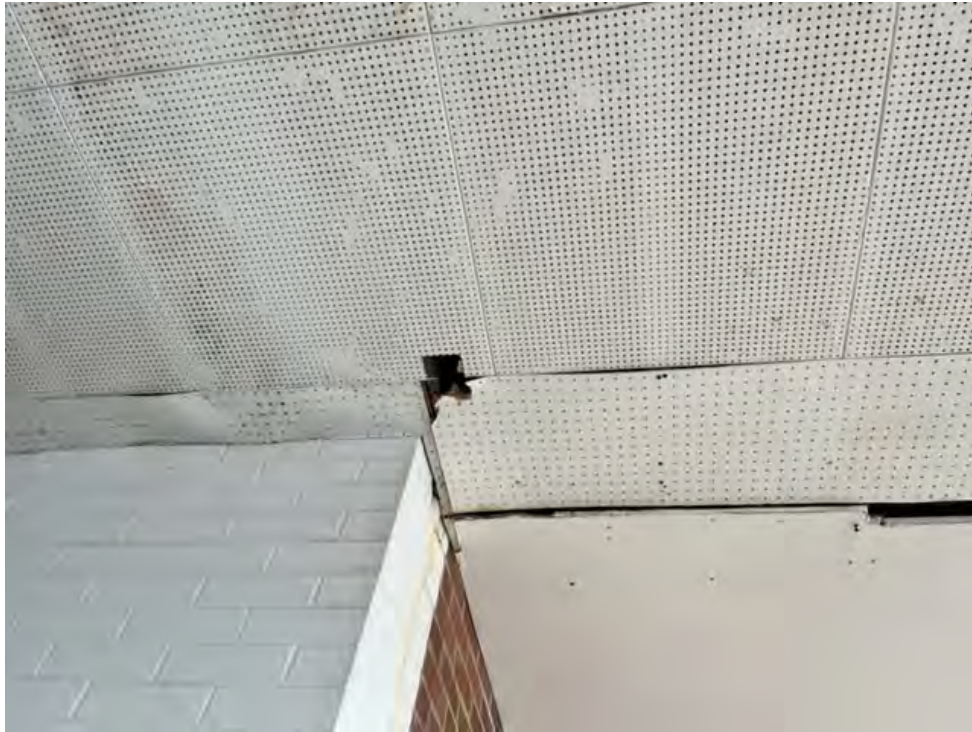
Buildings 1, 2, 3, 4 – representative ACM light grey cementitious perforated panel ceiling of walkway canopy roof

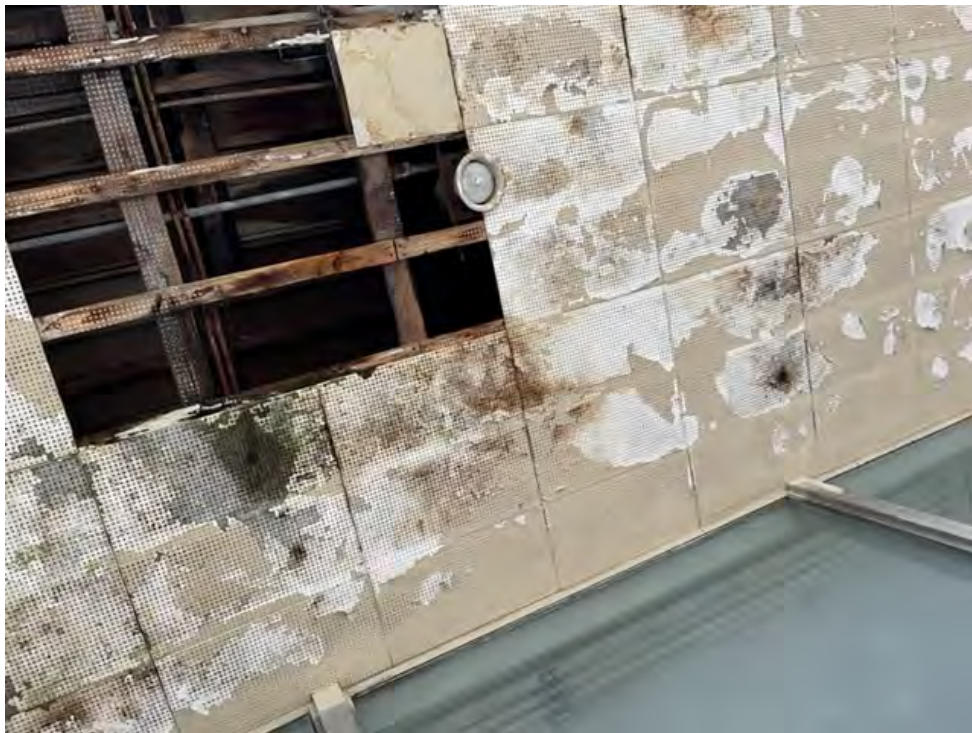
Buildings 1, 2, 3, 4 – representative ACM light grey cementitious perforated panel ceiling of walkway canopy roof

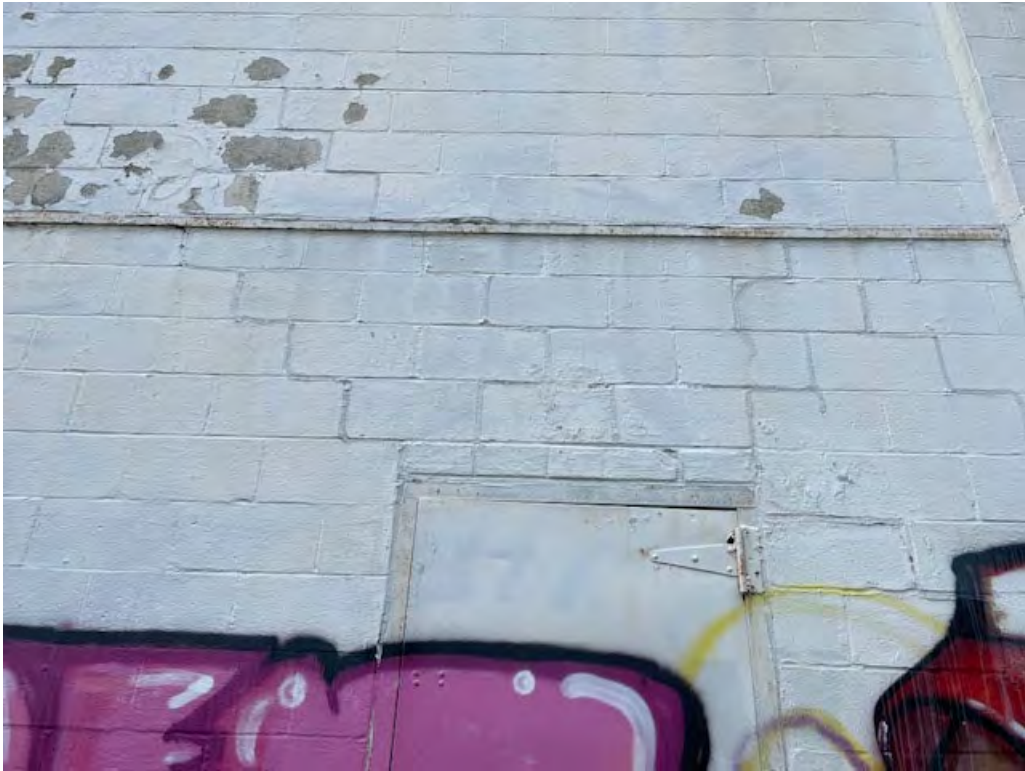
Building 2 - ACM horizontal joint caulks - grey original and white repair caulk

Item No. 10 – WHITE HORIZONTAL JOINT REPAIR CAULK REMOVAL AND DISPOSAL AS ACM

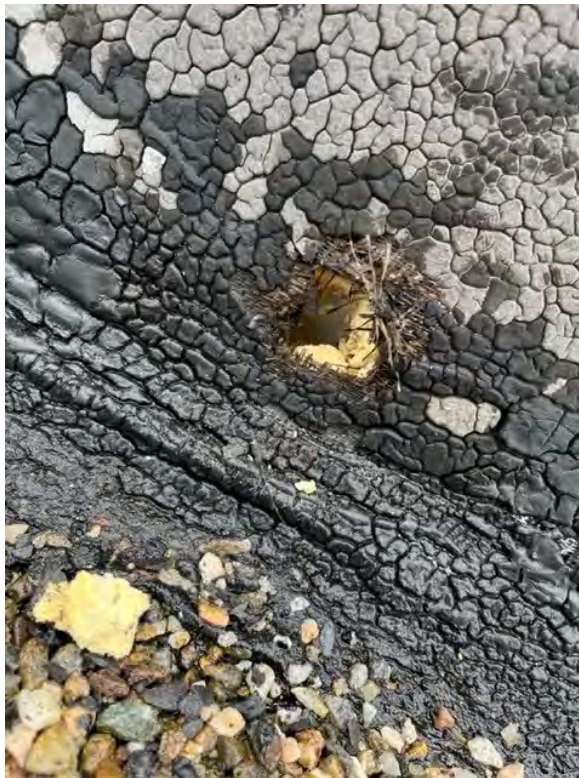
Building 2,3,4,5 – Representative ACM four ply asphaltic roof membrane

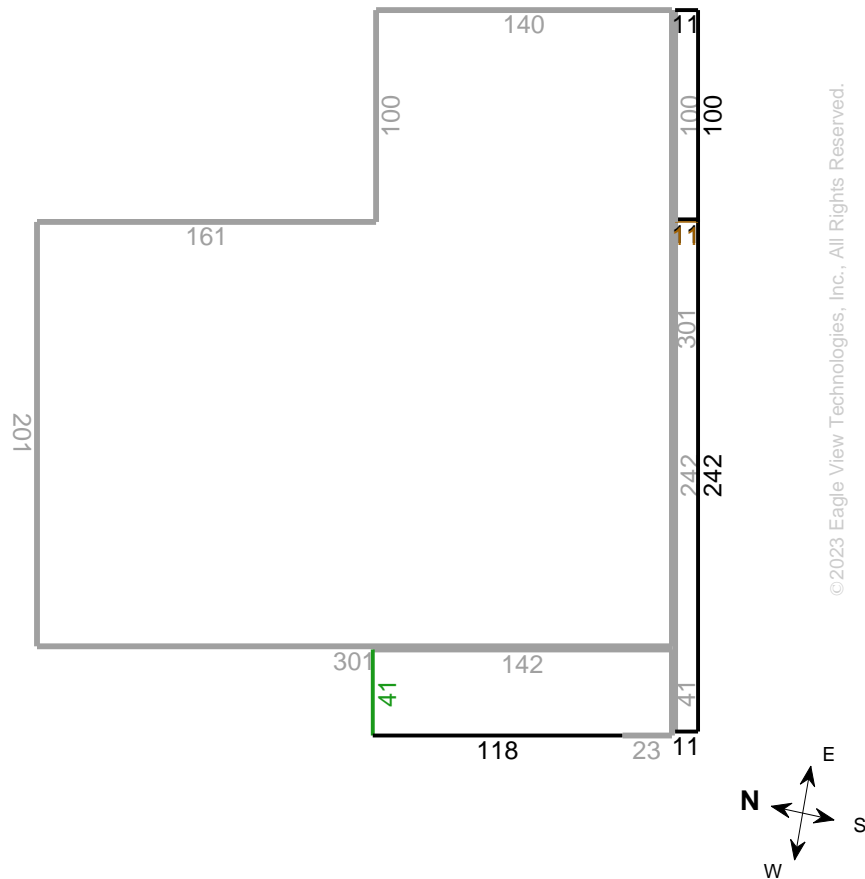
# LENGTH DIAGRAM

Valleys = 0 ft  
 Rakes = 41 ft  
 Eaves = 494 ft

Flashing = 11 ft  
 Step flashing = 0 ft  
 Parapets = 1,753 ft

Note: This diagram contains segment lengths (rounded to the nearest whole number) over 5.0 Feet. In some cases, segment labels have been removed for readability. Plus signs preface some numbers to avoid confusion when rotated (e.g. +6 and +9).

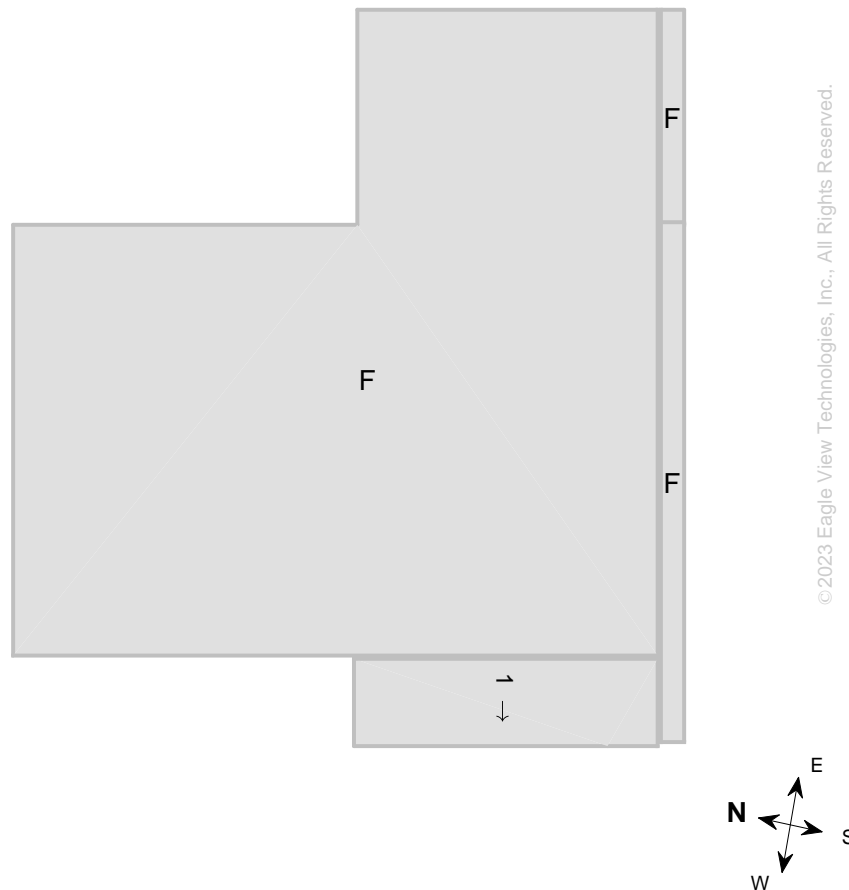
## PITCH DIAGRAM

Pitch values are shown in inches per foot, and arrows indicate slope direction. The predominant pitch on this roof is 0/12

Note: This diagram contains labeled pitches for facet areas larger than 20.0 square feet. In some cases, pitch labels have been removed for readability. Gray shading indicates flat, 1/12 or 2/12 pitches. If present, a value of "F" indicates a flat facet (no pitch).

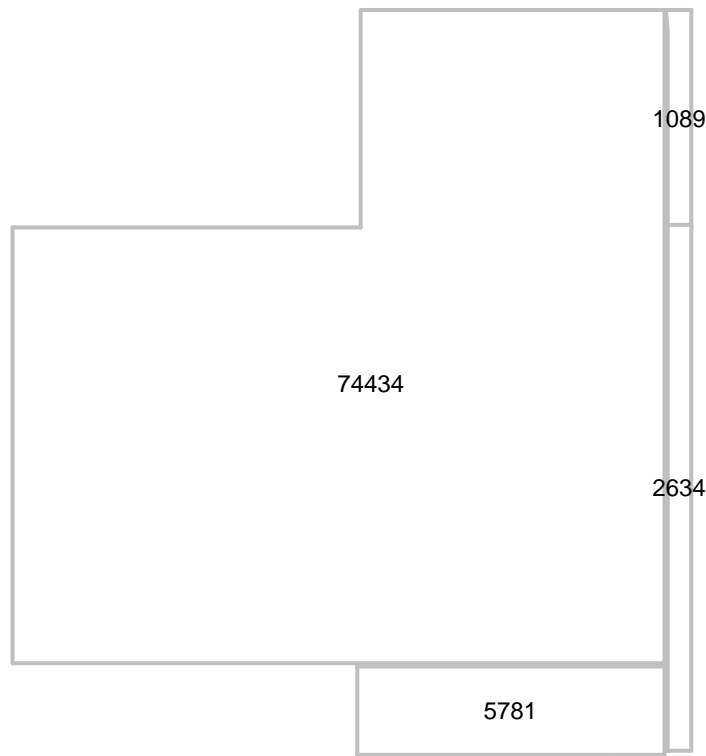
# AREA DIAGRAM

Total Area = 83,940 sq ft, with 4 facets.

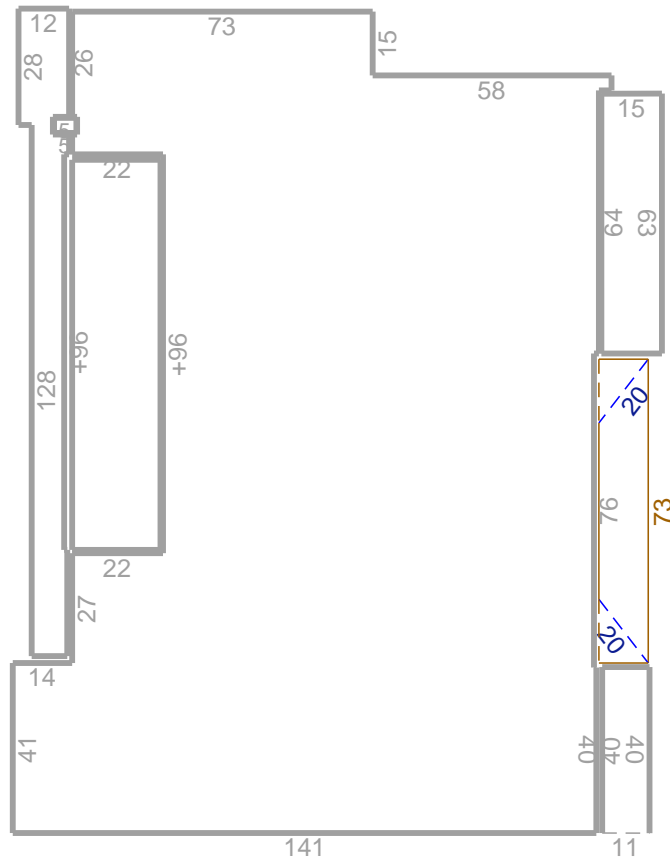
# LENGTH DIAGRAM

Valleys = 40 ft  
 Rakes = 0 ft  
 Eaves = 0 ft

Flashing = 140 ft  
 Step flashing = 32 ft  
 Parapets = 1,576 ft

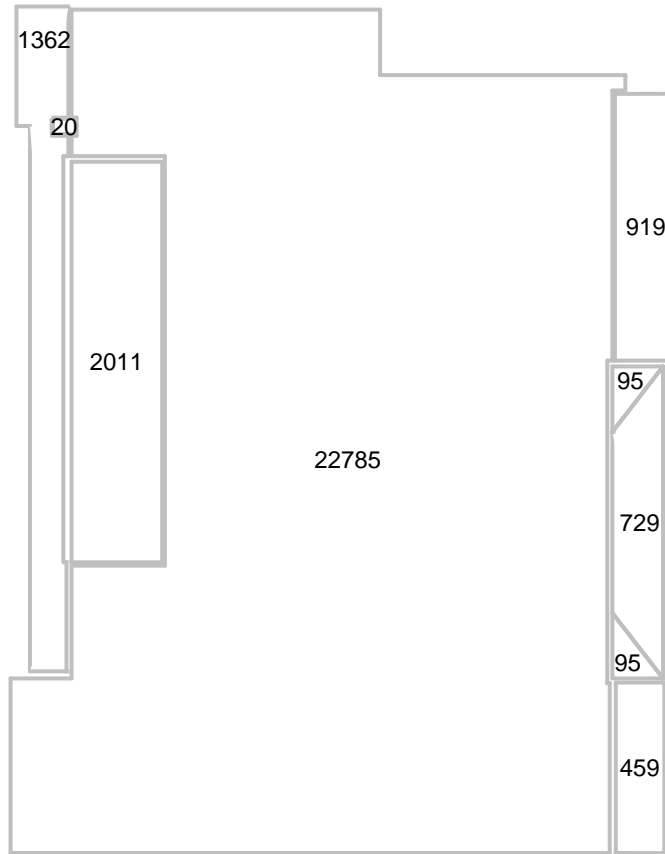
# AREA DIAGRAM

Total Area = 28,475 sq ft, with 9 facets.
