BID SPECIFICATIONS  
FOR  
**SILVER LANE PLAZA DEMOLITION**

794-810 & 832-848 SILVER LANE – PHASE 2

**CDRA Project #25-001**

**ADMINISTERED BY**  
CAPITOL REGIONAL DEVELOPMENT AUTHORITY  
100 COLUMBUS BLVD; SUITE 500  
HARTFORD, CT 06103

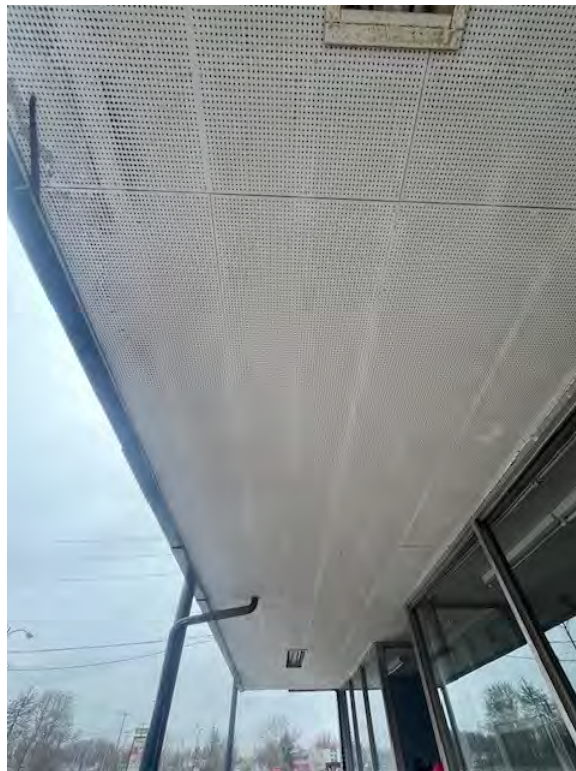
ACM Exterior Cementitious Walkway Ceiling Tiles (above storefronts at both buildings)

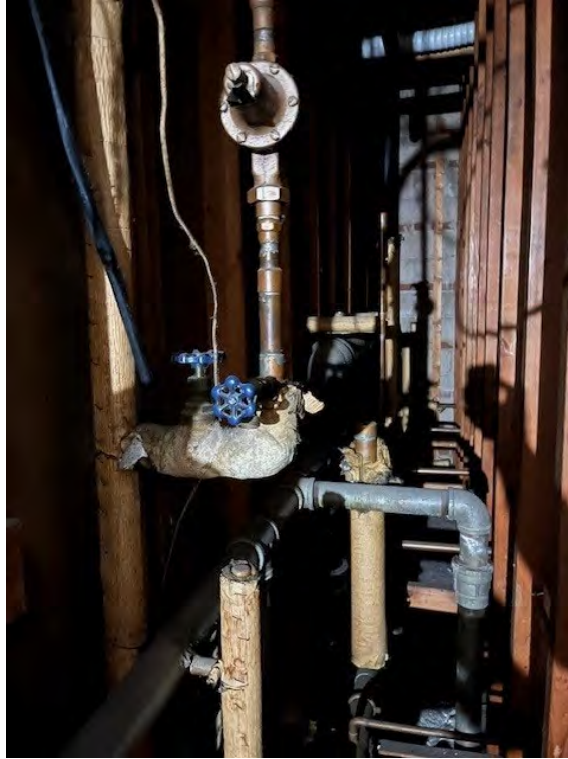
Men's bathroom pipe chase and ACM gray mudded fittings

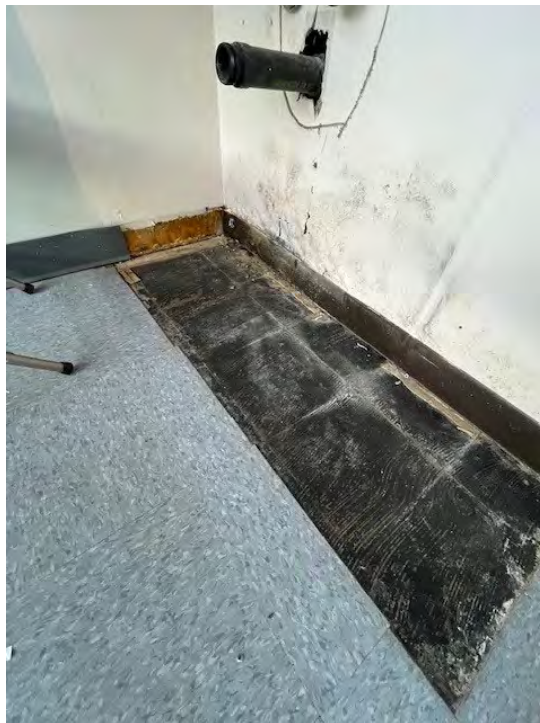
ACM Black original 9"x9" floor tile mastic (throughout buildings floors)

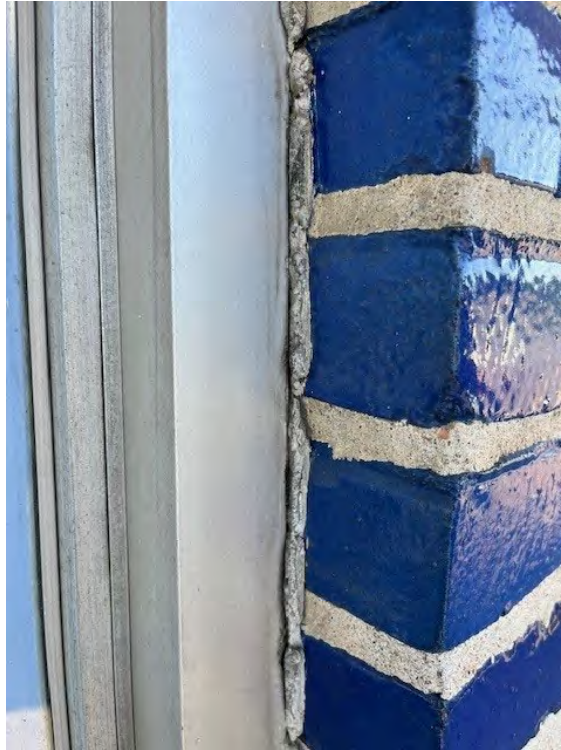
Light grey vertical caulk along exterior wall (multiple areas on single story building)

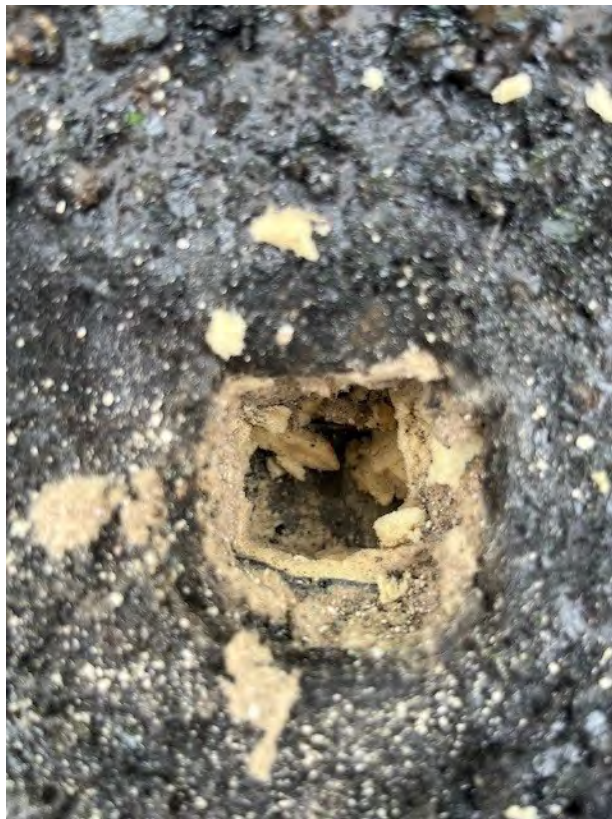
ACM Black 4-ply roof field/ flashing throughout both building roofs

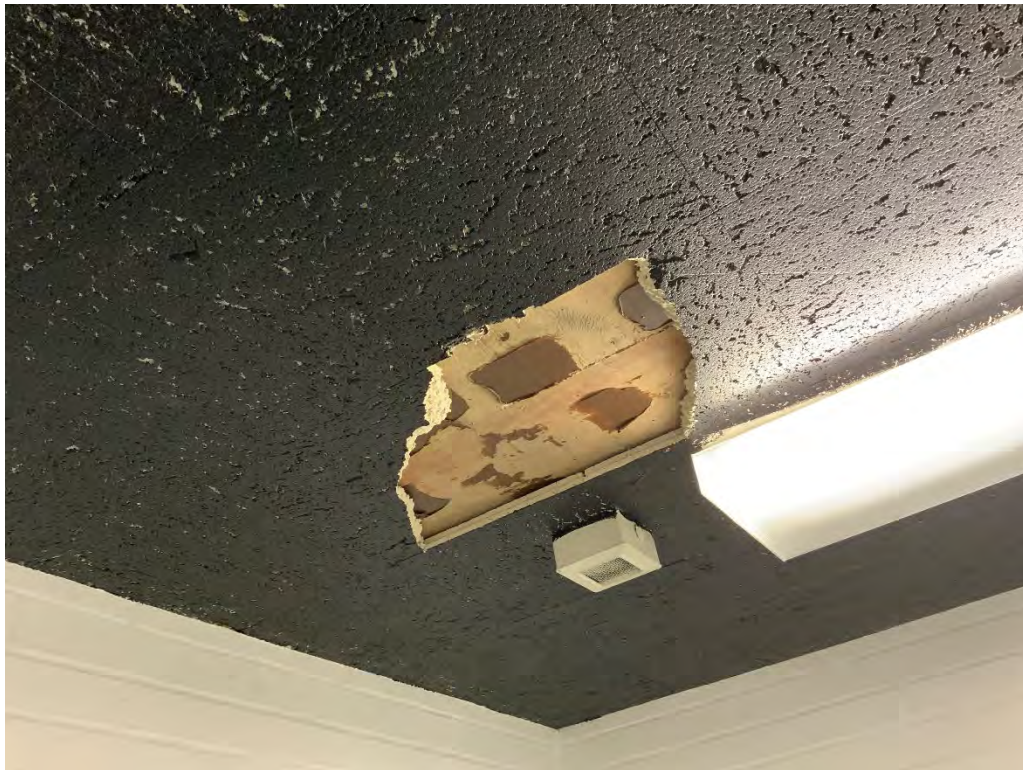
810 Northeast room - ACM Dark brown glue daubs associated with 1'x1' ceiling tiles.

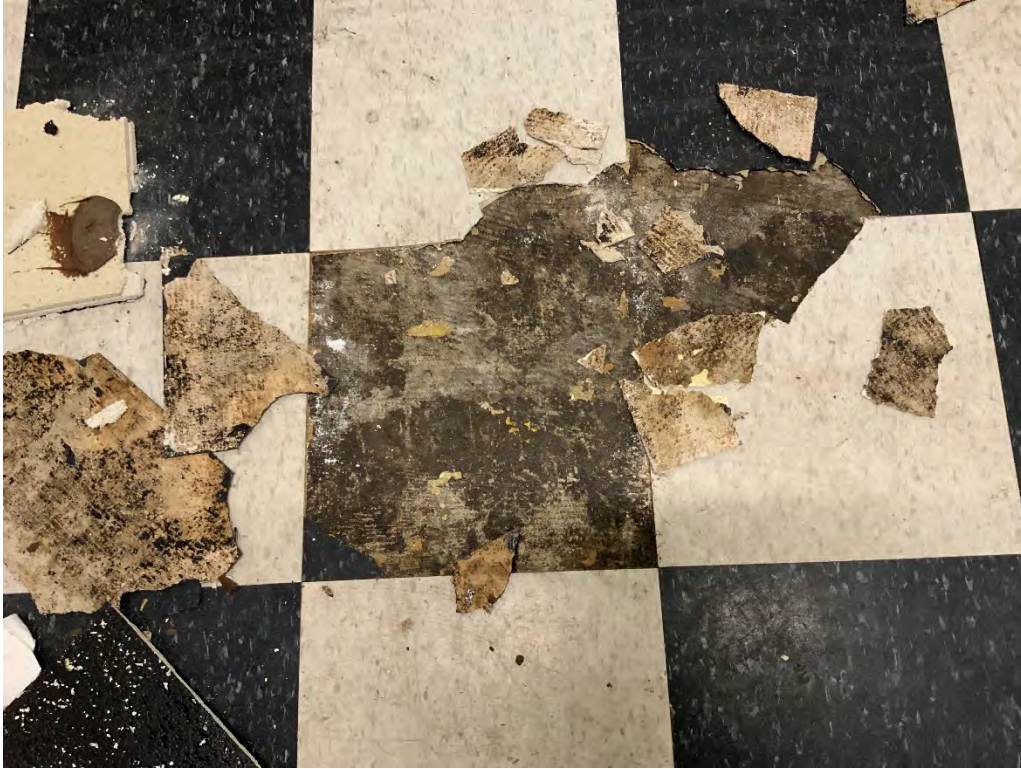
ACM Residual black mastic associated with floor tiles.

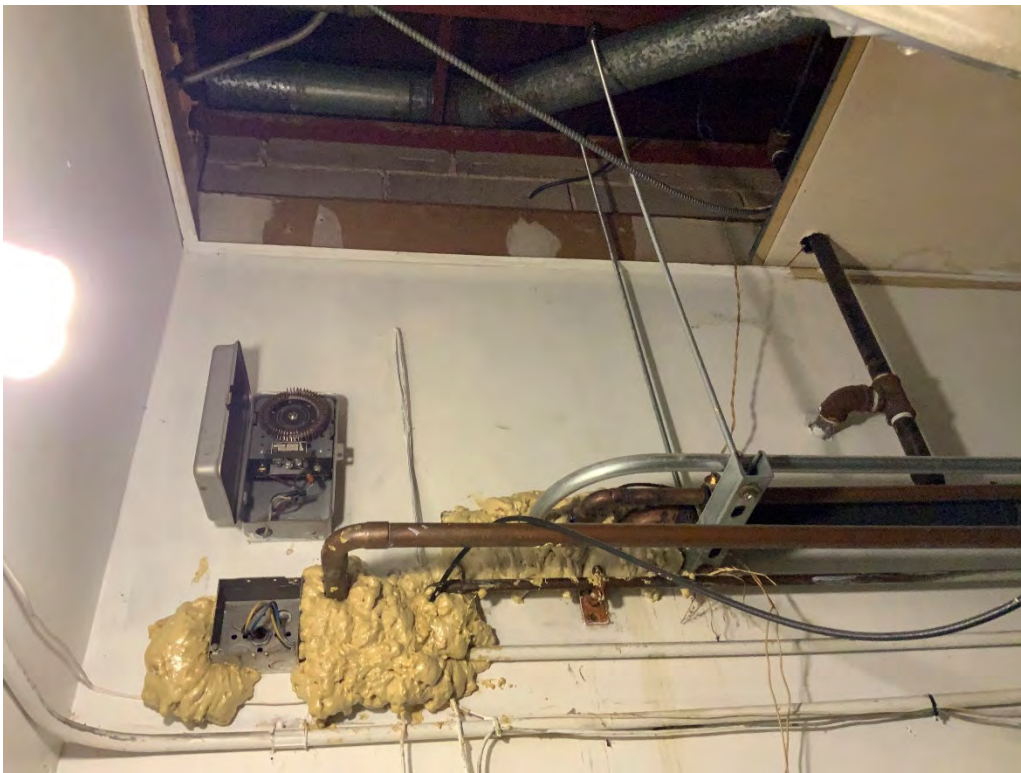
ACM tape & joint compound (throughout)
