Comprehensive Building Assessment

Rentschler Field at Pratt & Whitney Stadium

September 7, 2022
DRAFT FOR
DISCUSSION ONLY

CRDA | Capital Region
Development Authority

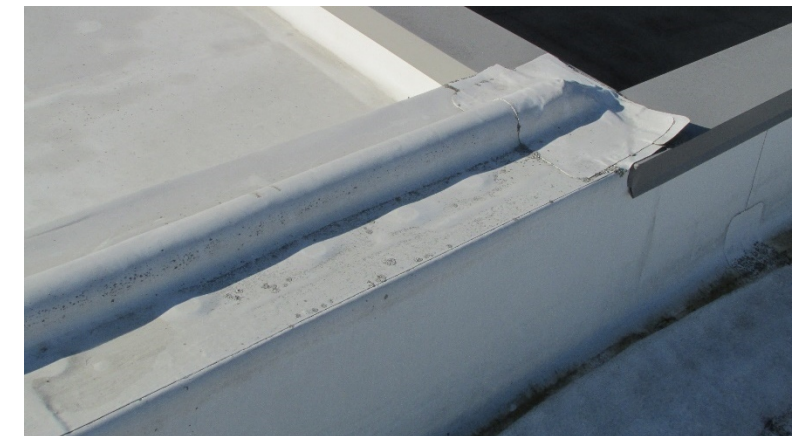
Buildings 5-6: An expansion joint is constructed between the two adjoining buildings, and an expansion joint cover assembly is installed atop the adjoining parapets. The expansion joint cover appears to have been fabricated on-site, from TPO membrane and other underlying materials. The multiple layers of TPO membrane that were originally adhered to the pre-finished sheet metal copings, are detached/delaminated and, as a result, the expansion joint is non-watertight.

This expansion joint cover is installed at the junction where Buildings 5 and 6 adjoin. The expansion joint cover is constructed atop the perimeter parapets, utilizing TPO membrane. The TPO membrane was originally adhered to the metal copings at both ends; however, the membrane is detached from the metal coping surface at the ends and, as a result, non-watertight.

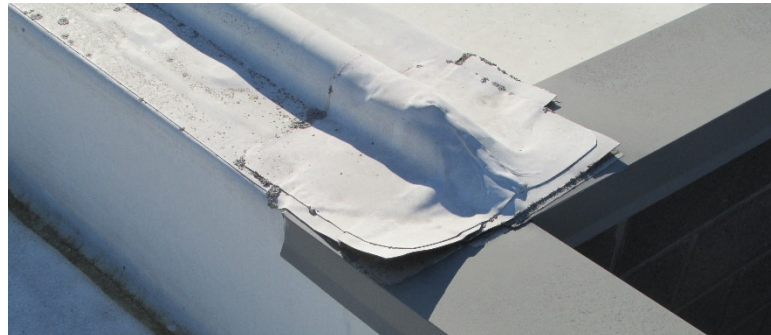
TPO membrane, at ends of an expansion joint cover, is loose/detached/non-watertight.

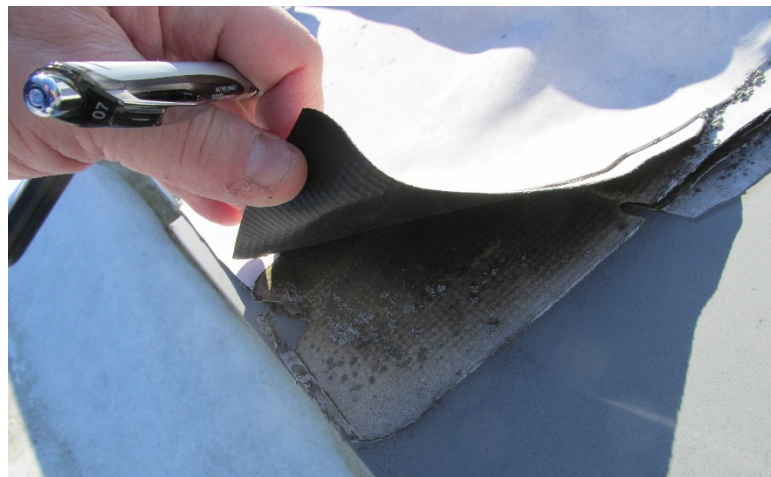
Loose/detached TPO membrane, at the end of this expansion joint cover, allows moisture infiltration into the roof covering systems and underlaying construction.

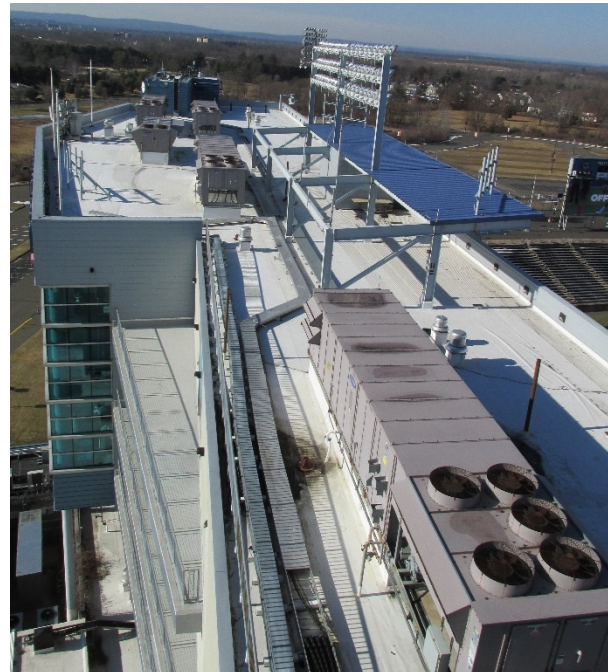
Overview of the main roof on the Tower Building, that utilizes a TPO single-ply membrane roof covering system.

Tower Building: The existing low-slope TPO single-ply membrane roof covering systems generally appear to be in very poor condition. There are active moisture leaks into the building interior that, we were informed, have not yet been addressed. We understand that the TPO roofing/flashing membrane has previously sustained burns/damage/leakage in many places, resulting from pyrotechnics/fireworks that were previously launched from the roofs. There are numerous patches/repairs throughout the Tower Building roofs. It was also noted that the membrane base flashings surrounding an equipment curb (west penthouse roof) are delaminated from the field roof membrane, and non-watertight. Based upon a visual examination of the roof covering system, it is evident that there is substantial moisture saturation of the roof insulation and roof deck substrate beneath the roof membrane, and it is very likely that an extensive portion of the roof insulation/underlayments and the concrete roof deck are moisture-saturated.

In our opinion, the single-ply membrane roof covering systems on the Tower Building require complete removal/replacement, as soon as fiscally possible.

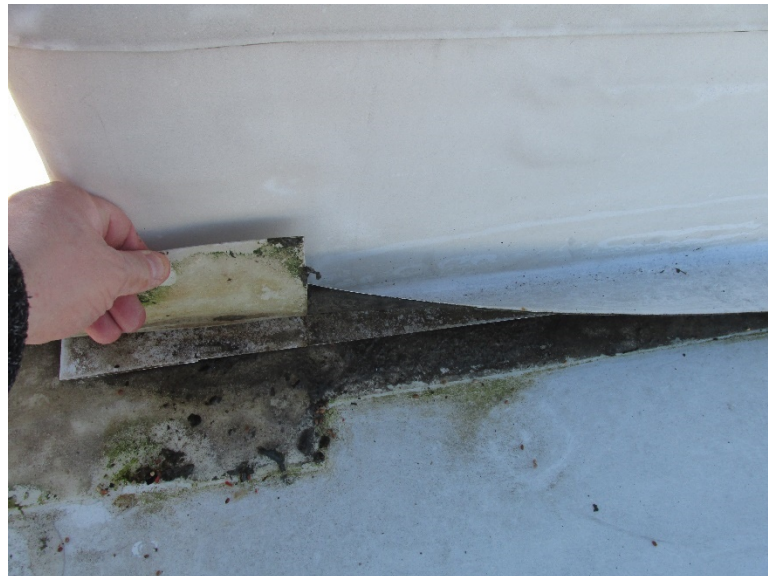
TPO membrane base flashings surrounding an equipment curb are delaminated from the roof membrane, and non-watertight.

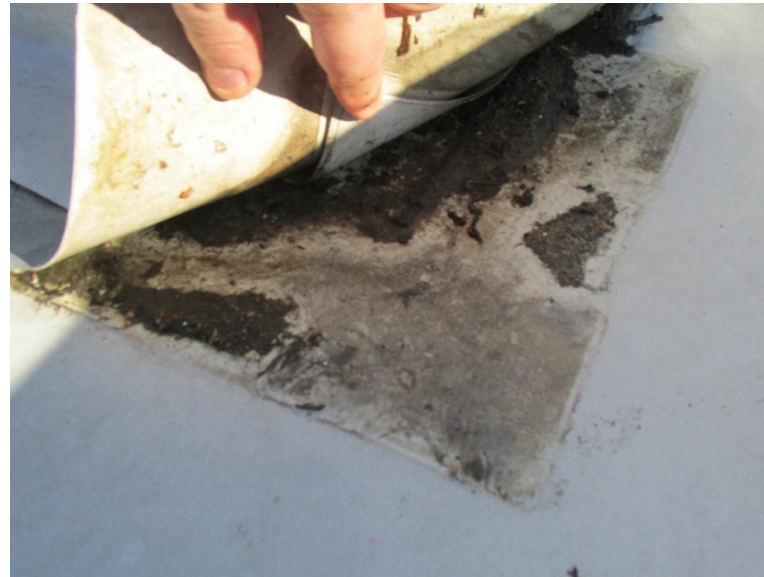
Non-watertight TPO membrane base flashings surrounding an equipment curb on the west penthouse roof of the Tower Building.

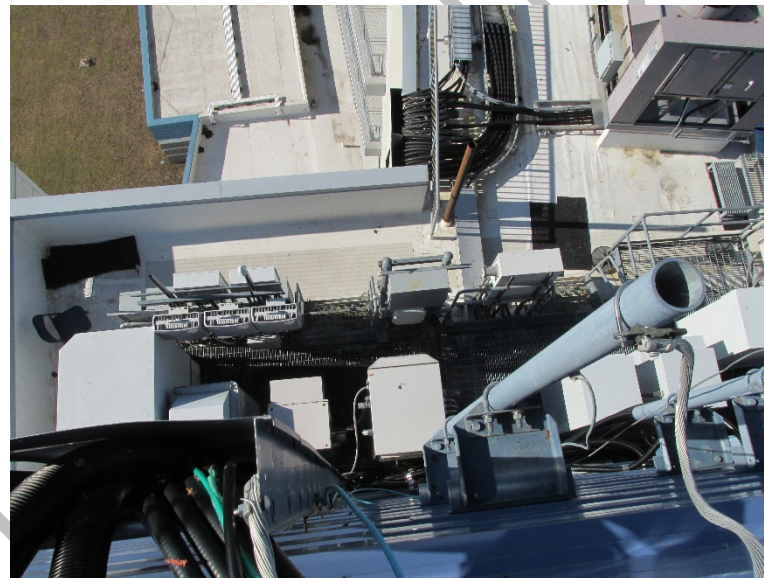
A labyrinth of telecom equipment/cabling is installed atop the Tower Building roofs. The equipment is installed, operated, and maintained by several independent cellular carriers, and much of this equipment is installed directly atop the surface of the roof covering system, often with little or no protection of the roofing/flashing membrane.

2. Tower Building: Coordinate with all telecom carriers with equipment/cabling on the roofs, for temporary removal/reinstallation of their equipment from the roofs, so as to provide full access to all areas of the roofs, for removal/replacement of the roof covering systems. Completely remove the existing roof covering systems, including all membrane, insulation/underlayments, sheet metal flashings, etc., down to the concrete roof deck. Make all necessary repairs to any damaged/deteriorated roof deck/ substrates. Allow the concrete roof deck to properly dry, prior to applying new insulation/roofing materials. Make repairs to the existing drainage elements or remove/replace the roof drains/overflow drains. Install a new roof insulation assembly, to meet current codes for thermal efficiency and wind uplift. Install a new single-ply membrane roof covering system that is fully-adhered to the roof insulation assembly/substrate, and to comply with current wind uplift requirements. Install all new pre-finished sheet metal flashings associated with the roof replacement. Design and install new fall protection equipment (that may also include reinstallation of exiting equipment, to meet current codes/safety requirements. Install safety/fall protection equipment, to comply with current codes/regulations.

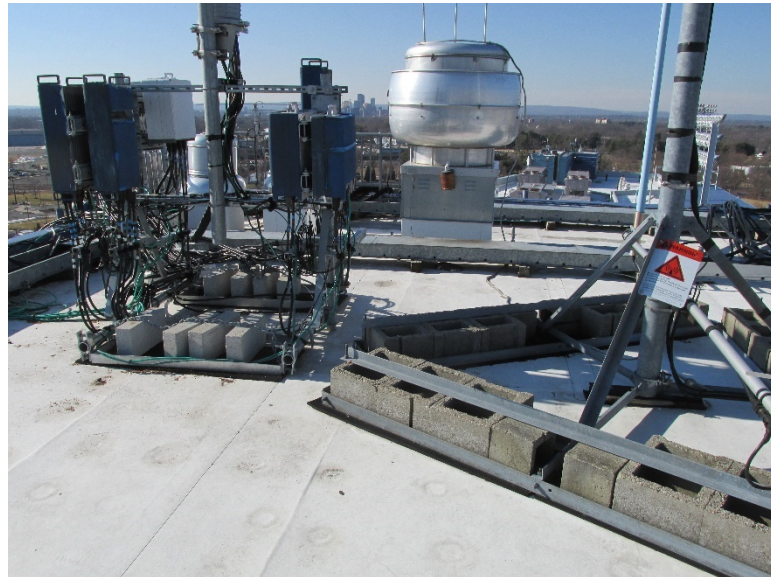
Much of the east elevator penthouse roof surface is covered with telecom equipment.

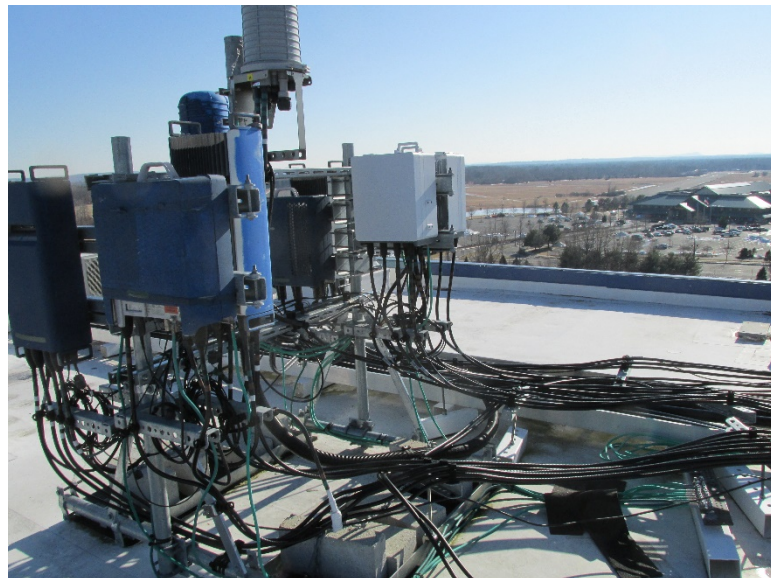
Much of the west stair/elevator penthouse roof is covered with telecom equipment/antennae/cabling.

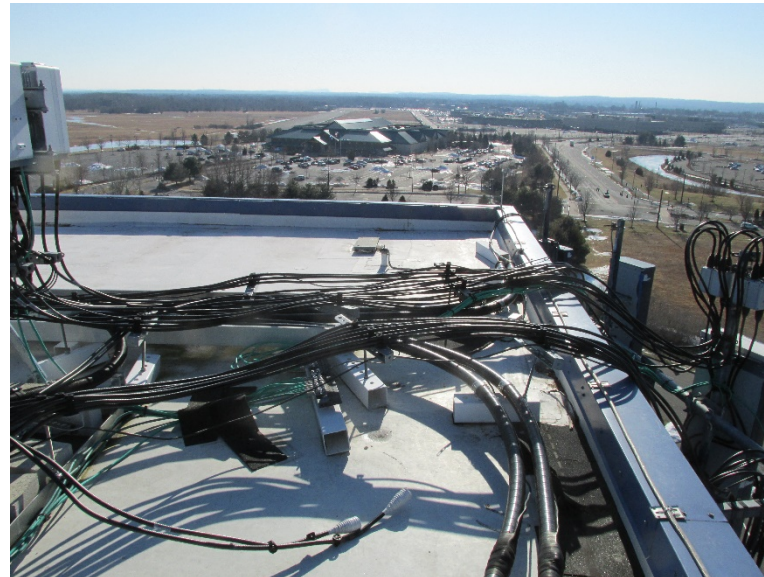
Numerous telecom cables are extended from equipment atop the west stair/elevator penthouse roof, over the roof edge, and downward to connect with other equipment installed in other areas of the building and/or grounds.

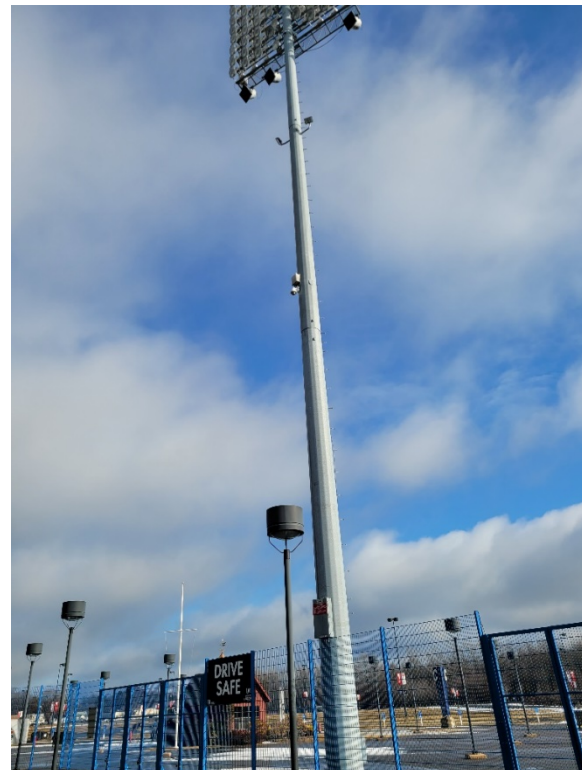
The video surveillance has been updated over the years in an ad hoc manner. It is comprised of both analog and IP-based cameras of which 18 of the 35 cameras on site are not currently functioning properly. This is due to either damage to the camera or cabling infrastructure to the camera. The parking lot cameras, which were installed in 2016, are configured as a “wireless-mesh” network and do not have reliable connectivity to the building network for monitoring. The four pole-mounted PTZ cameras are utilized the most, however they are mounted approximately 25’-30’ above grade and sway with the light pole to which they are affixed causing visibility and imagery issues.

Pole-Mounted PTZ camera

2. Recommend manufacturer consolidation and replacement of cameras. At the stadium, this work would include camera replacement and physical cabling plant replacement as required. For the parking lot areas, this work would include new pole-mounted cameras, new exterior underground raceways, new composite fiber optic cable plant, as well as new combination POE/Media conversion equipment.

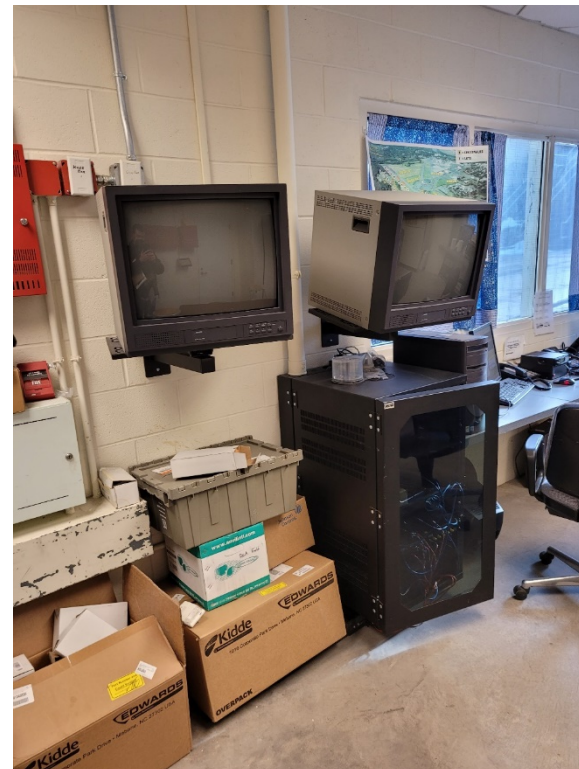
Also, there is no active video recording system for surveillance, which poses an issue in operational functionality. Room Security/Fire CMND S113 houses the original camera monitoring system, however the monitors are no longer in use. Also, an existing PC operated Veracity Coldstore video surveillance storage recorder is located within IDF 5B, however it is outdated and not used in daily operations.

Room Security/Fire CMND S113 monitors

1. Recommend replacing video surveillance system management and adding new Network Video Recording (NVR). This scope of work would include the replacement of existing equipment, software, licensing, as well as providing new physical cabling plant as required.

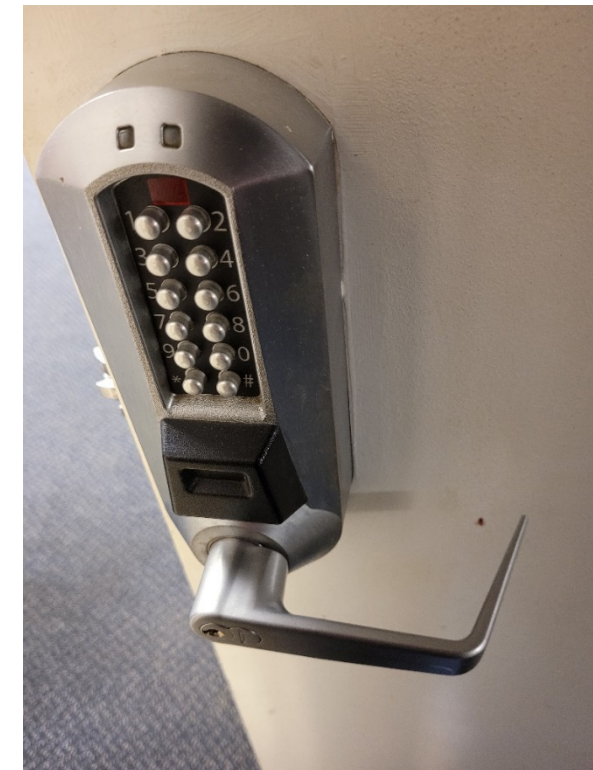
The access control system is original (2003) and used as a local means of access and not monitored. Lobby elevators on floors one and two have readers intended for “after hours” access, however they do not appear to be functioning allowing access at any time. The primary locking system is done through a “master” physical key. The facility maintenance contractors, police, and fire department all have physical master keys as means of access. The main offices for food service access are via a stand-alone non-networked keypad doorknob.

Food service office keypad

5. Recommend adding intrusion detection at (2) locations with safes and at concession stands around concourse.
6. Recommend replacing access control panels, card readers, door switches, cables, and monitoring as the existing systems age exceeds the recommended “end-of-life” cycle.

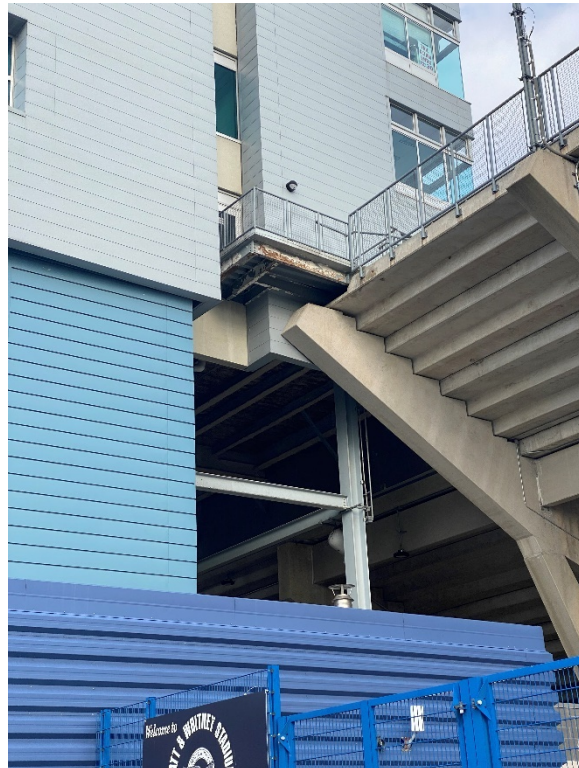
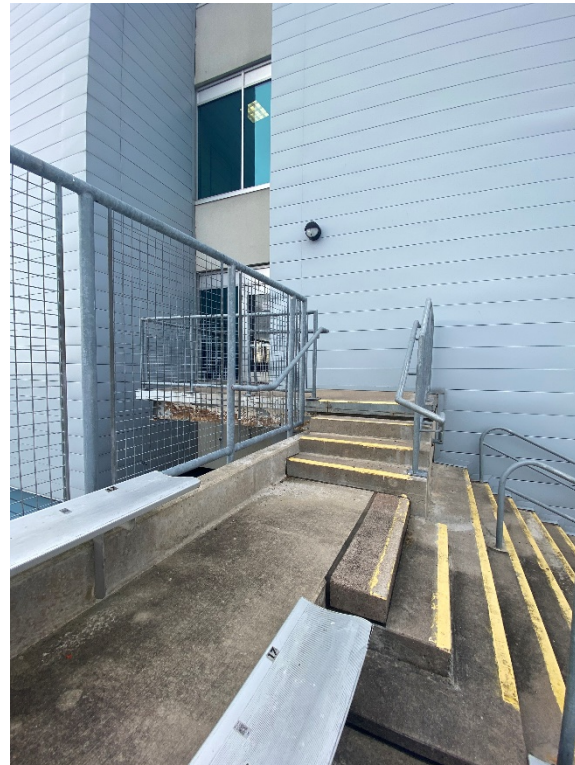
Club Level stair landing is showing signs of rust and water damage.

South/east exterior club level stair landing and exit door bowl facing; the steel support is showing rust and deterioration of concrete and sealant joints

1. The rusting club level stair landing should be sanded, primed and painted. Any structural issue observed should be addressed as well.
2. Replace thermal gaskets at SE exterior club egress door.

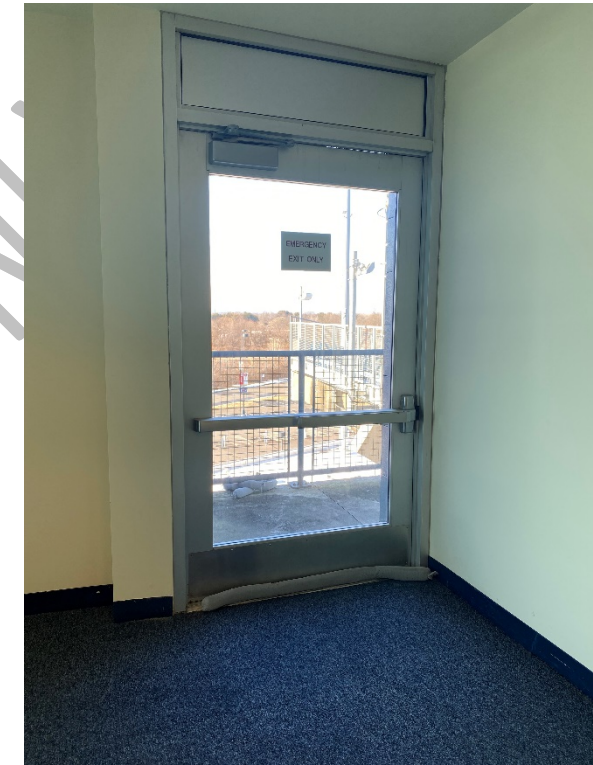
Exit door has air gaps to exterior at SE Club Level

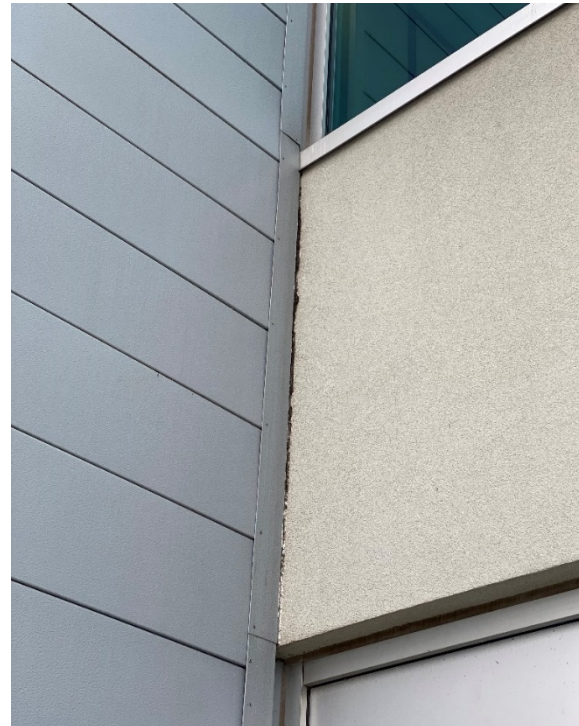
Above SE Club Level Exit -gap at exterior finish system most likely allowing water to infiltrate.

3. Repair exterior finish system above club egress door.
4. Recommend the concession/restroom building downspouts should be hard piped to storm drainage system to mitigate further erosion and damage to building.

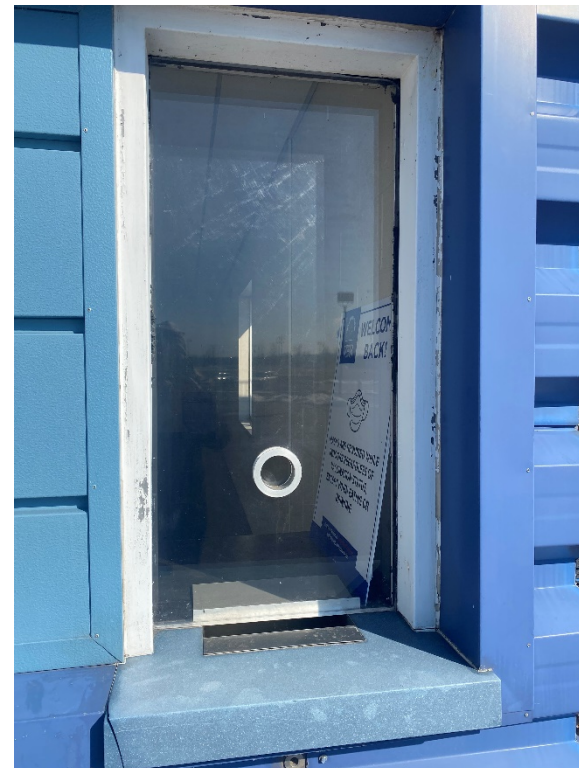
Ticket window at end of life.

5. The ticket windows should be replaced and the signage updated. The exterior CMU walls need to be repainted. A canopy over the ticket windows could provide protection for ticket windows and provide a new elevated look to these areas. LED displays are often used above windows for messaging and could be considered if it is desirable. Stadiums are trending towards paperless tickets and often times the quantity of ticket windows can be reduced in a building of this age. Quantity of ticket windows should be considered based on ticketing system and future upgrades of ticketing system. A new window and signage are needed at the guest service window too.

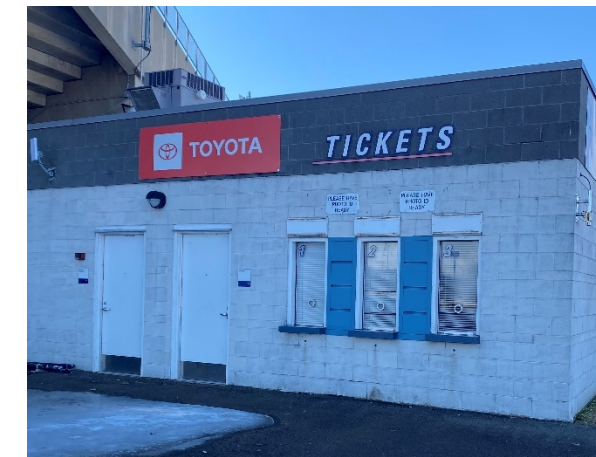
Ticket window at end of life - rust observed; window shades at end of life

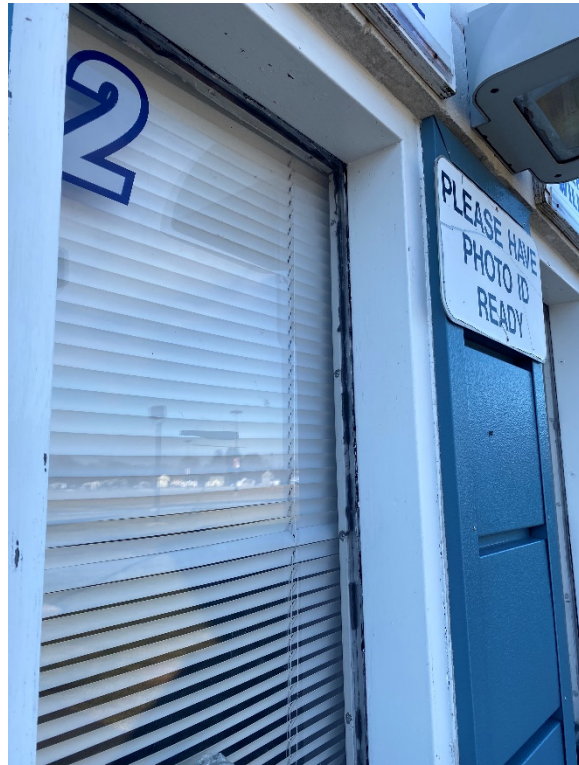
Windows are rusted, rotting and sealant and signage is deficient

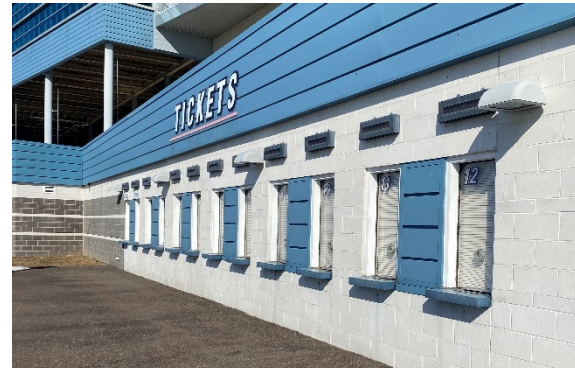
Determine current ticket office requirements; windows are rusted, rotting and sealant and signage is deficient and at end of life

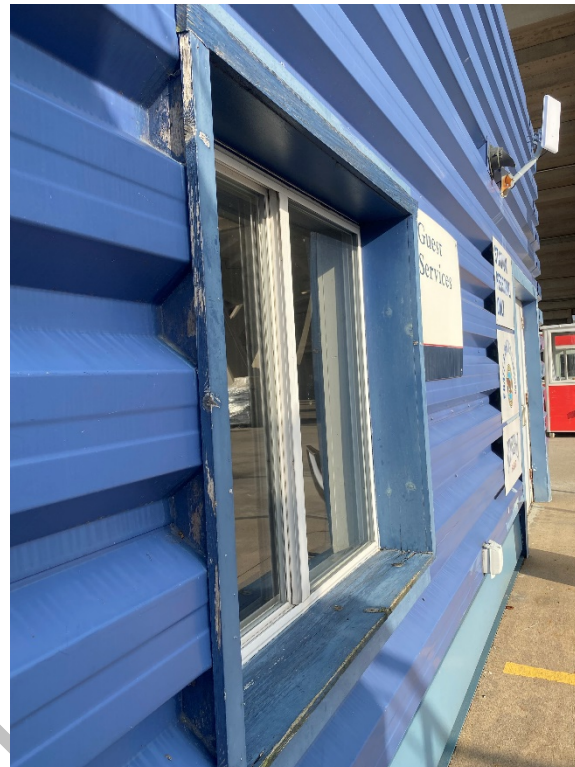
Guest Service window- wood is rotting and paint is faded

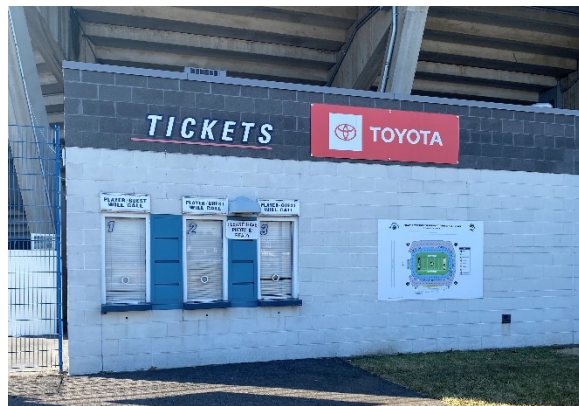
Windows are rusted; sealant and signage are deficient and at end of life

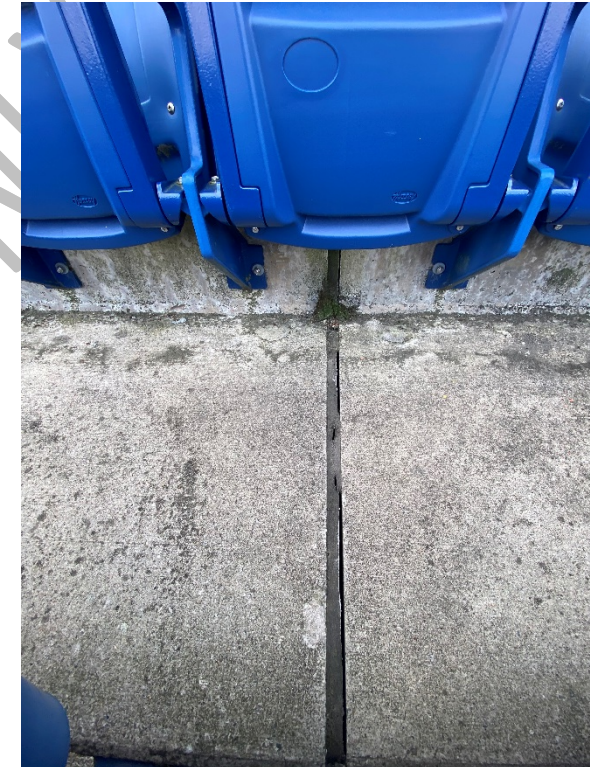
Sealant maintenance/replacement required; sealant is pulling away from concrete

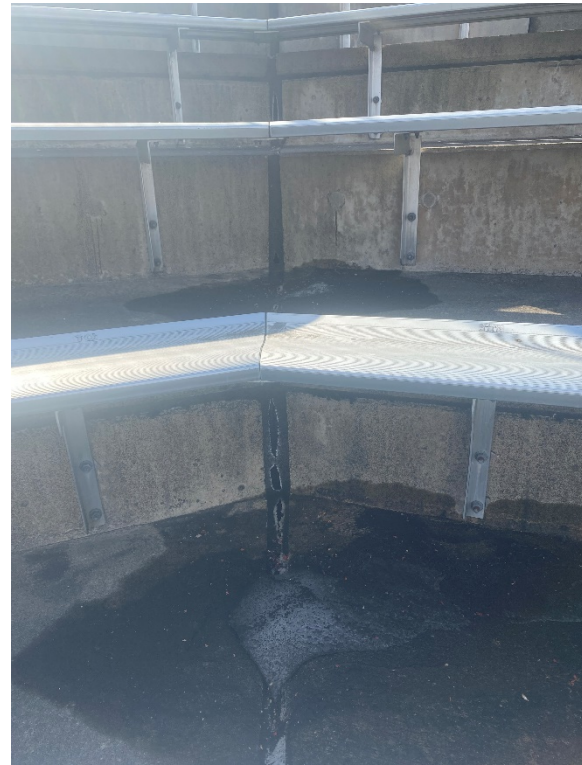
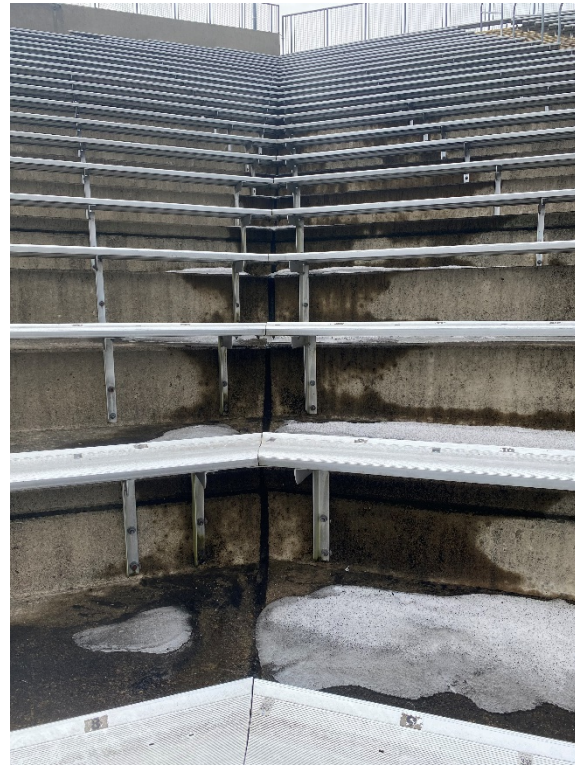
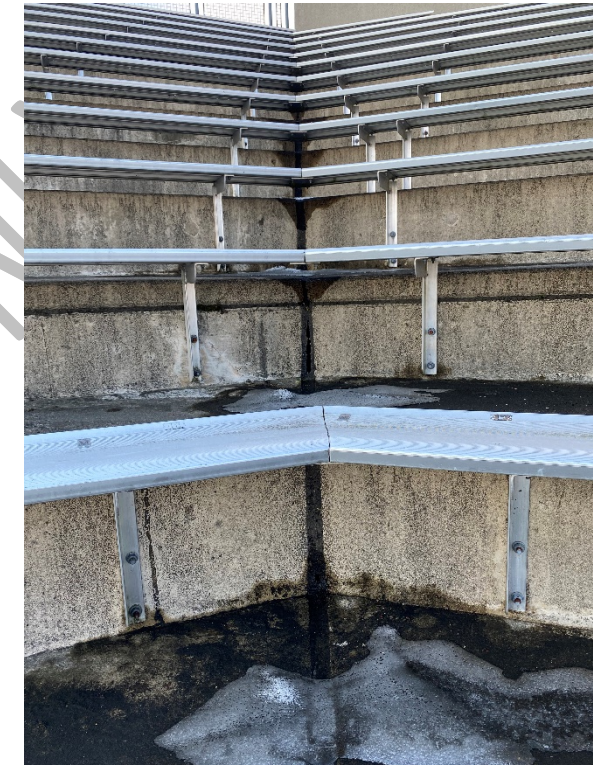
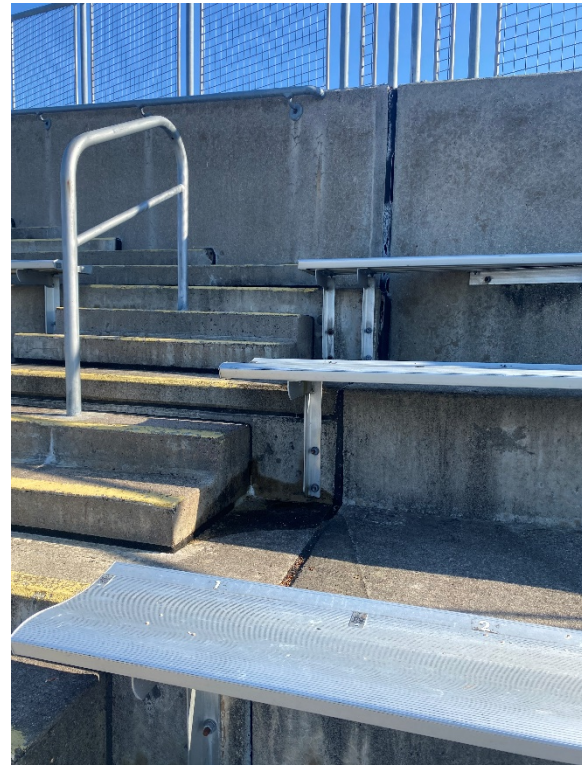
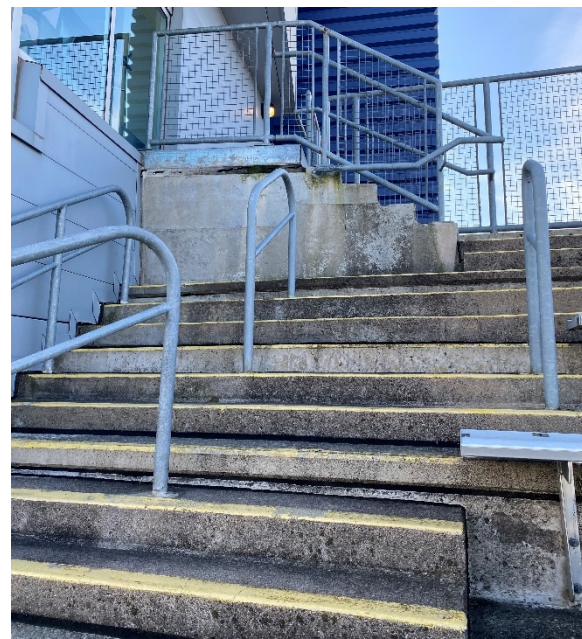
Sealant maintenance/replacement required

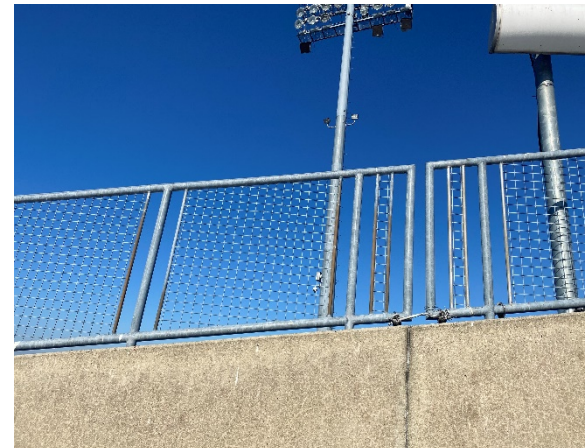
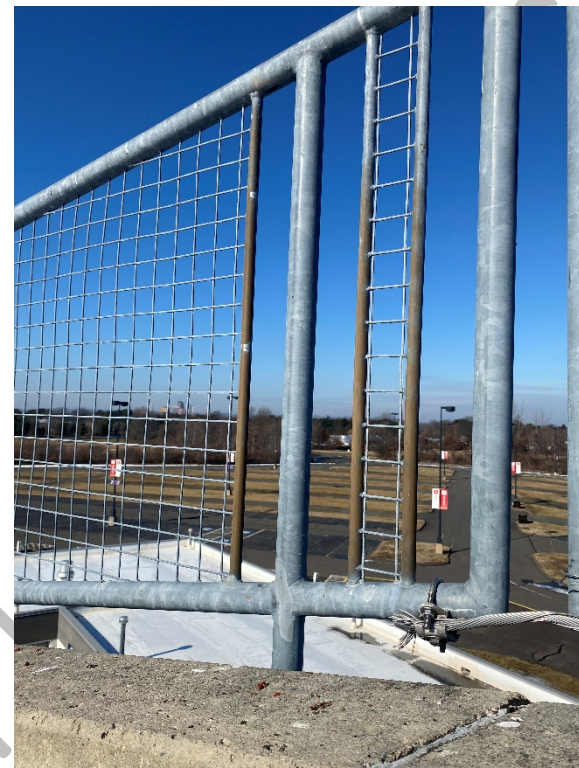
Rust observed on guardrail at back of bowl

6. Recommend removing rust from aisle railings and guardrails.
7. Recommend removing rust from scoreboard steel and guardrails.
8. Recommend replacement of concourse asphalt.

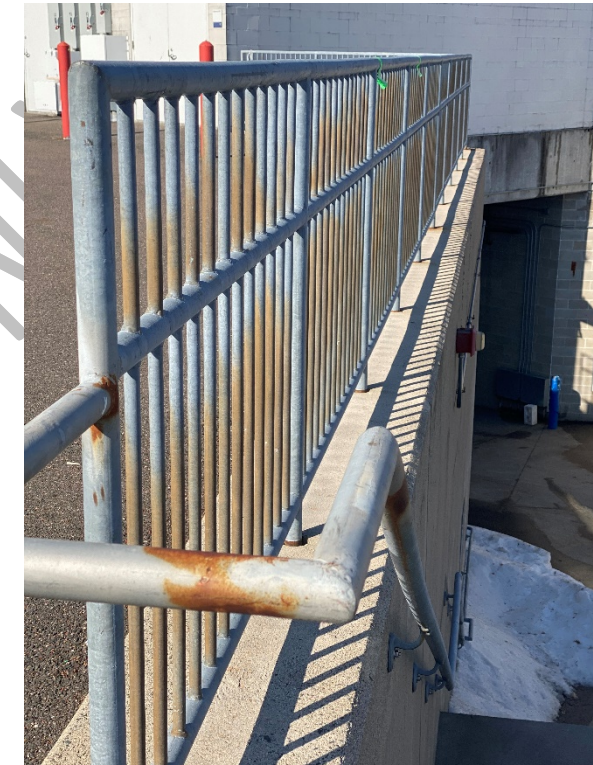
Rust observed on guardrail around loading area

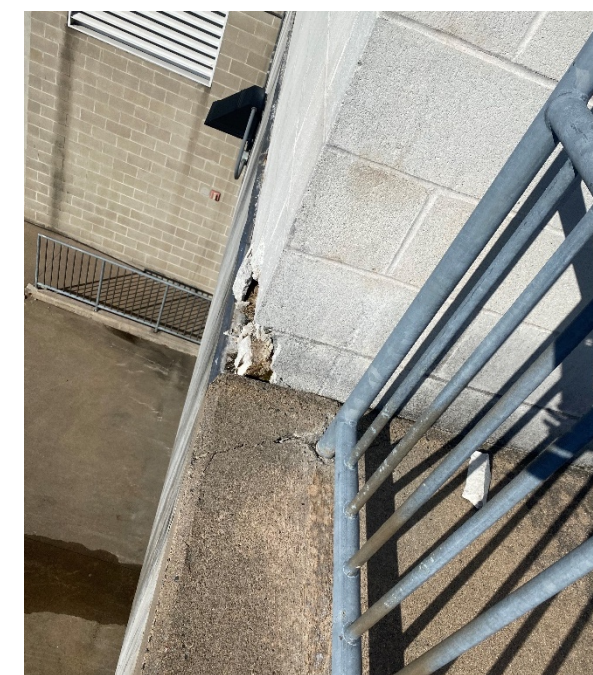
Rust observed on guardrail around loading area; damage to concrete masonry above loading dock area

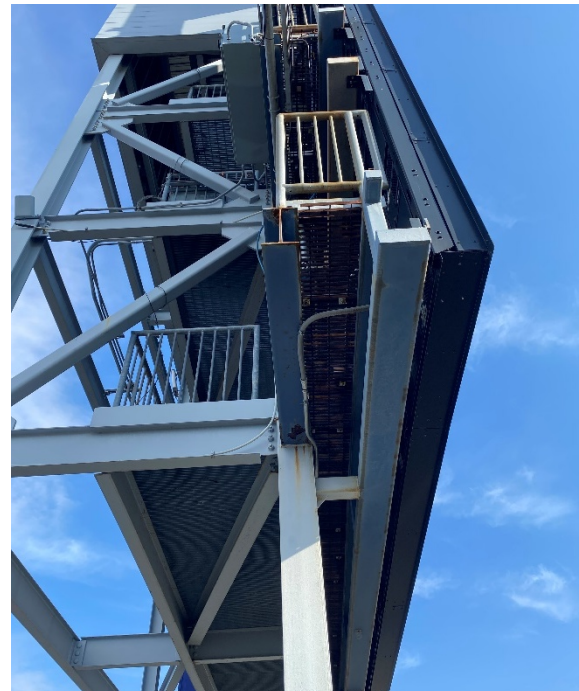
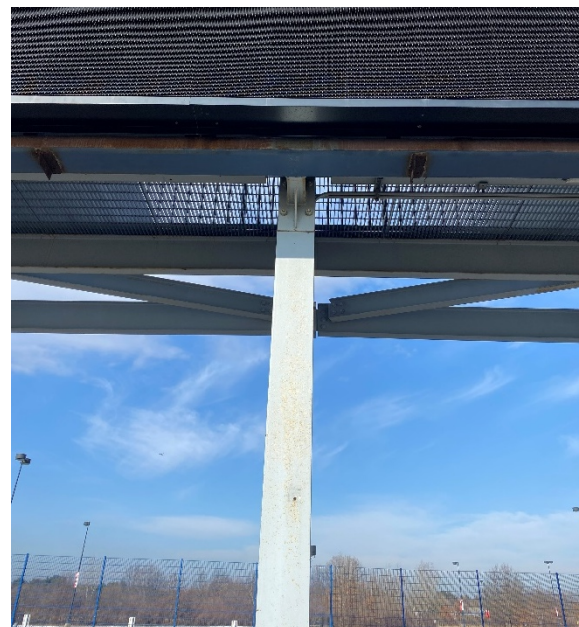
Guardrails and steel rust at scoreboard

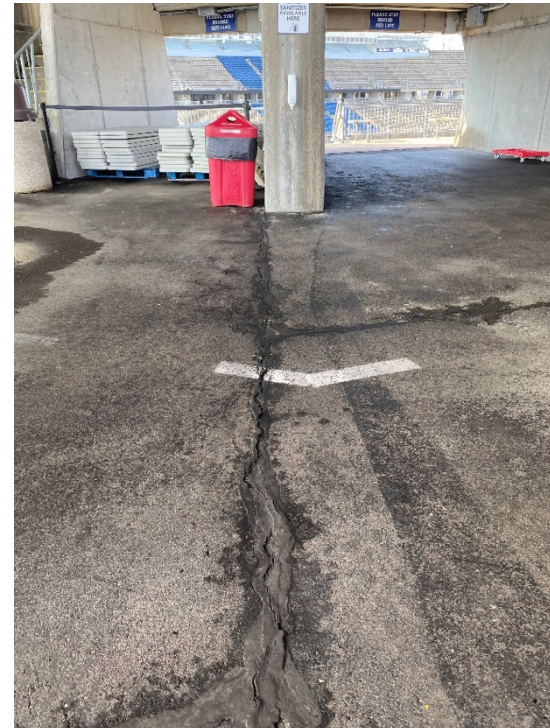
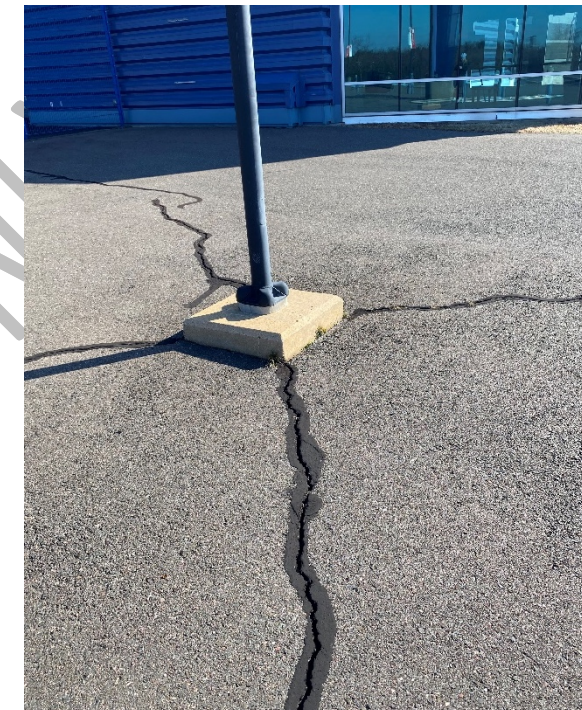
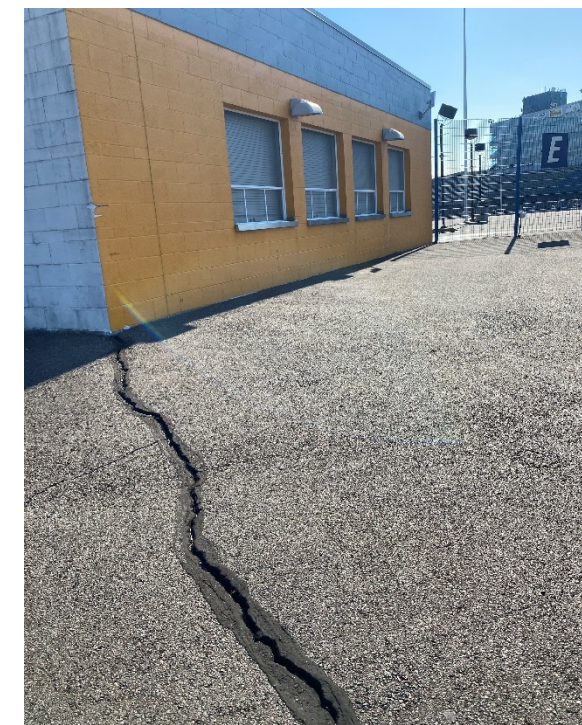
The asphalt concourse has several large cracks.

Asphalt crack on concourse

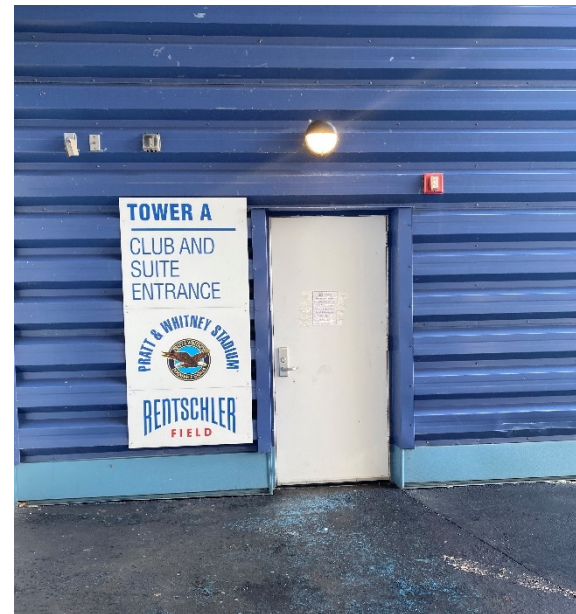
Club Ceiling

Club Entry and signage need an update

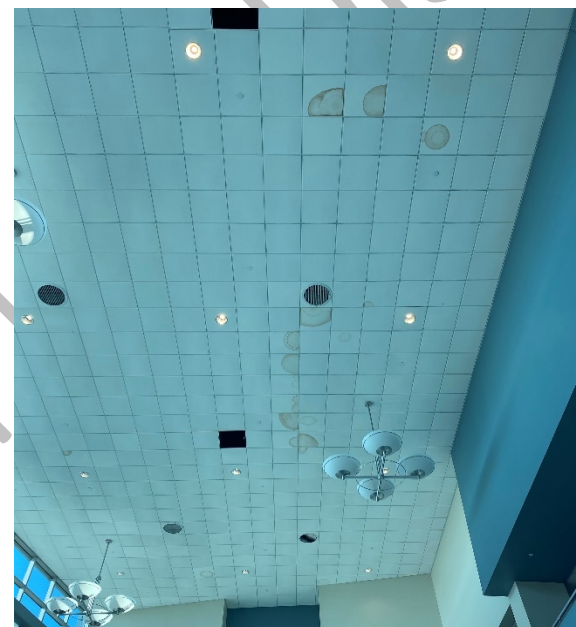
Water-stained ceiling tiles

10. Recommend determining cause of water damage in club area ceiling and repairing.
