Comprehensive Building Assessment

Rentschler Field at Pratt & Whitney Stadium

September 7, 2022
DRAFT FOR
DISCUSSION ONLY

CRDA | Capital Region
Development Authority

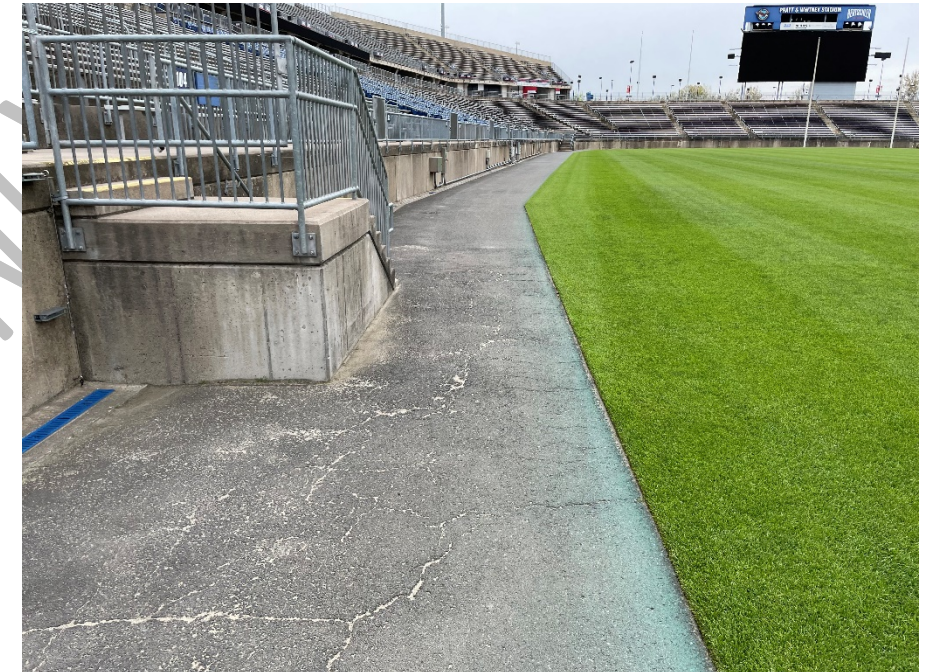
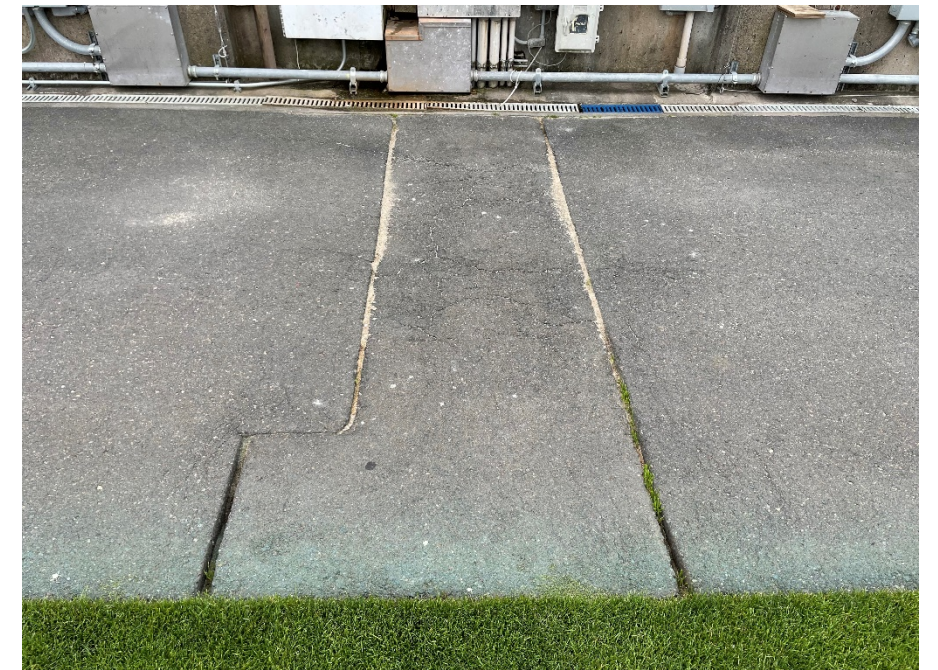
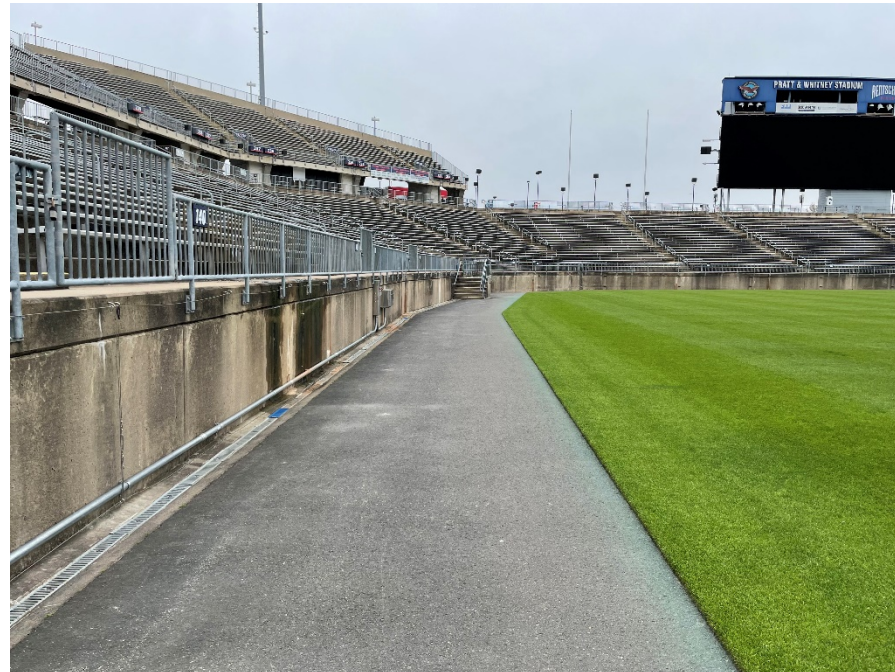
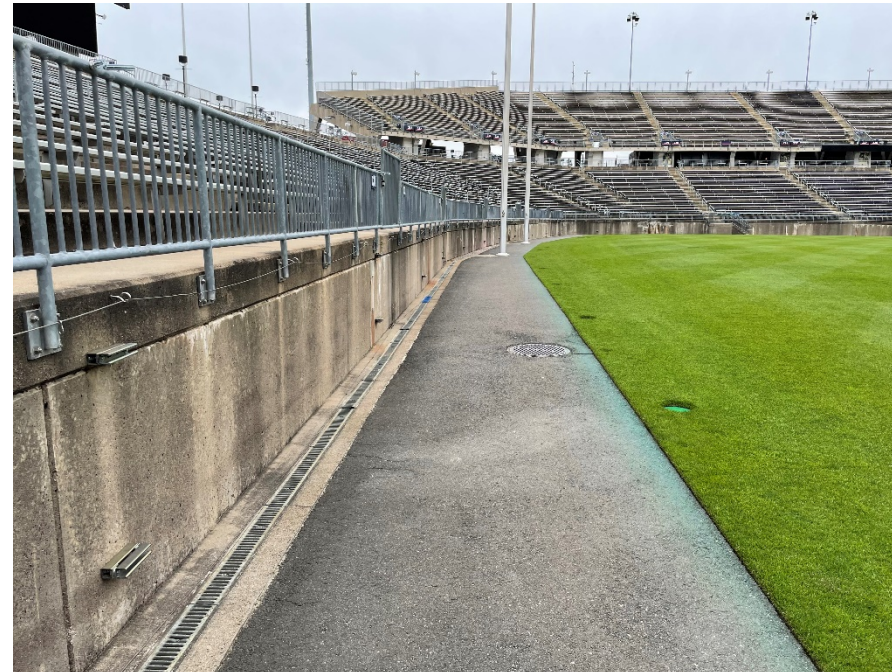
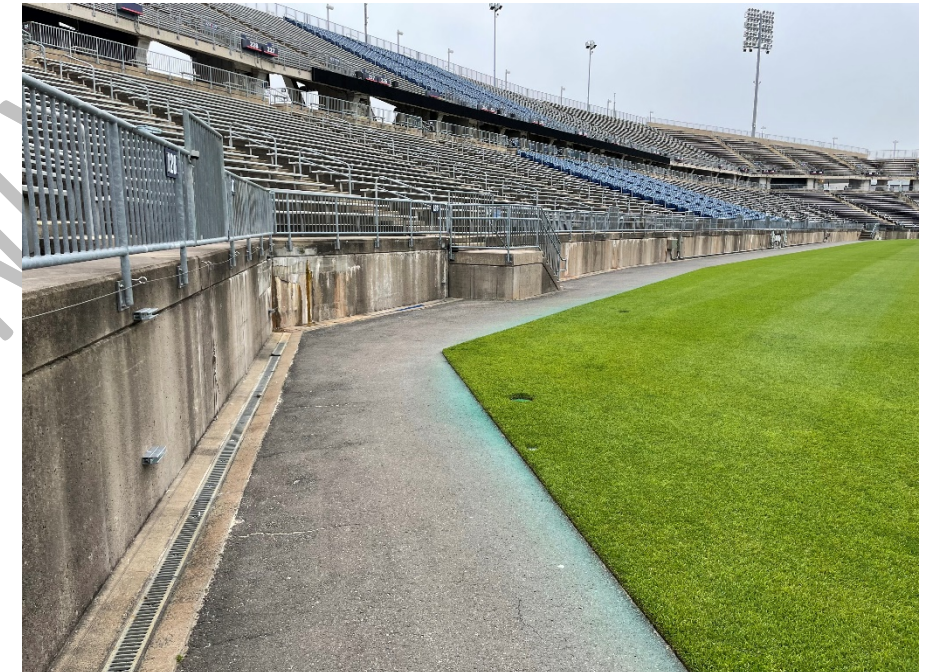
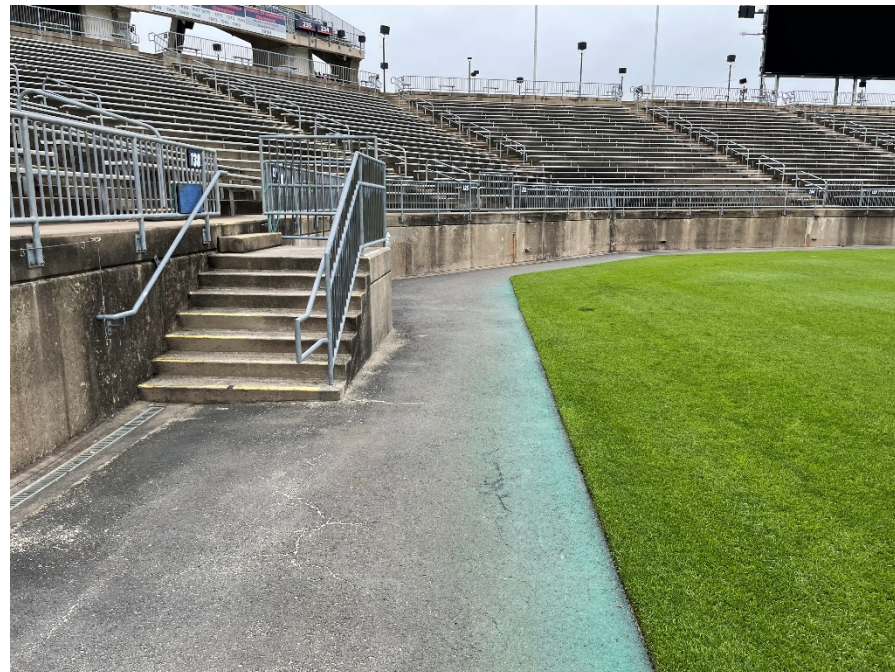
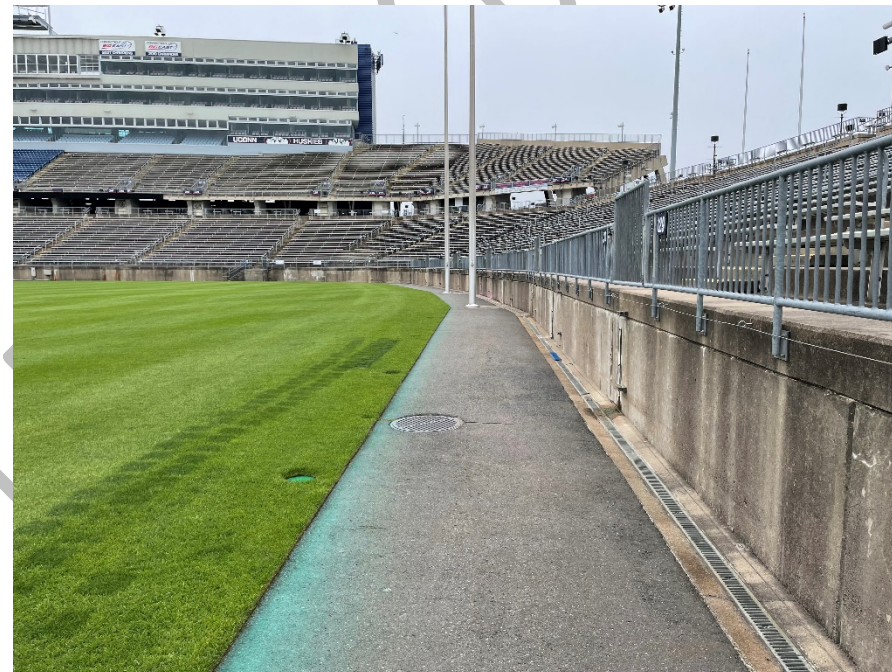
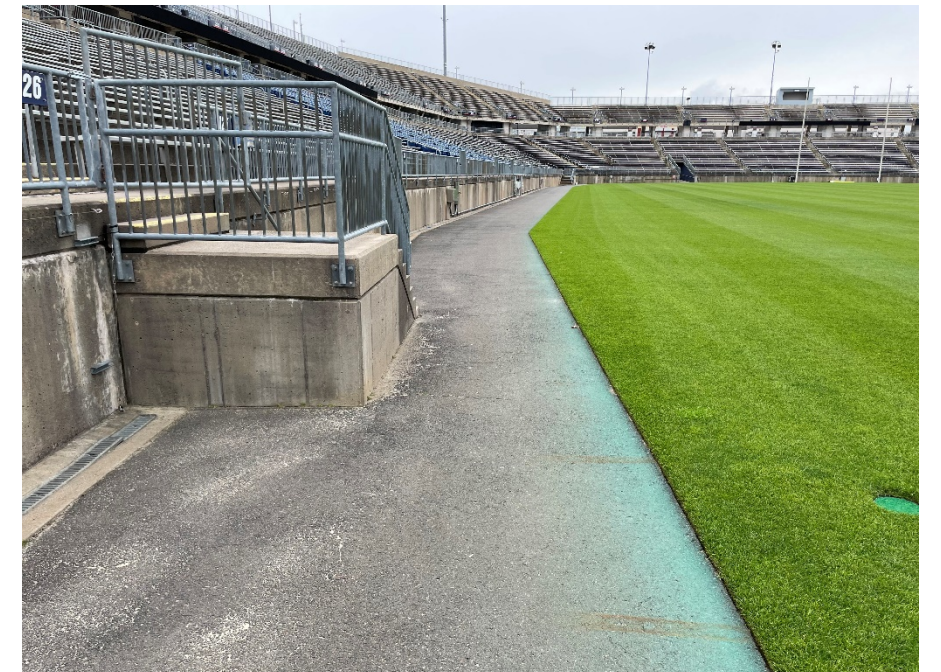
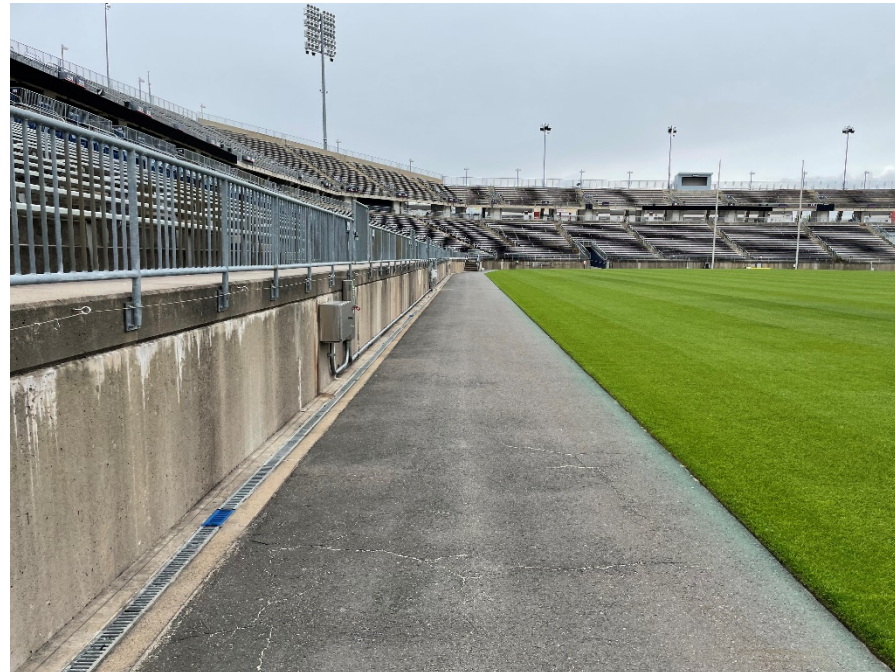
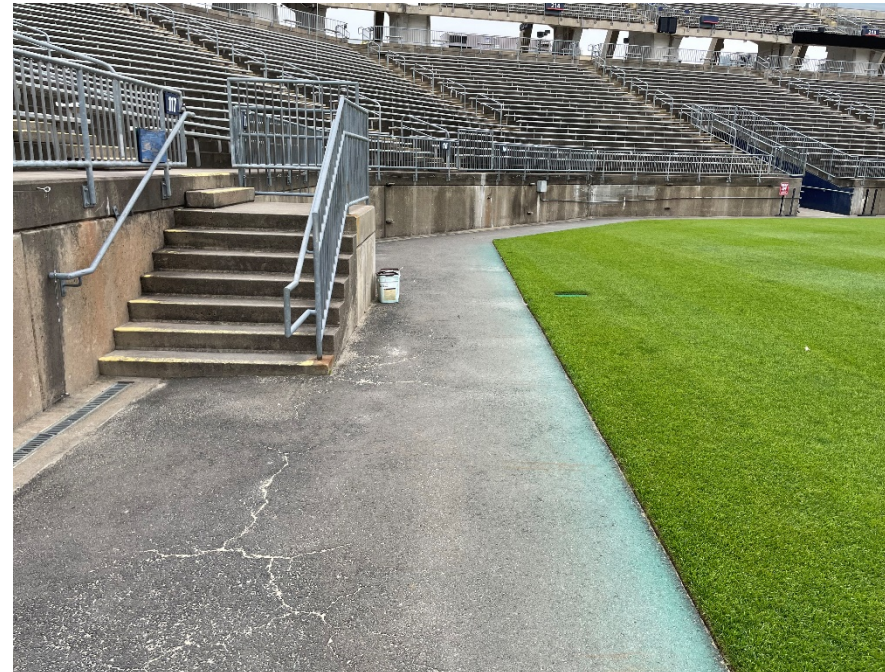
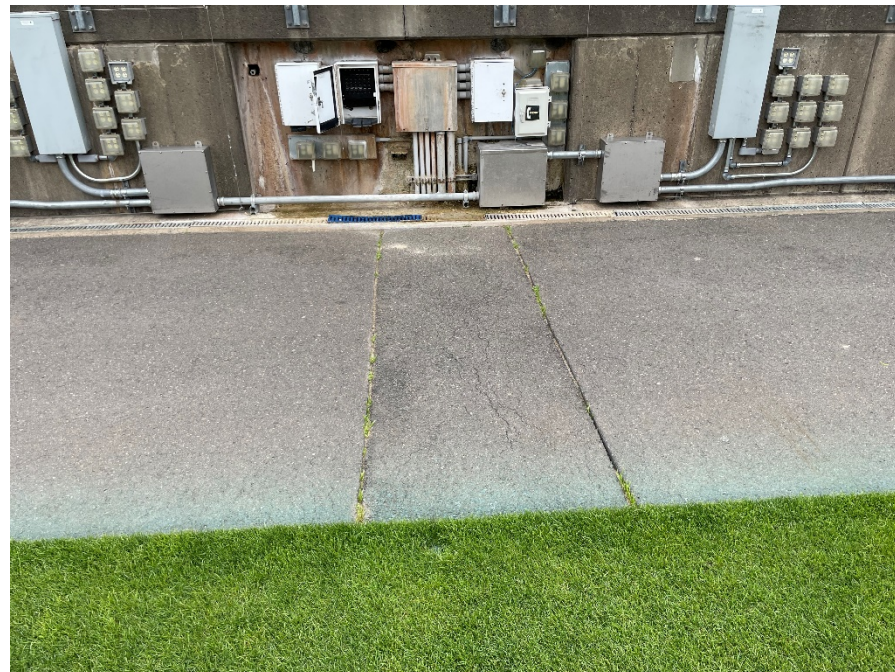
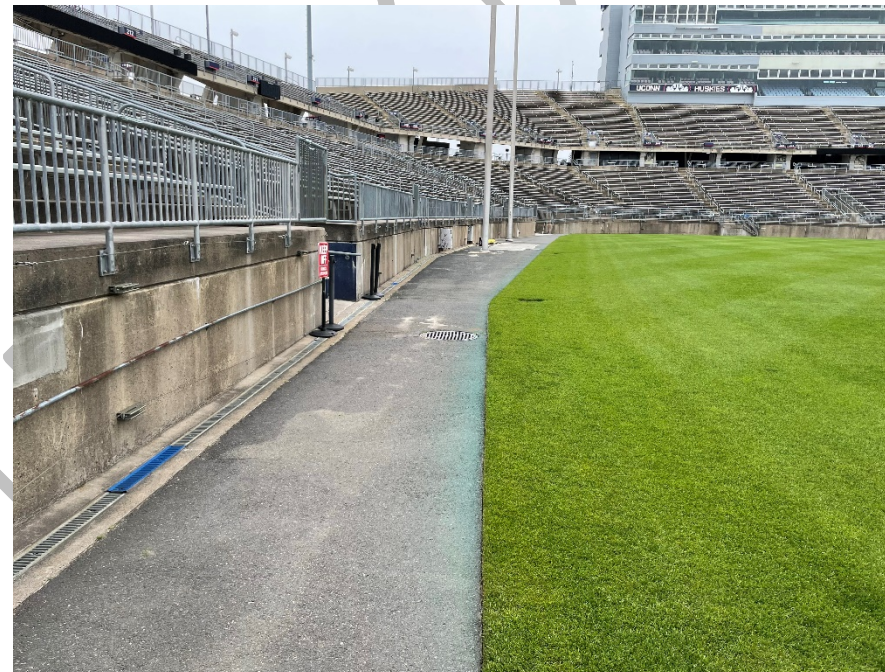
The Perimeter Track displays significant cracking. There are significant gaps in the pavement where it has been cut out for the installation of conduits.

Perimeter track at SW Stairs

Due to the required process of playing field construction, the correction/replacement of these items should occur with the next field replacement.

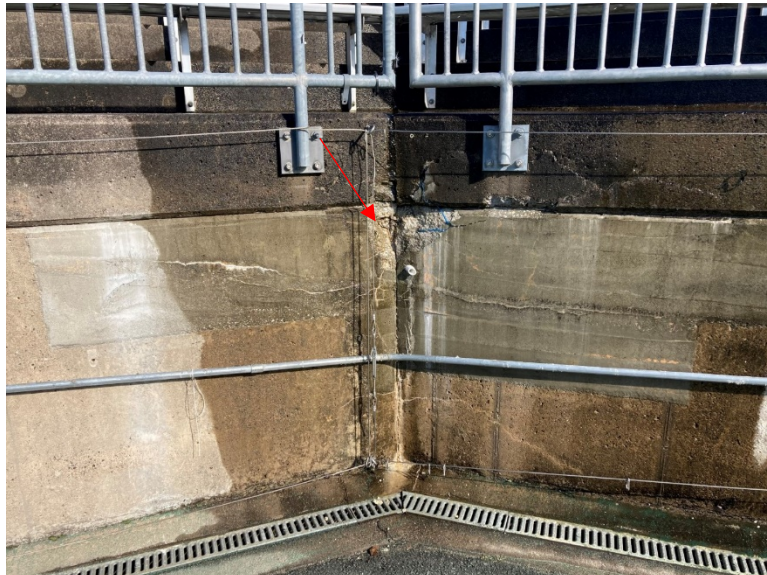
- Concrete wall and column cracks at isolated locations throughout the Service Level and Main Concourse as well as concrete wall cracks and delaminations throughout the below-grade field wall with water staining, including failure of previous concrete repairs at some locations. These cracks did not appear to be a result of overloading, but rather a result of differential movements (due to shrinkage and temperature) that are not properly accommodated by the structure.

Overall view of previous repairs and delaminating concrete at field wall

Recommendation: Epoxy inject cracks greater than 1/32-inch in width.

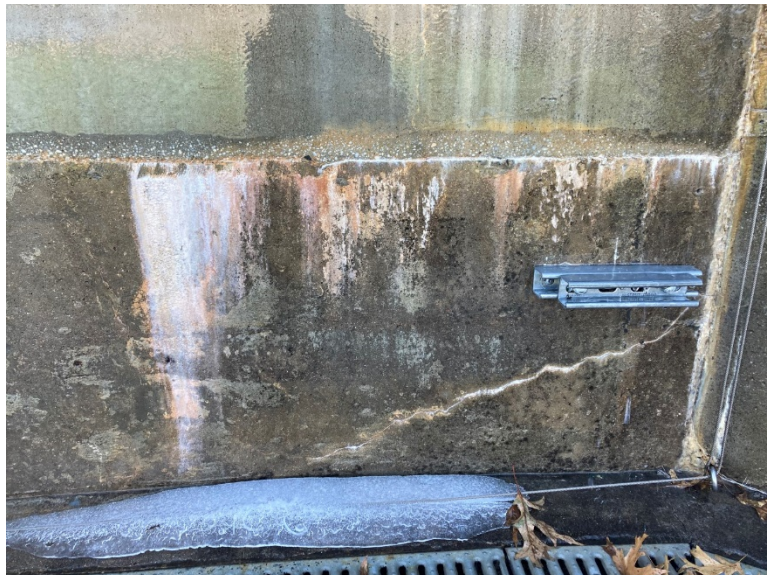
Concrete wall cracks with water staining at the below-grade field wall

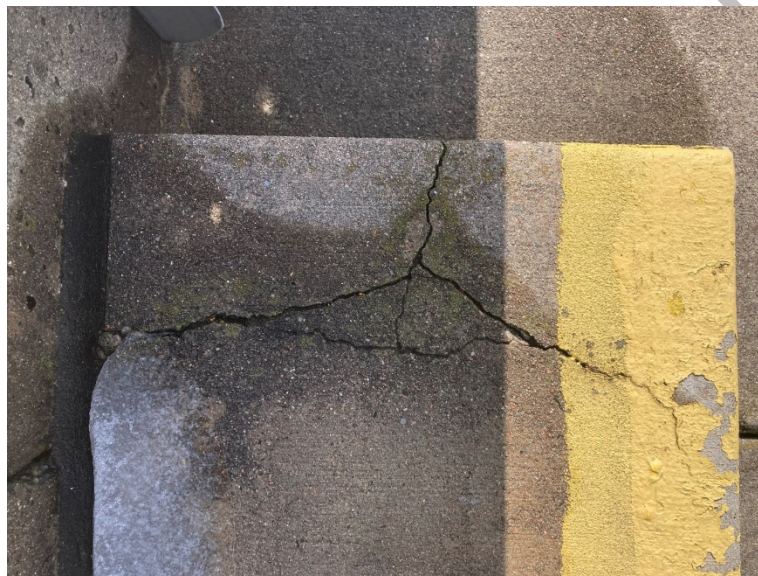
- Cracked, delaminated, and spalled concrete steps at multiple locations throughout Upper and Lower Bowls. Spalled concrete will result in trip hazards.

Cracked and delaminated concrete step in seating bowl (typical throughout)

Recommendation: Replace deteriorated concrete in steps in accordance with ICRI standards.

Alternatively, replace entire step with a new precast concrete step.

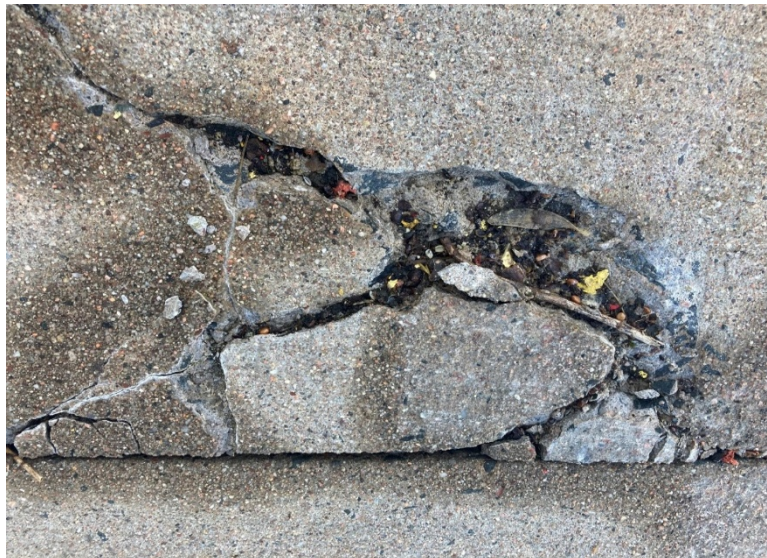
- Concrete floor slab delaminations and spalls at several locations on the Main Concourse. As mentioned above, concrete delaminations and spalls will likely result in trip hazards and will lead to faster deterioration of the concrete elements.

Concrete floor slab spall on Main Concourse near ramp on east end

Recommendation: Replace deteriorated concrete in steps in accordance with ICRI standards.

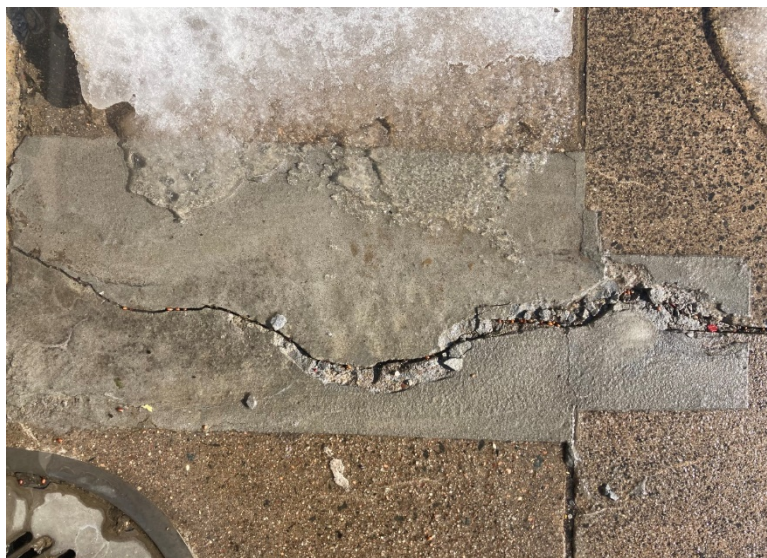
Previous concrete floor slab repair, failed/delaminating, on Main Concourse near ramp on east end

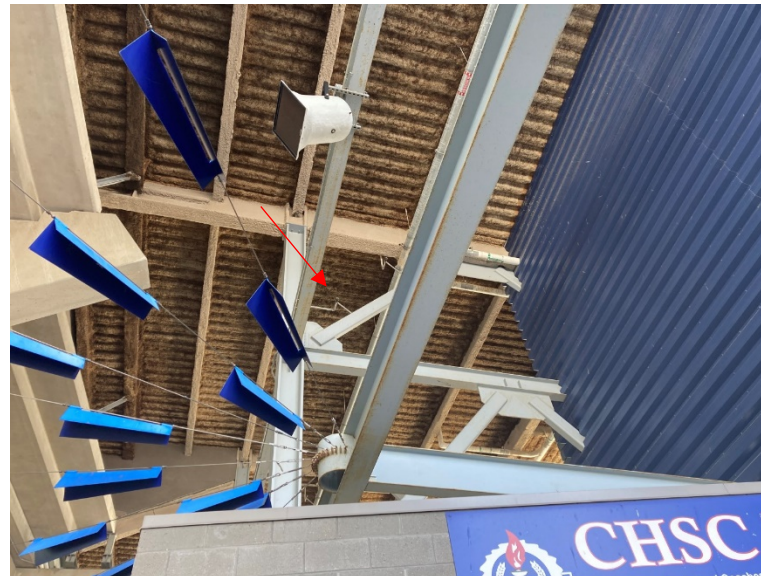
- Corroded steel framing below Club Level, at Scoreboard, and at Roof Level structures. There was no evidence of significant section loss due to corrosion.

Minor surface corrosion of steel framing below Club Level

Recommendation: Clean and recoat structural steel with evidence of corrosion.

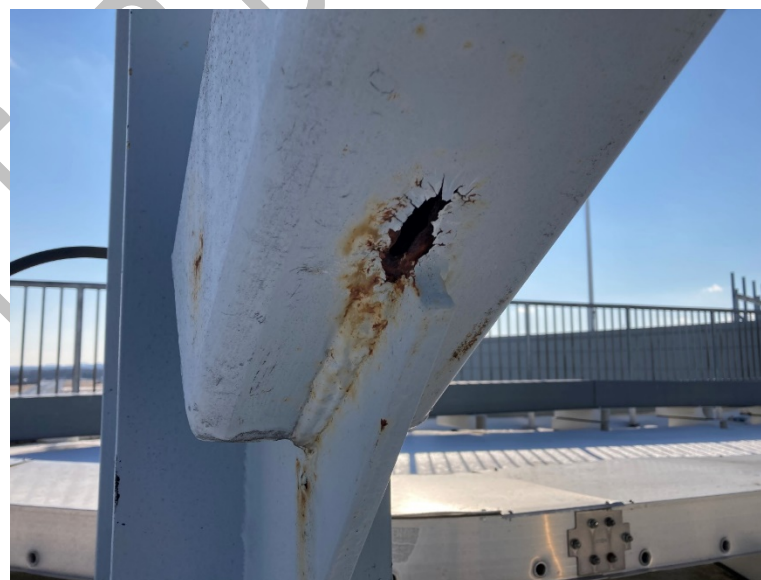
Corroded steel framing at Roof Level canopy

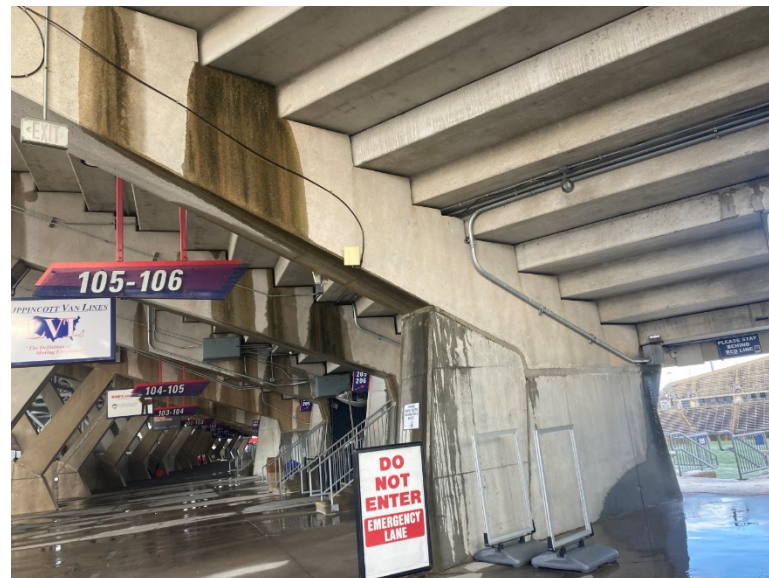
- Active water is leaking below the Upper Bowl throughout the Main Concourse. The active water leaking is a result of failed sealant at the horizontal and vertical joints between the precast seating units, and failed expansion joint. Water penetration through the joints may lead to accelerated deterioration of the concrete elements

Active water leaking from upper bowl to main concourse (typical throughout)

Recommendation: Replace failed sealant joints and expansion joint systems.

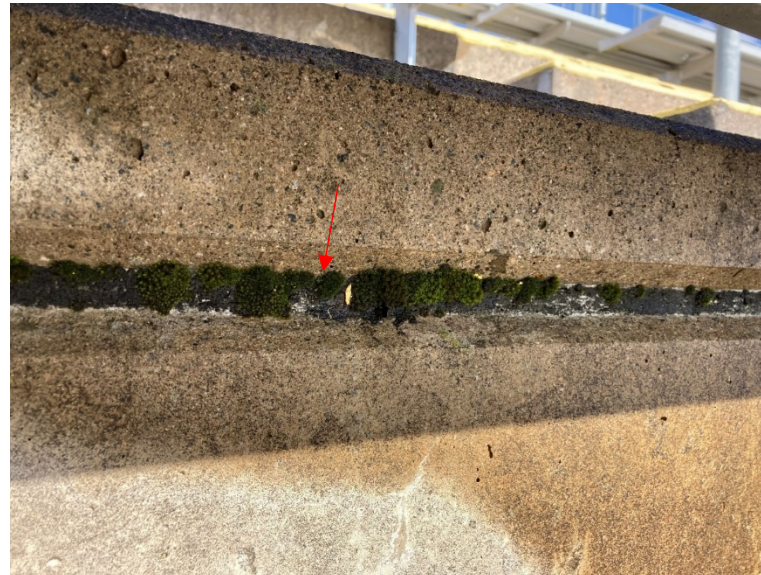
Deteriorated horizontal precast joint sealant (with vegetation growth) at upper bowl (typical throughout)

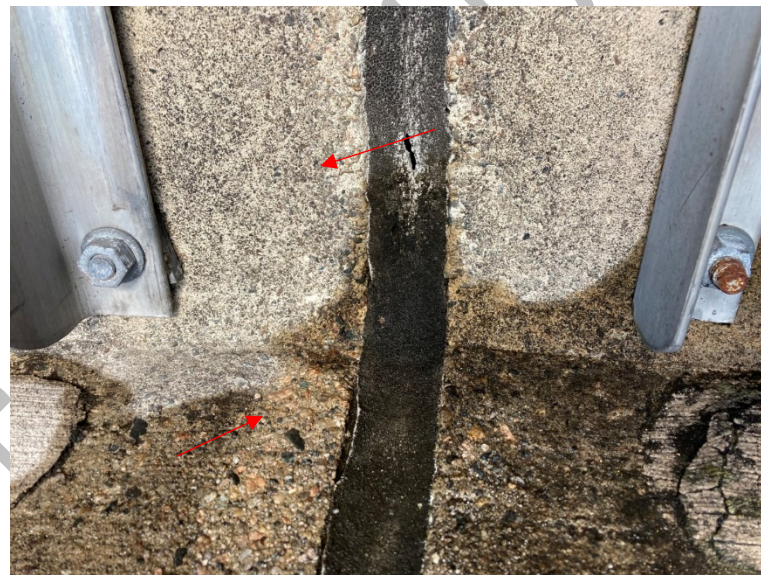
Deteriorated vertical precast joint sealant at upper bowl (cohesive and adhesive failure - typical throughout)

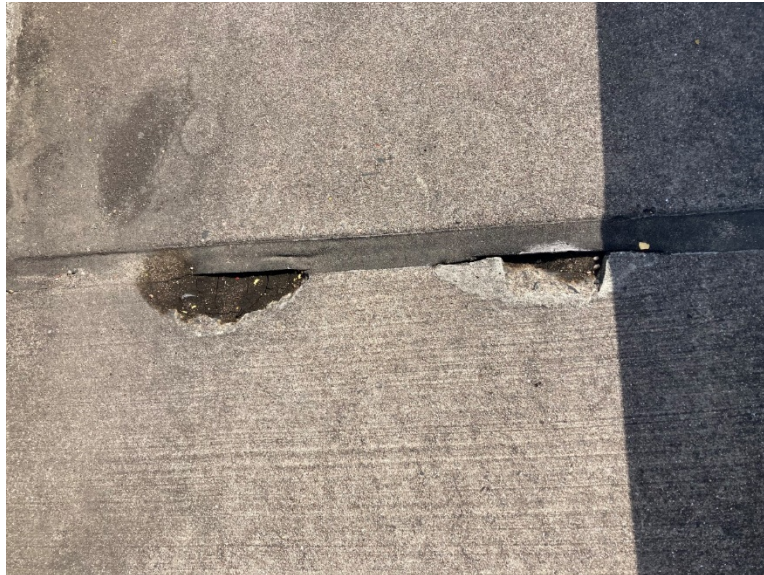
- Deteriorated joint sealants at control joints throughout Lower Bowl.

Deteriorated joint sealants in lower bowl (typical throughout)

Recommendation: Replace failed sealant joints and expansion joint systems.

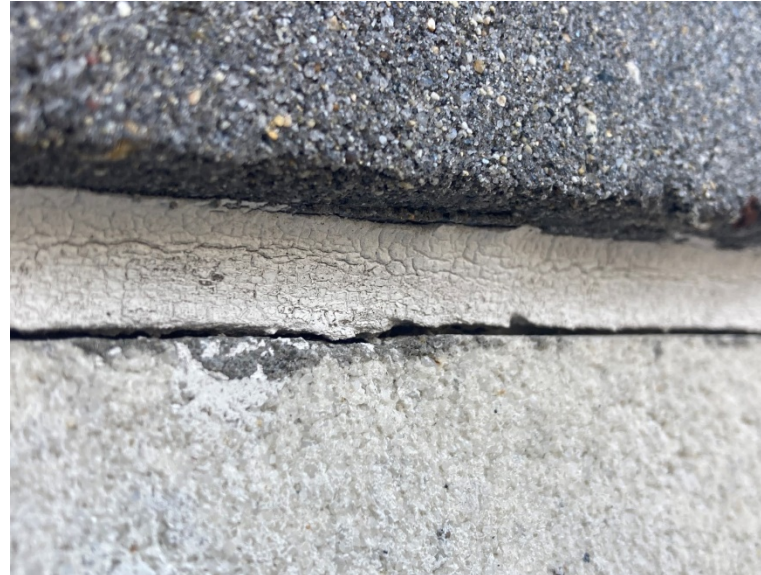
- Deteriorated joint sealants on CMU walls on Main Concourse. Deteriorated joint sealants will result in water infiltration through the walls.

Deteriorated horizontal joint sealant on CMU wall on Main Concourse (typical throughout)

Recommendation: Replace deteriorated joint sealants.

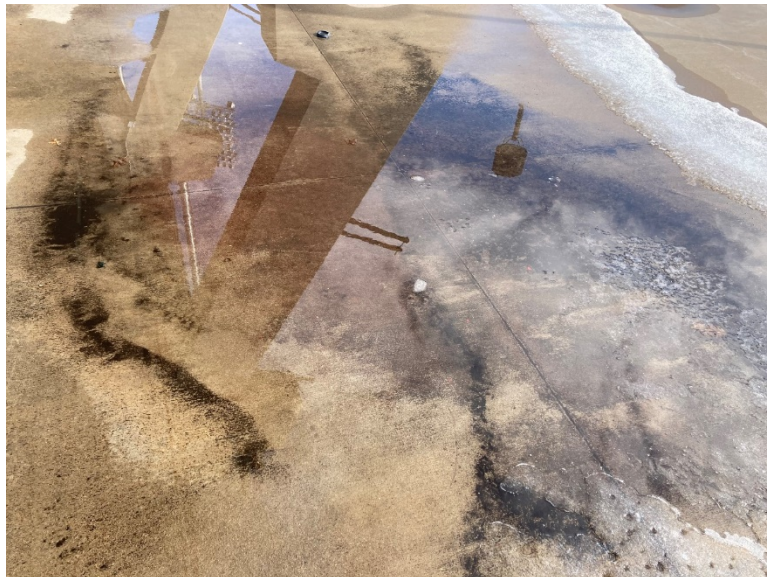
- Evidence of water ponding at isolated locations on the Main Concourse. Ponding water may result in trip hazards in the winter due to freezing water. In addition, it may lead to accelerated deterioration of the concrete surfaces.

Active water ponding and staining on Main Concourse near east end

Recommendation: Provide concrete wash to properly slope slab towards drains.

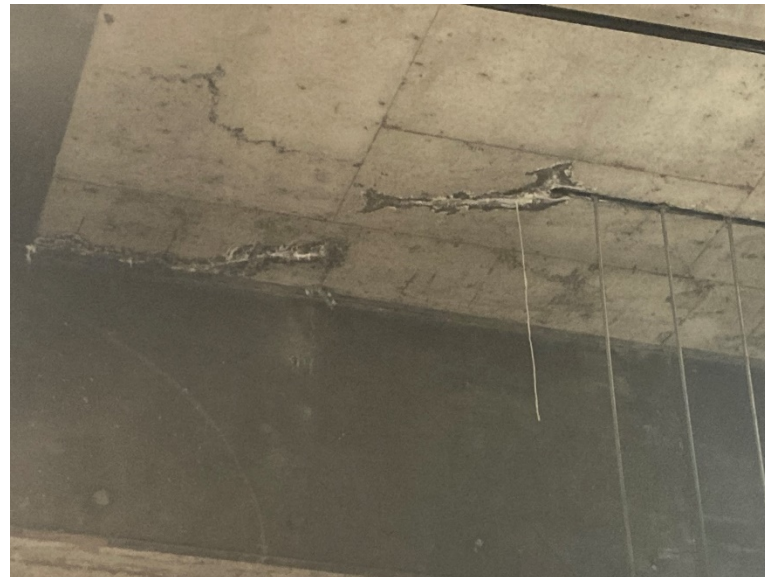
- Overhead concrete slab cracks and overhead construction joints with efflorescence staining throughout Service Level in Rooms S107, S108, S109, and in tunnel/hallway areas. Properly sealing any cracks on level above will limit water intrusion through concrete slab.

Overhead concrete slab crack with efflorescence in Room S108

Recommendation: Rout and seal slab cracks above.

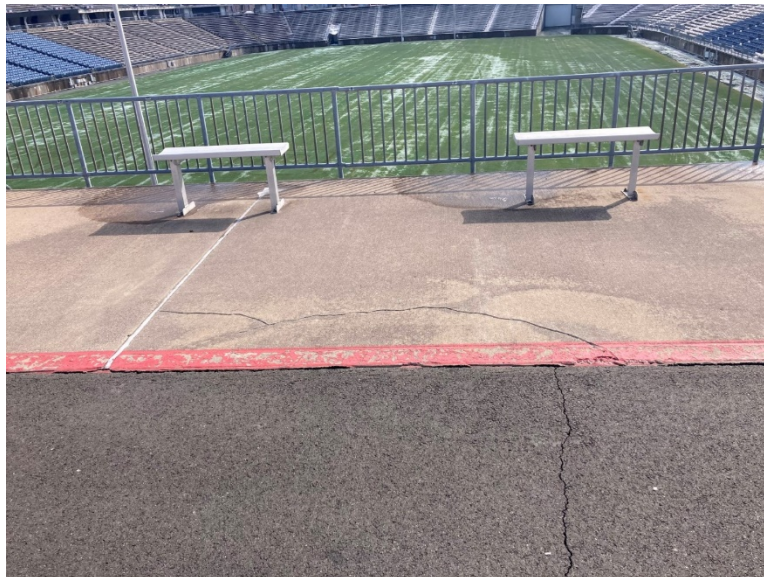
- Cracking of slab-on-grade concrete slab and asphalt pavement on the Main Concourse.

Slab-on-grade cracking on Main Concourse near scoreboard on west end (typical throughout)

Recommendation: Rout and seal cracks in pavement that exceed approximately 1/8-inch to avoid potential trip hazards.

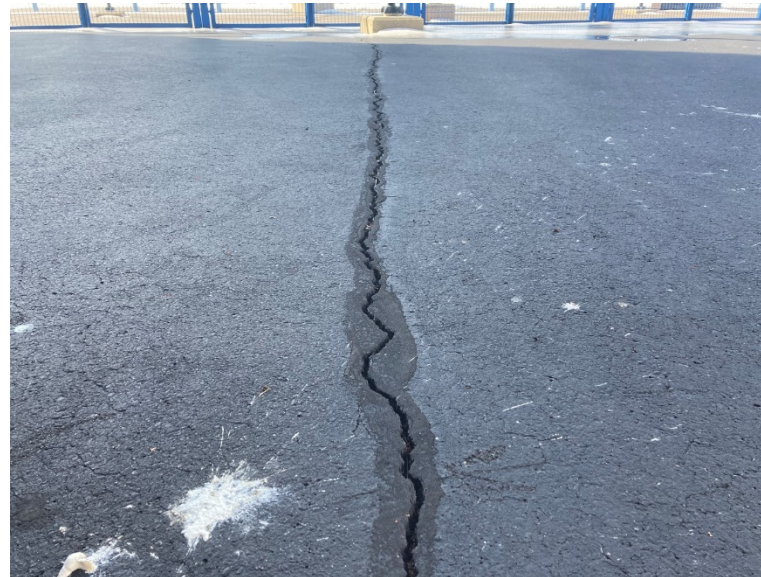
Flexible pavement cracking on Main Concourse

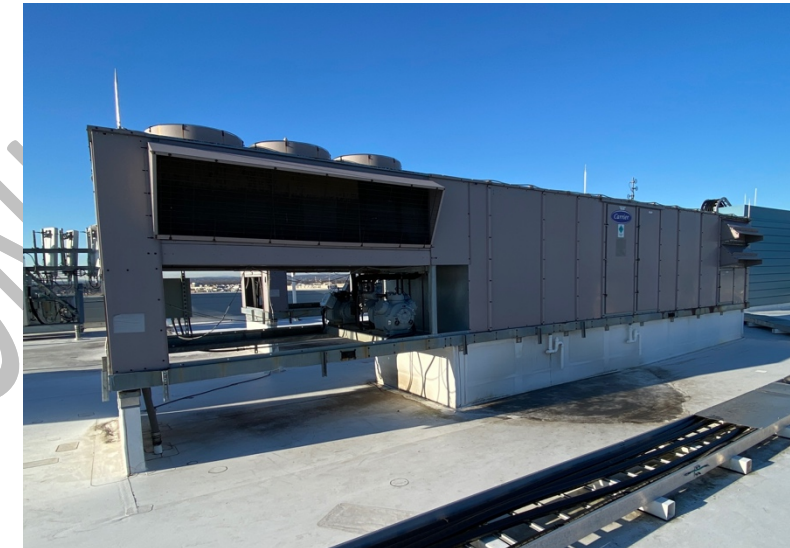
Carrier roof top unit

Due to the age, most of the equipment is R-22 refrigerant based. The refrigerant R-22 has been phased out by the Montreal Protocol and production of the refrigerant, even for use in existing equipment was halted in the year 2020. Because production is halted, the only source of R-22 is from reclaimed sources which has resulted in a sharp price increases.

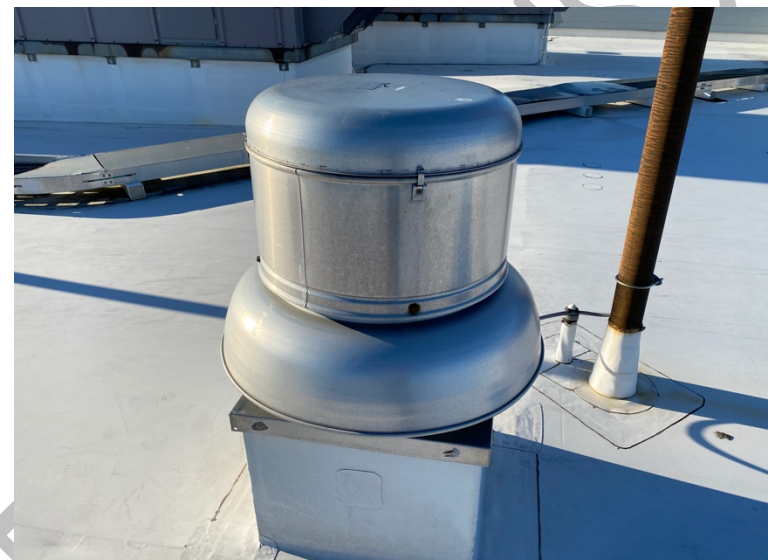
General exhaust fan

All equipment is original to the building and appears to be in a good working condition considering the age of the building. During the walkthrough there was an exhaust fan on the roof of the tower that was not operating due to a motor failure.

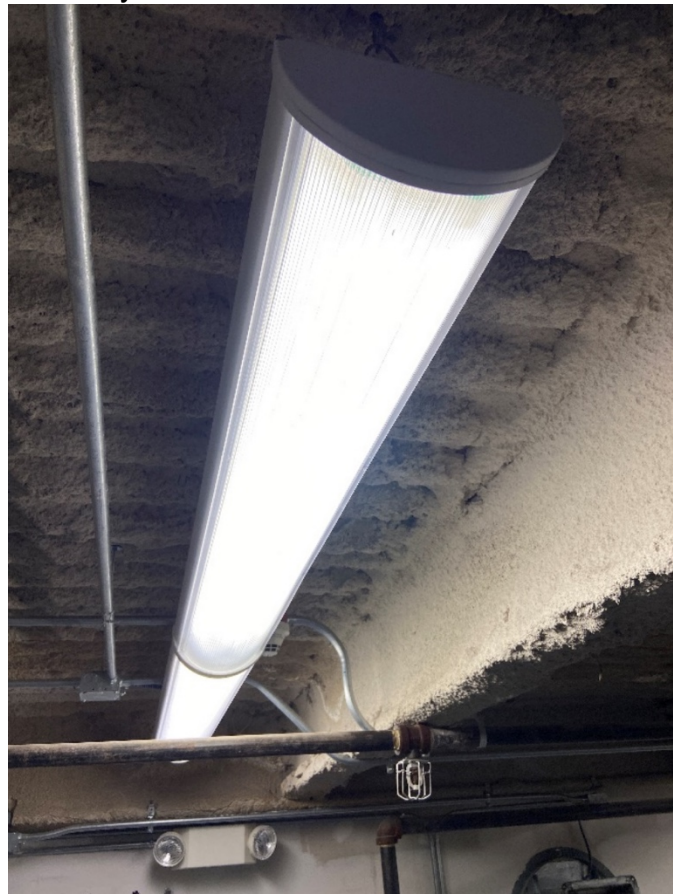
A majority of existing interior luminaires feature fluorescent lamps, which have a shorter lifespan and lower energy efficiency than equivalent LED light sources. As such, lamp replacements are a frequent task for facilities maintenance personnel, requiring time and expense to access light fixtures, remove lensing, and maintain a large stock of spare inventory.

Fluorescent luminaire in back-of-house equipment room

1. Replace all fluorescent lamp luminaires with LED light sources. 1-for-1 replacement with new LED luminaires recommended; alternate option to swap out existing lamps with LED-lamp retrofit kits.
2. Test exit signs and emergency egress lighting. Replace all failed units and/or 20-year old batteries with new.
3. Upgrade stadium and concourse lighting controls, replacing manual switching of contactors and circuit-breakers with relay-based lighting control panels equipped with remote control and scheduling capability (further discussed as part of Phase 3 upgrades)
4. Provide point-of-use uninterruptible power supply (UPS) equipment with local surge protection to safeguard sensitive electronics.

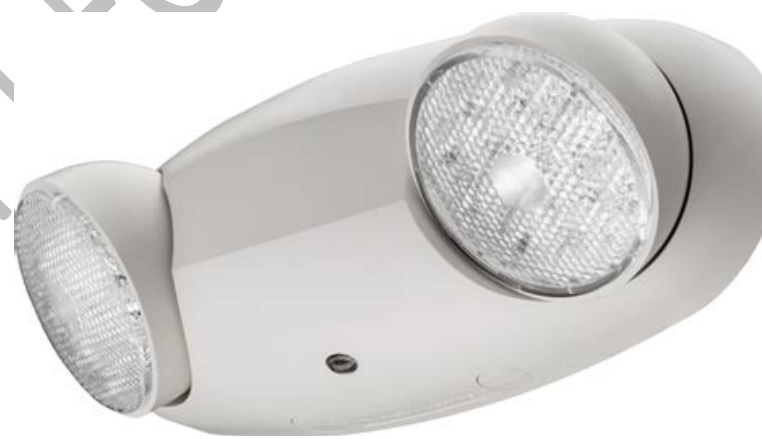
Some emergency lighting units were not functioning when tested during the site visit. All emergency egress lighting should be routinely tested in accordance with NFPA 101. Any exit signs or emergency “unit equipment” lighting equipped with VRLA batteries are now at the end of expected 20-year nominal life and should be replaced.

Example of “unit equipment”, commonly referred to as “bug-eye” fixtures.

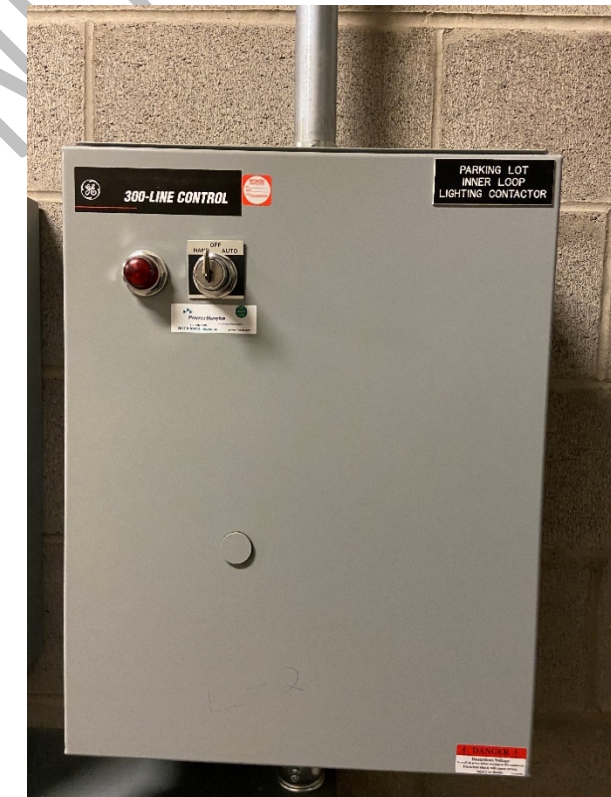
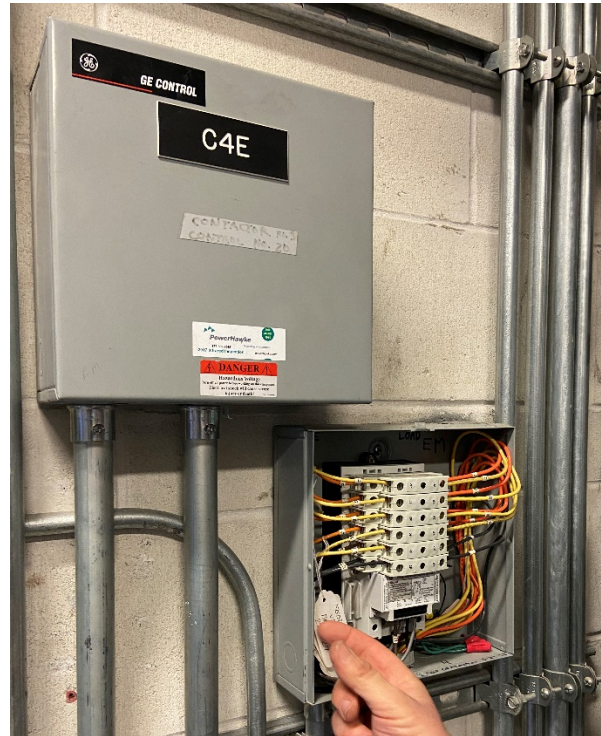
Controls for exterior lighting is primarily accomplished via manual switching of contactors and branch circuit breakers. During the site visit, maintenance personnel stated that contactors frequently fail, requiring replacement.

Manual contactor-based lighting circuit switching.

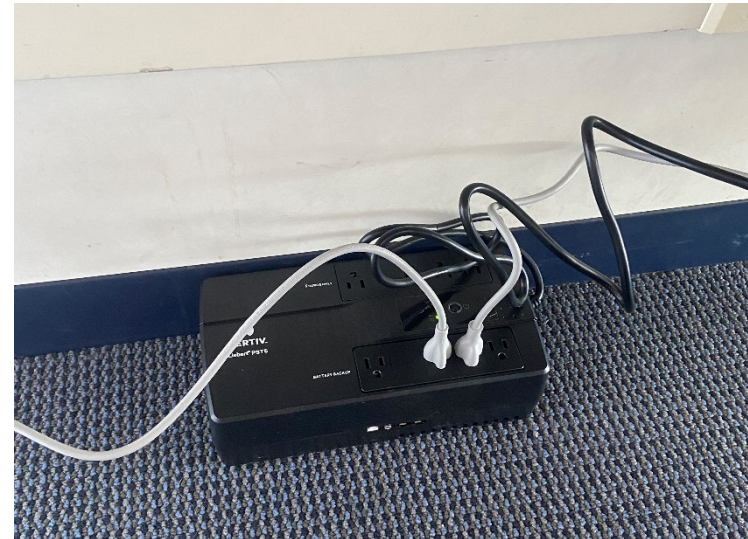
Sensitive electronics are susceptible to electrical surges, this type of equipment is integral to game-day operations. Maintenance personnel stated that equipment has been damaged on numerous occasions from surges, for example Technology and A/V Systems in the Suite/Press level P.A. Scoreboard / and AV Room. Additional uninterruptible power supply units (UPS) are recommended to protect electronic systems and critical plugloads throughout the facility (coordinate efforts with Technology section of the report).

Point-of-use UPS protecting equipment in PA/Scoreboard Room.

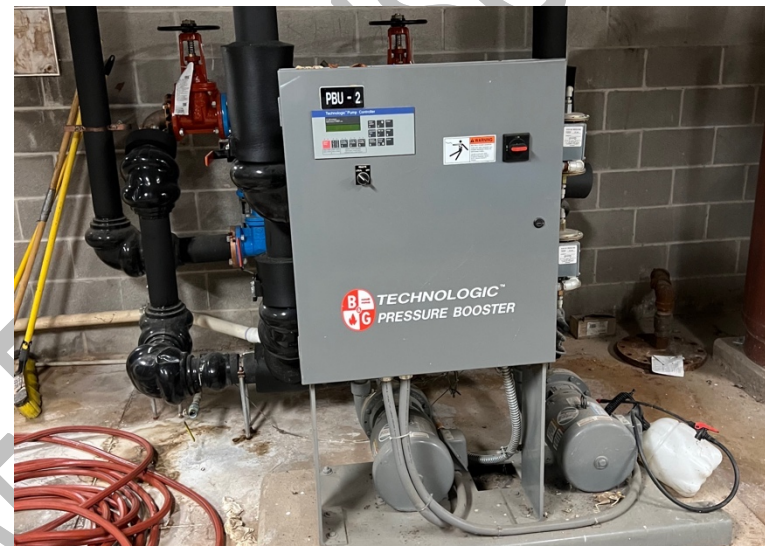
A 10" Domestic water supply main is routed to the Mechanical Room at service level. All service entrances supplies are in a good condition. The main is then routed to the booster pump to serve the Press Box. The booster pump is not used; we recommend it's removal.

Domestic Booster pump not in use

1. Recommend removal of booster pump not in use. The current mechanical room appears to be congested; removal of pump would allow for clear floor space.
2. Recommend replacing sensor valves with manual valves or installing different manufactured valves at different areas of facility to test for failure.
3. Recommend replacing all hose bibbs at field level.
4. Replace grease interceptor at Club level with similar "Big Dipper" provided at concessions. We also recommend using New Age cast iron pipe or similar product for future p-trap replacements. The piping product is epoxy lined and would greatly increase the life of the fitting.

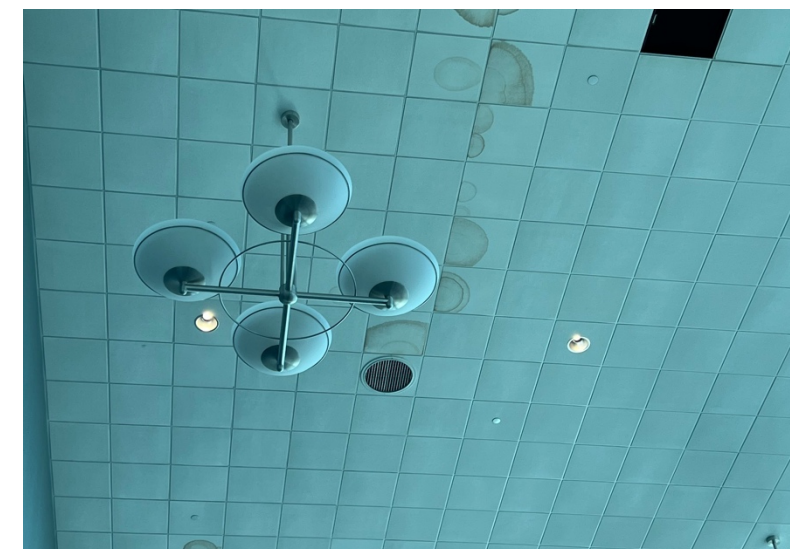
The building is equipped with a primary and secondary overflow scupper system where necessary. All primary storm water drainage piping is routed down through the building to discharge city storm sewer. All secondary overflow scupper spill to daylight. The ceiling in levels below appear to have leaks from the roof. Overall, roof drainage system appear to be in good condition.

Ceiling leaks from roof above

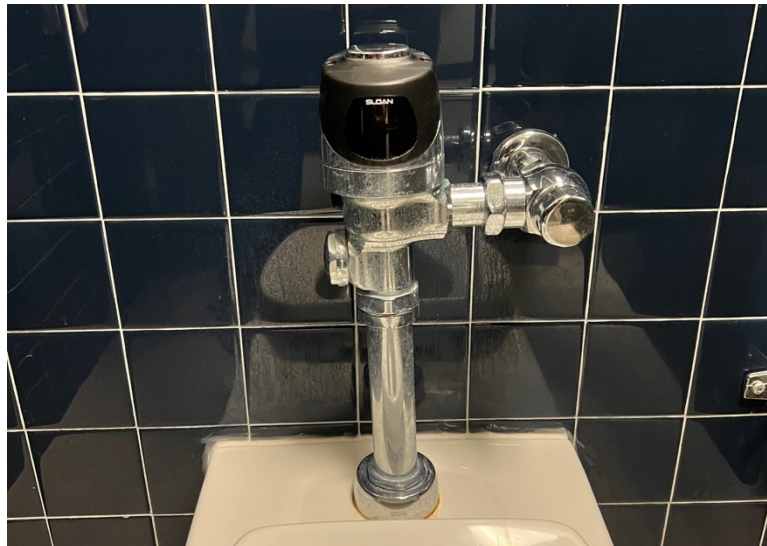
Overall, plumbing fixtures appear to be in good condition. Sloan Sensor Flush Valves were referred as constant maintenance. The failure can be caused by water quality, high water pressure or manufacturer assembly.

Typical Sloan Flush valve

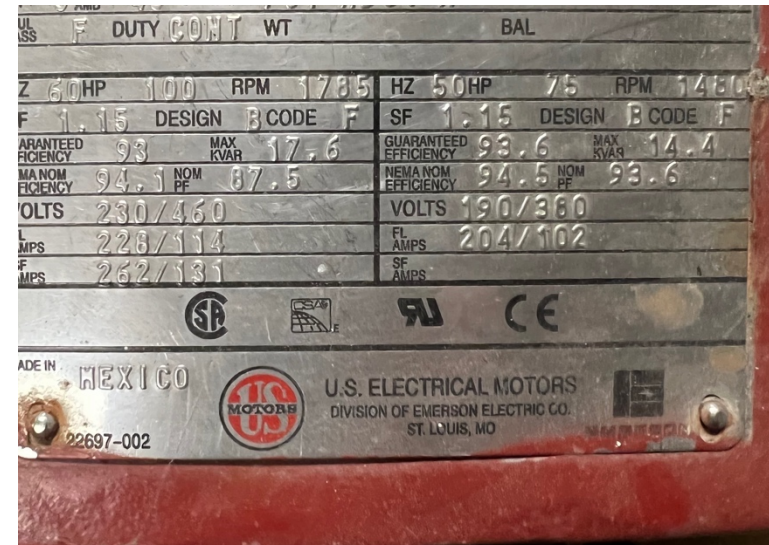
Existing Fire Pump

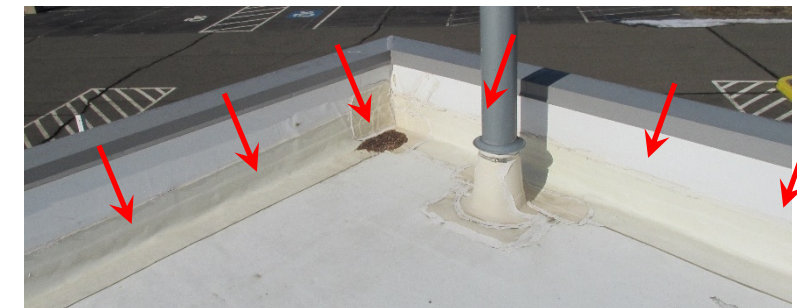
When the overlay roof covering systems were installed (in 2020), the new EPDM roof membrane was turned up onto the face of perimeter parapets, and flashed with a strip of self-adhering flashing membrane (see arrows). Edges of the flashing membrane are caulked with elastomeric sealant.

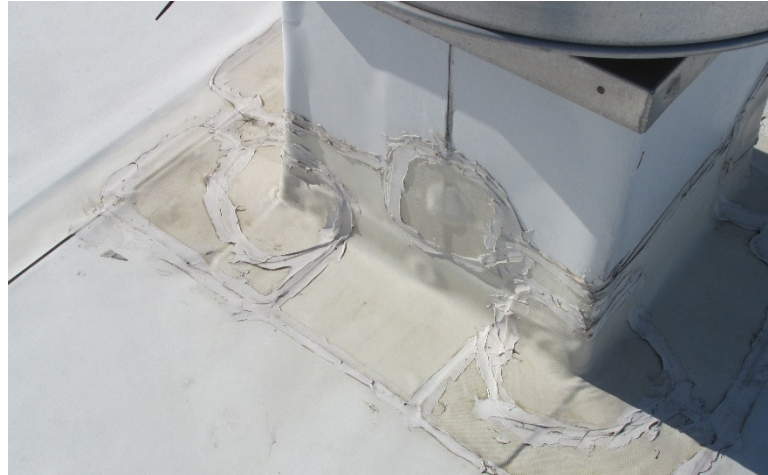
When the 2020 overlay roof covering systems were installed (Buildings 1, 3, and 9), the original TPO membrane parapet and curb flashings were left in place, and new self-adhering membrane was turned up vertically onto curbs, and flashed with a strip of self-adhering flashing membrane. Edges of the flashing membrane are caulked with elastomeric sealant.

The general, overall condition of the overlay roof covering systems on Buildings 1, 3, and 9 is fair. It generally appears that the overlay roof covering systems were installed with a minimally evasive design, as evidenced by the base flashing design that avoided removal/reinstallation (or replacement) of metal copings on parapets, and leaving all curb-mounted rooftop equipment in place. As a result, the original base flashing membrane is still exposed along upper portions of parapets and curbs, and the new membrane is not properly counterflashed by the original membrane. In our opinion, this

type of recover roof covering system design and application is less than ideal, and vulnerable to premature deterioration along the "back-water" lapping of the new membrane in front of (rather than behind) the original membrane. It is also a concern that lap seams (many of which are up-facing) are somewhat dependent upon caulk/sealant for watertightness.
