Comprehensive Building Assessment

Rentschler Field at Pratt & Whitney Stadium

September 7, 2022
DRAFT FOR
DISCUSSION ONLY

CRDA | Capital Region
Development Authority

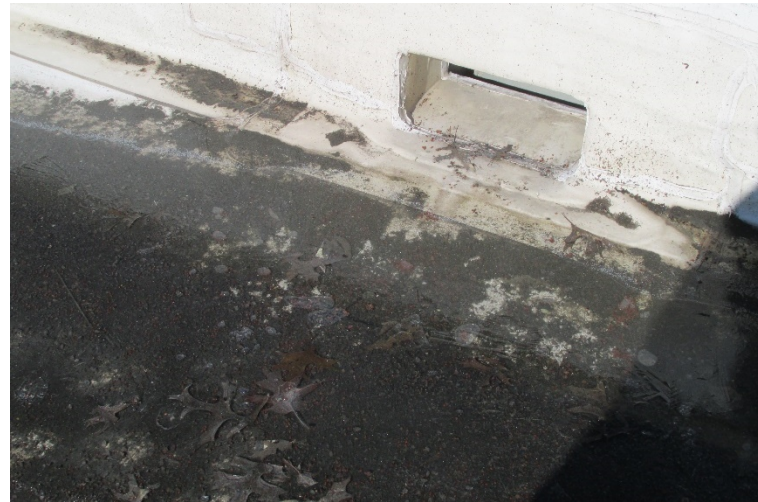
When the overlay roof covering systems were installed in 2020, some deficiencies that existed in the original TPO roof covering system were left in place, and covered over with the new EPDM membrane system, such as through-wall scuppers not being properly sumped below the surface of the roof membrane (photo above). As a result, the roof continues to retain water at the scuppers.

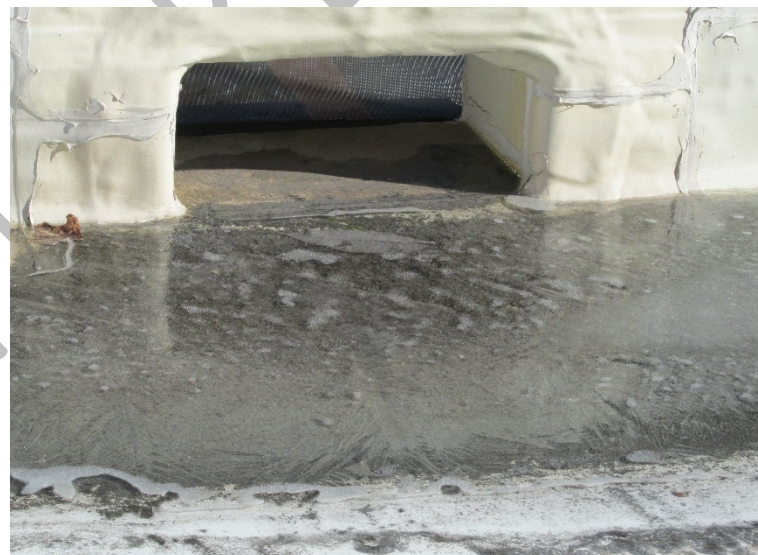
Through-wall scuppers (Buildings 1-7 and 9) are not properly sumped below the roof surface level and, as a result, water is retained (ponding) on the roof at many of the scuppers. This deficiency was not corrected when the new overlay roof membranes were installed on Buildings 1, 3, and 9, and can contribute to premature aging of the roof covering system.

It was also noted that, when the overlay roofing/flashing membrane systems were installed, certain existing deficiencies were not addressed or corrected; in particular, the existing scupper openings were not properly lowered and, as a result, they continue to impede the outflow of water from the roof surfaces (see additional description below).

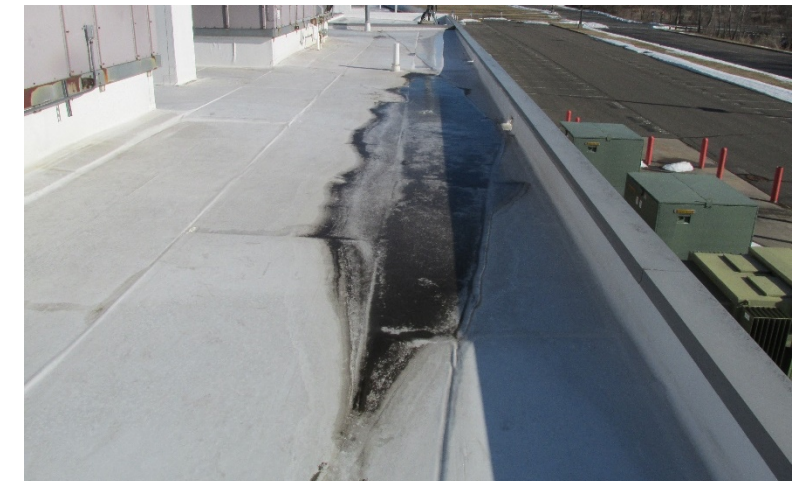
As a result of through-wall scupper openings not being sufficiently sumped below the surface level of the roof membrane, water is ponding on the roofs around many of the scuppers. Water retention on roofs can potentially cause premature deterioration of the roofing/flashing membrane.

Deficiencies - Buildings 1-9 (General): It was noted that, generally, the existing through-wall scuppers on these buildings (Buildings 1-7 and 9) are not properly sumped below the surface level of the roof covering system and, therefore, impede the flow of water through the scuppers and into the conductor heads/downspouts (see photos above).

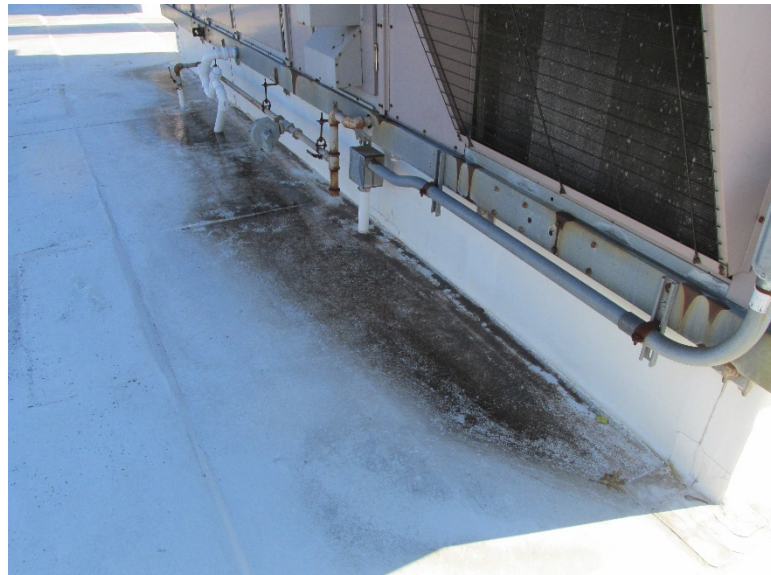
Several large rooftop mechanical units are curb-mounted on the roofs of Buildings 5, 6, and 7; however, the roof insulation assemblies on these buildings lack proper crickets along the up-slope side of the equipment curbs, to direct the flow of rooftop water around the equipment curbs. As a result, water is ponding along the base of the equipment curbs.

Large curb-mounted rooftop mechanical units (Buildings 5, 6, and 7) lack proper crickets to direct the flow of water, up-slope from the curb, around the curb, and down-slope to the drainage elements. As a result, water is retained against the up-slope side of the equipment curb.

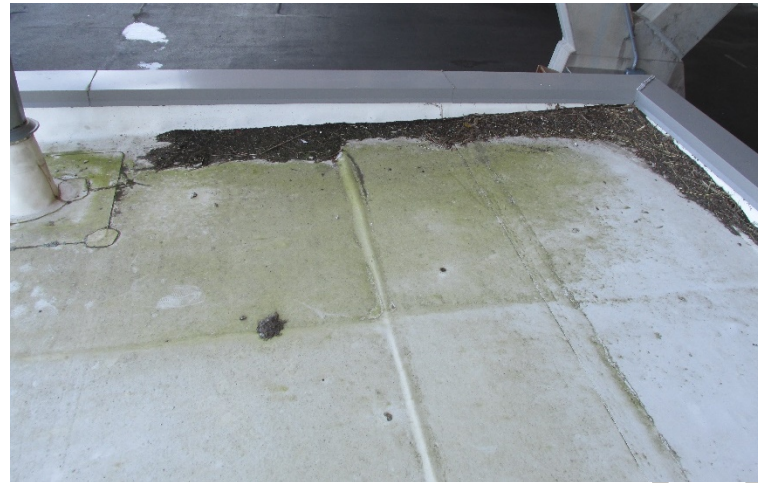
It was noted that the height of the parapets along the up-slope roof perimeters does not meet the minimum industry-standard height of 8 inches above the finished roof surface.

Perimeter parapets, along the up-slope perimeters of some roofs, do not meet the minimum industry-standard height of 8 inches above the finished roof surface. As a result, water/snow/ice may enter beneath the metal coping, potentially damaging the roof covering system and structural/interior elements below.

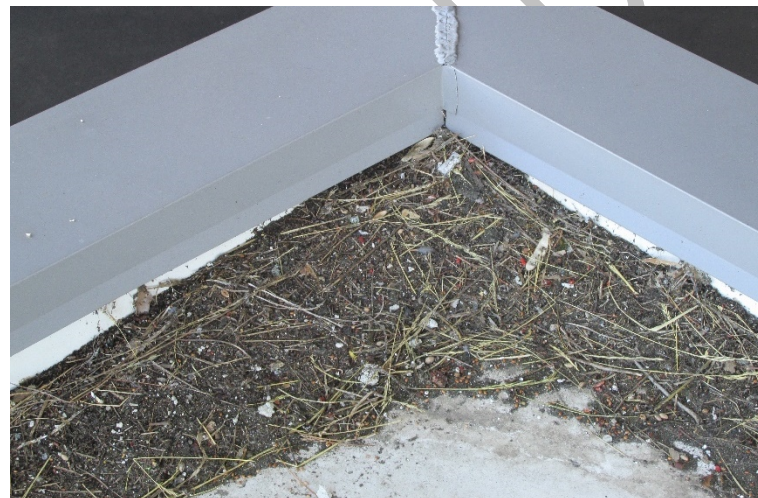
The parapet height in this corner appears to be no more than 5-6 inches, less than the minimum industry-standard 8 inch height.

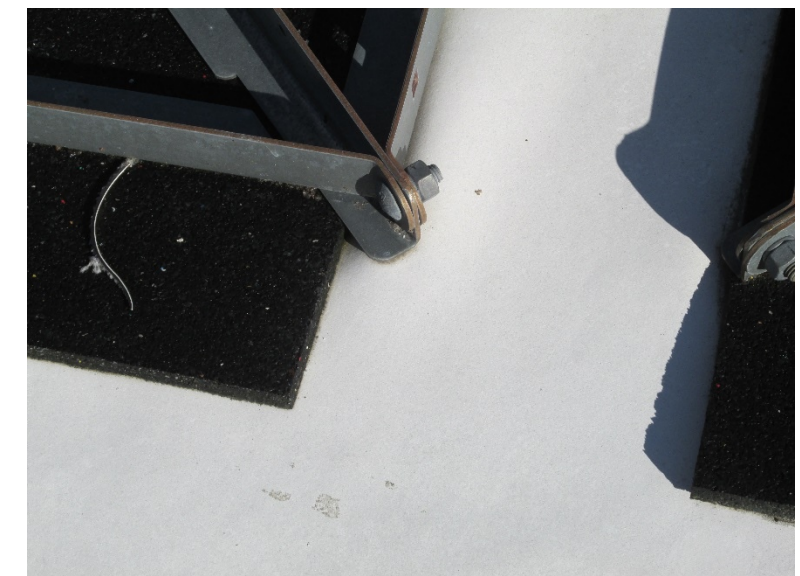
This support frame for rooftop telecom equipment is not properly placed atop the protection mat and, as a result, part of the steel frame is bearing directly on the surface of the roof membrane, potentially damaging and/or puncturing the roof membrane.

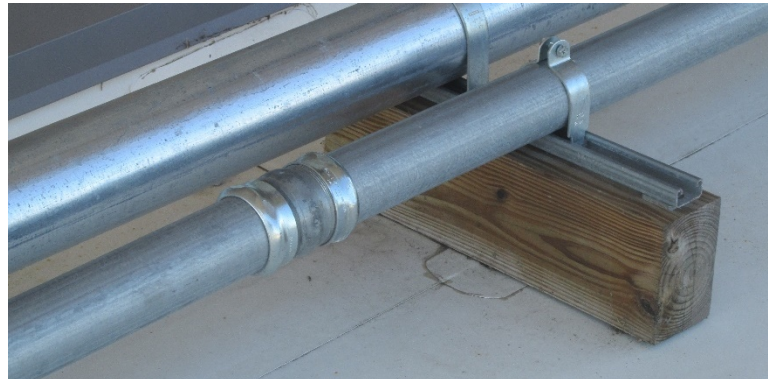
Conduits are supported above the roof surface on wood sleepers. In this area, many of the sleepers are resting directly on the (unprotected) surface of the roof membrane.

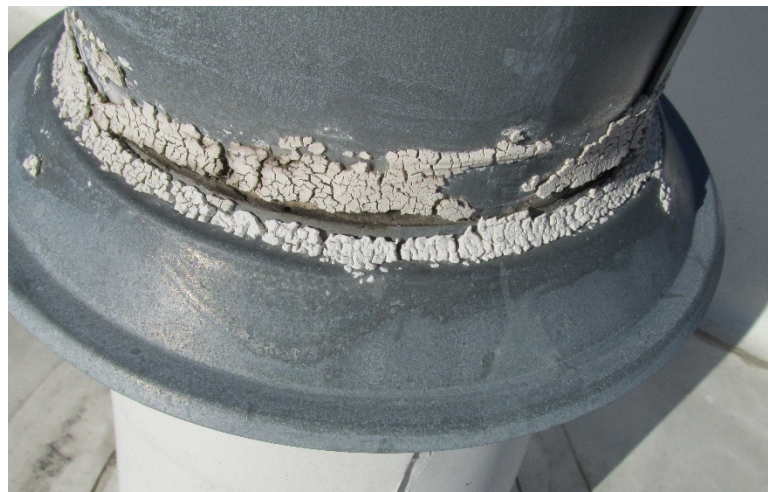
Sealants surrounding some roof penetrations, such as metal flue stacks, are severely deteriorated and non-watertight. Flue stacks and other roof penetrations that reach high temperatures typically require sealant materials that are specifically formulated for high-temperature applications.

7. Carefully inspect all sealant joints associated with all roofing, flashings, and equipment on/ above the roofs, and remove/replace any sealants that are damaged, deteriorated, or otherwise non-watertight, with new elastomeric sealant that is appropriate for the application.

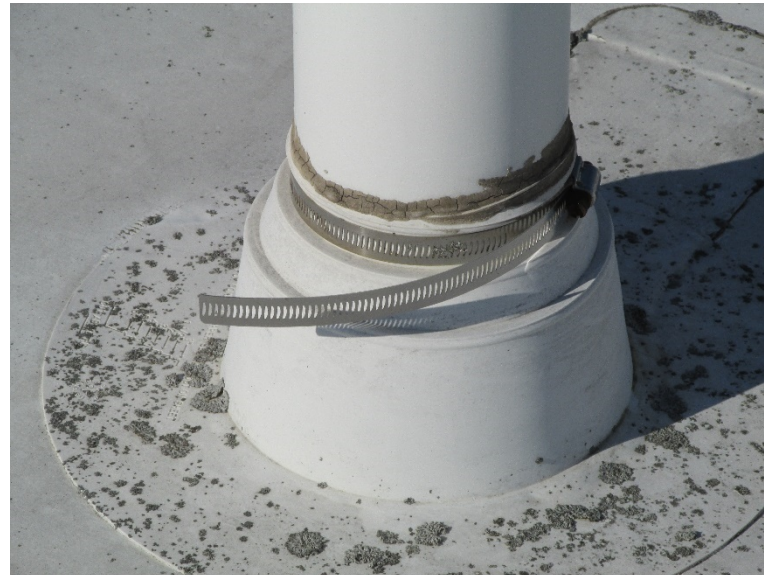
Pipes, conduits, and other round items that penetrate the roof are flashed with a premanufactured TPO flashing boot that is heat-welded to the roof membrane, and terminated at the top with a metal draw band and an application of elastomeric sealant. The existing sealant on some roof penetrations is poorly installed and/or deteriorated, and potentially non-watertight.

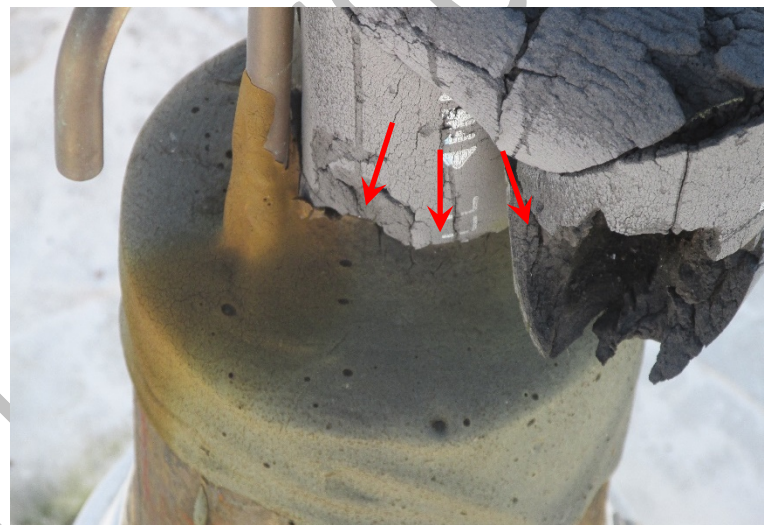
It appears that some type of elastomeric sealer/coating material is applied around this insulated roof penetration/flashing. It appears that the sealant is not properly bonded to the roof penetration insulation, and does not appear to be watertight (see arrows).

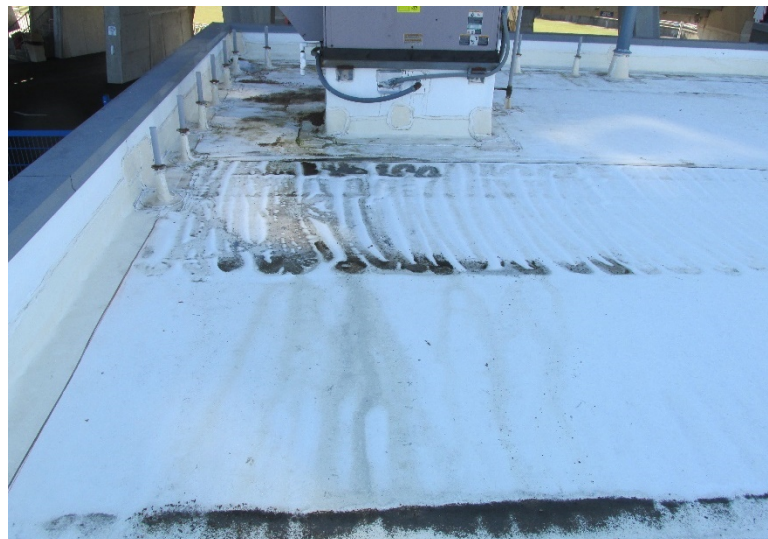
Building 1: There are several wrinkles in the roof membrane, and some areas where it appears that the roof membrane was not properly embedded in the adhesive at the time of original installation. The wrinkled membrane can impede the flow of water to the drainage elements, and is also vulnerable to damage from foot/equipment traffic on the roof, and if the wrinkled membrane is not properly adhered, and may potentially become susceptible to wind uplift/damage.

The EPDM overlay roof membrane (Building 1) is significantly wrinkled in this area. This area of roof membrane generally appears to have been improperly installed.

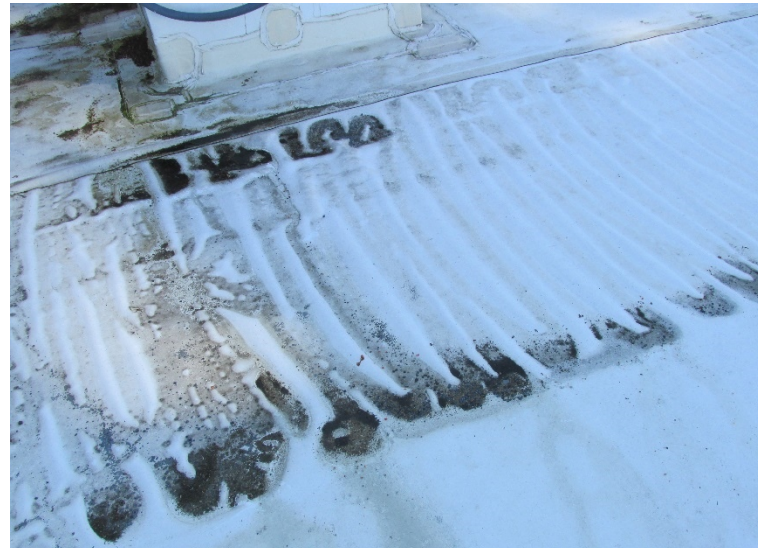
It appears that the wrinkling in the overlay roof membrane (Building 1) is the result of a workmanship deficiency during installation, and/or the roof membrane/adhesive being installed at a time when atmospheric conditions were not suitable for roofing application.

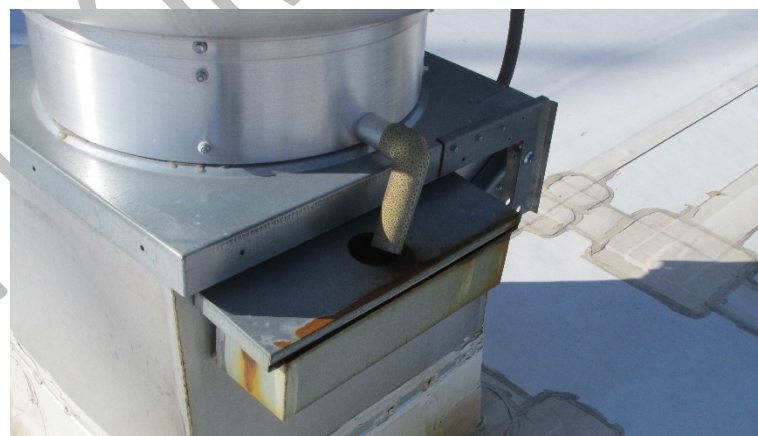
The outflow pipe for the kitchen grease collector on this rooftop exhaust fan is displaced (Building 3), potentially allowing grease contamination/damage to the roof membrane.

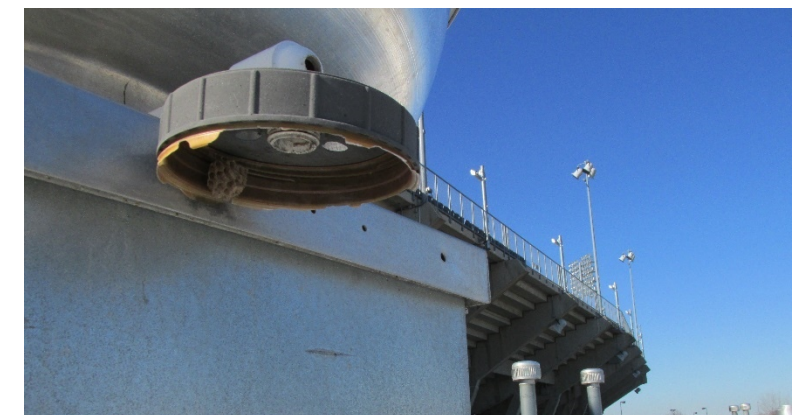
The kitchen grease container, which is normally attached to the screw-top flange, appears to be broken off or missing from this exhaust fan unit (Building 3), thus potentially allowing food grease to drip onto the roof surface, causing damage.

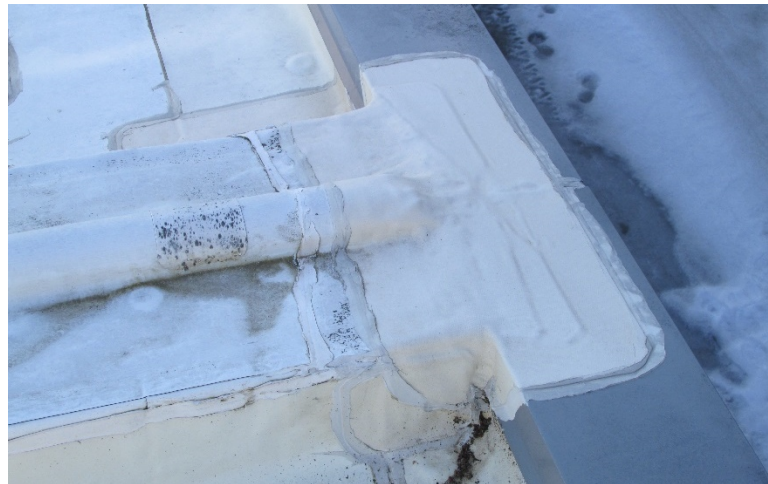
The flashing membrane atop an expansion joint cover is terminated on a flat surface atop a metal parapet coping (Building 3); however, the membrane is not extended over the edge and onto the face of the coping, so as to shed water from atop the membrane.

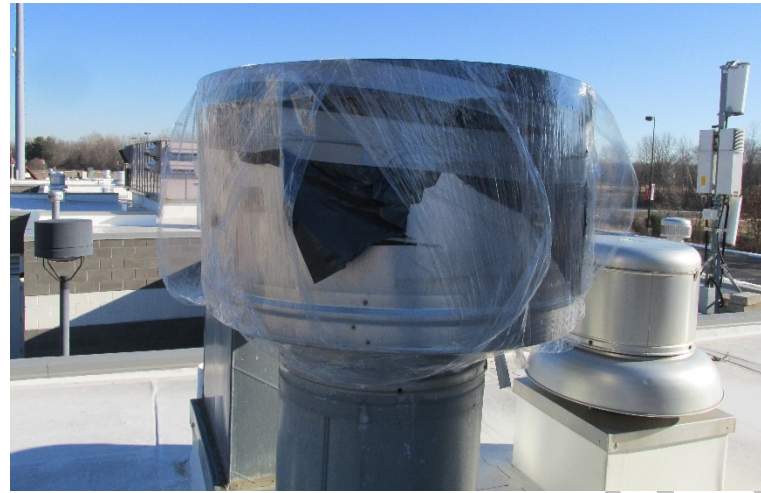
A metal flue stack (Building 6) appears to be leaking moisture or is faulty in some other manner, as evidenced by it being covered over with polyethylene sheeting.

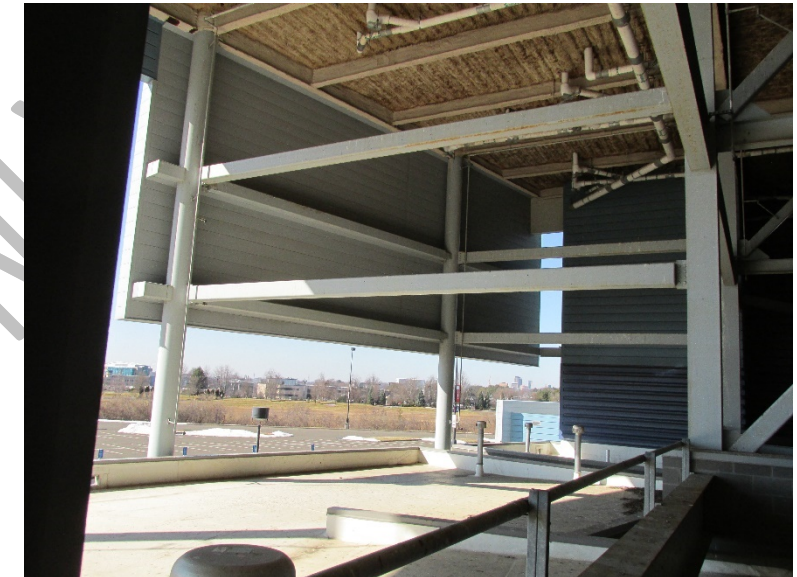
There is a significant open gap between the roofs of Building 8 and the underside of the Third Floor on the Tower Building.

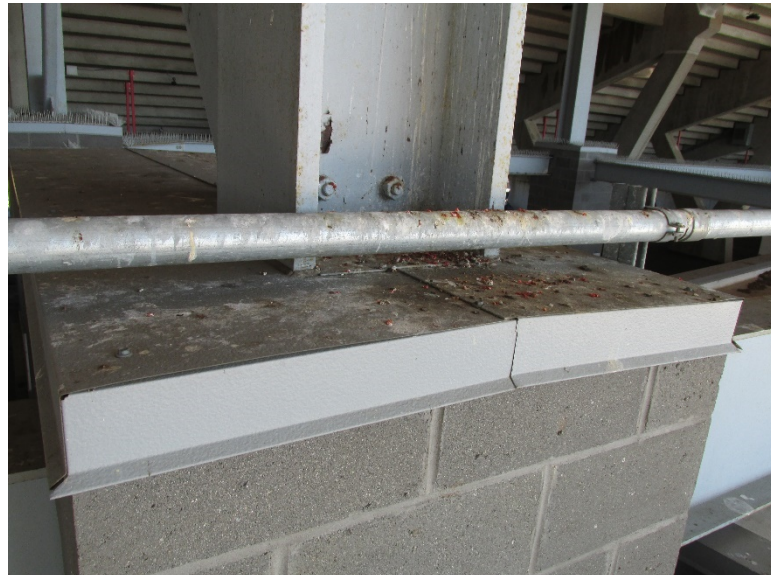
The acidity of bird droppings causes damage to paint/finishes on sheet metal flashings, as well as conduits and steel structural members. Once the paint/coatings on metals/steel are eroded through, bird feces typically will cause corrosion of the underlying metal/steel.

2. Install additional bird deterrent strips, netting, or other practical means to prevent bird infestation on and above the roofs (Building 8).
3. Replace the original roof covering systems (Buildings 2 and 4-8) with new TPO single-ply roof covering systems. Furthermore, it is not recommended to overlay the existing roof covering systems with a new single-ply membrane (as was done in 2020 on Buildings 1, 3, and 9). In our opinion, completely removing all components of the existing roof covering systems, ensuring that the roof decks/substrates are dry and in good repair, and correcting other existing deficiencies (such as lowering through-wall scupper openings to improve roof drainage, and raising parapet heights to a minimum of 8 inches above the finished roof surface), will be effective to produce a much higher-quality and longer-lasting new roof covering system, for the remainder of the Concourse building roofs.

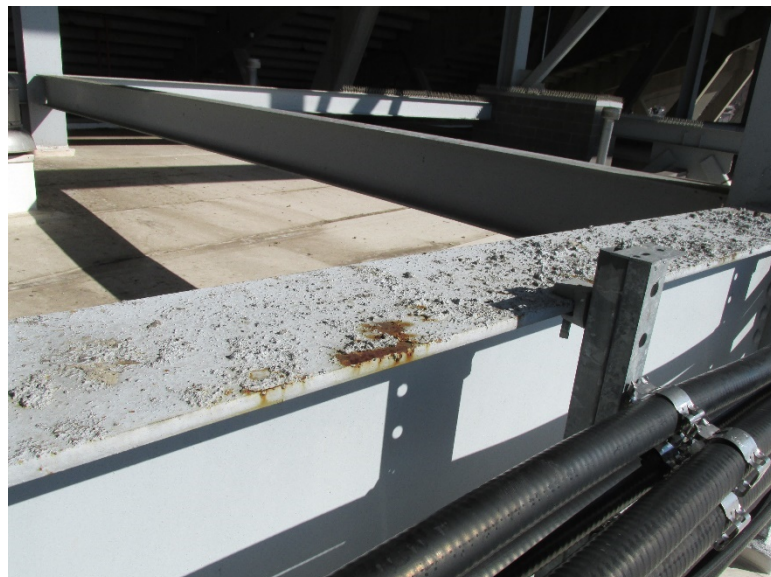
The paint on the top surface of this steel structural member is significantly eroded and, as a result, the steel is rusting. Many exposed steel members are in need of being cleaned, prepared, primed, and painted,

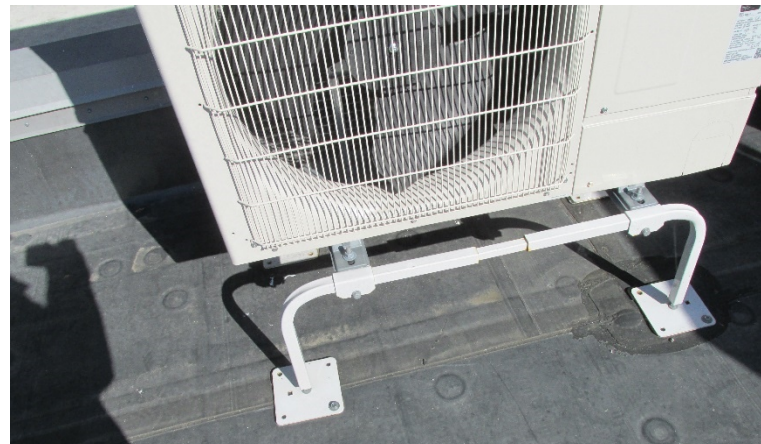
Flanges of a steel support frame, for a rooftop mechanical unit, are installed directly atop the (unprotected) surface of the EPDM roof membrane, and secured to the roof with screws installed directly through the roof membrane. There is no sealant or any other means to protect the fastener holes from moisture infiltration/leakage (see next 2 photos).

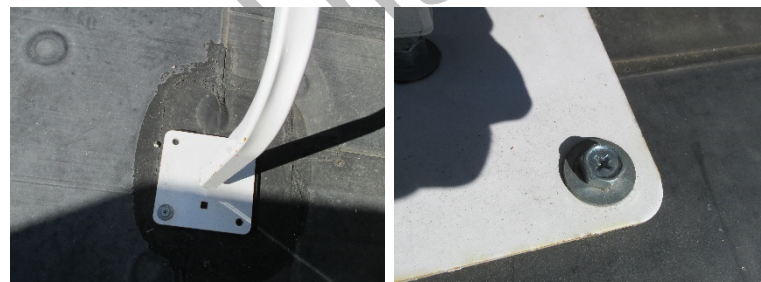
Steel flanges for a rooftop mechanical unit support frame are screw-fastened directly through the roof membrane, with no means in place to make the fastener penetrations through the roof membrane watertight.

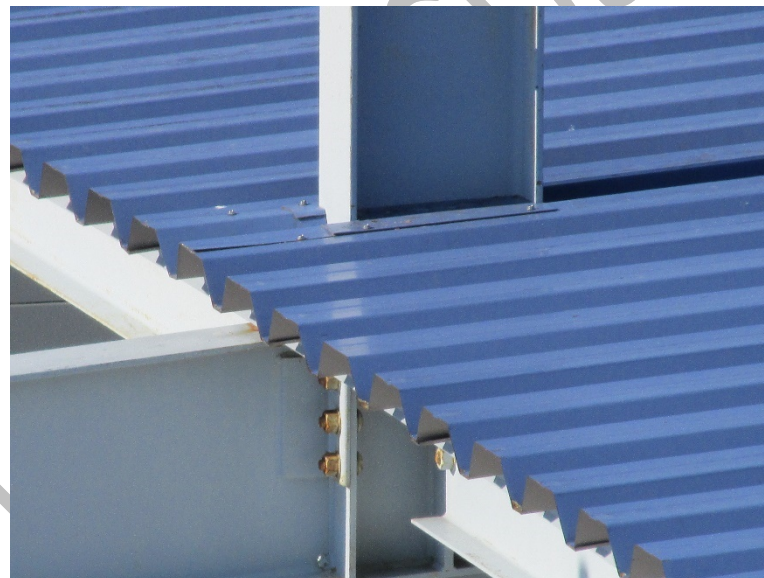
The paint/finish on the top surface of the pre-manufactured metal panel roof covering system generally appears to be in fair-to-good condition. There was no visible rusting or deterioration of the metal or the paint/finish.

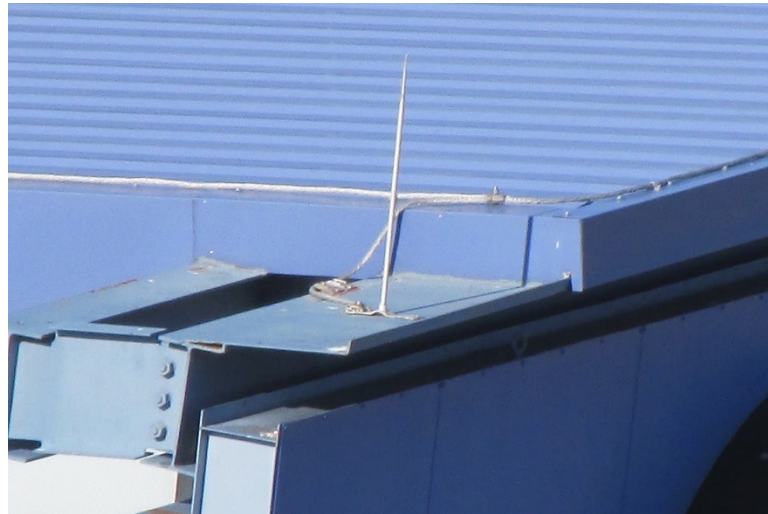
The paint/finish on the Scoreboard roof generally appears to be in fair-to-good condition. Based upon a visual observation from a distance, there is no visible rust or other damage to the metal panel roof covering system.

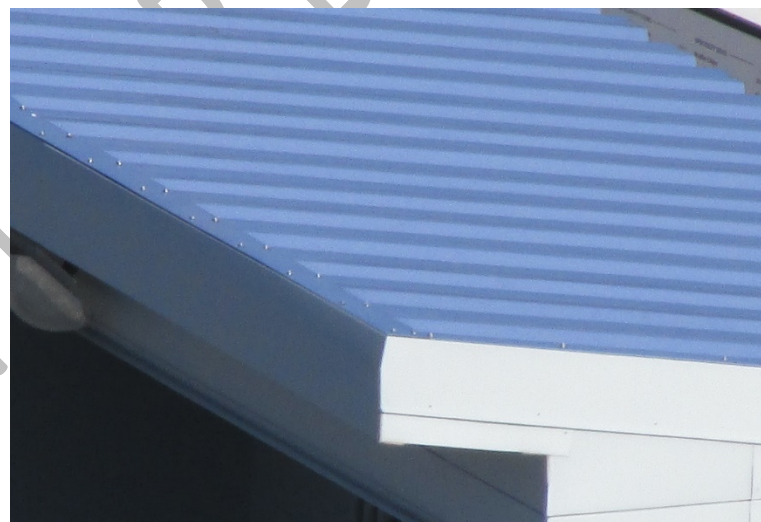
As viewed/photographed from a distance, the existing paint/coating on the Video Booth roof generally appears to be in fair-to-good condition, and no rusting, damage, or other deficiencies were noted.

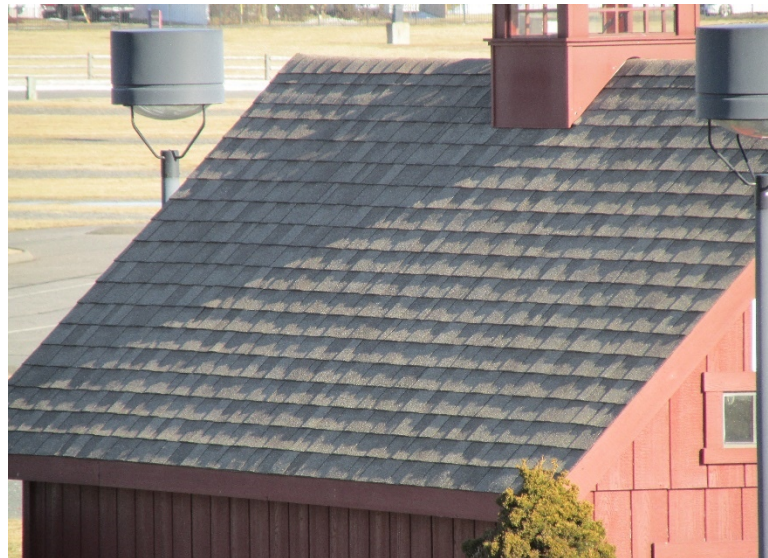
The asphalt shingle Radio Broadcasting Building roof generally appears to be in good condition. The roof has a steep slope, to shed water. There were no visible deficiencies.

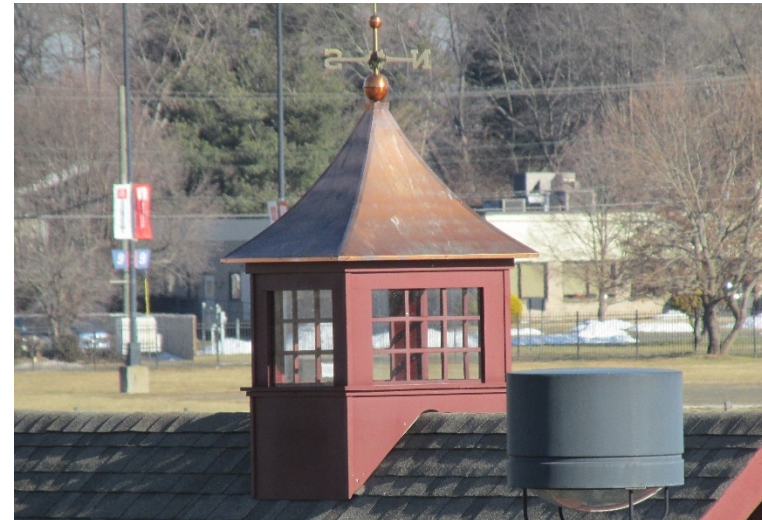
The metal-clad cupola, at the center of the Radio Broadcasting Building roof utilizes a copper roof covering system. The cupola and copper roof generally appear to be in good condition.

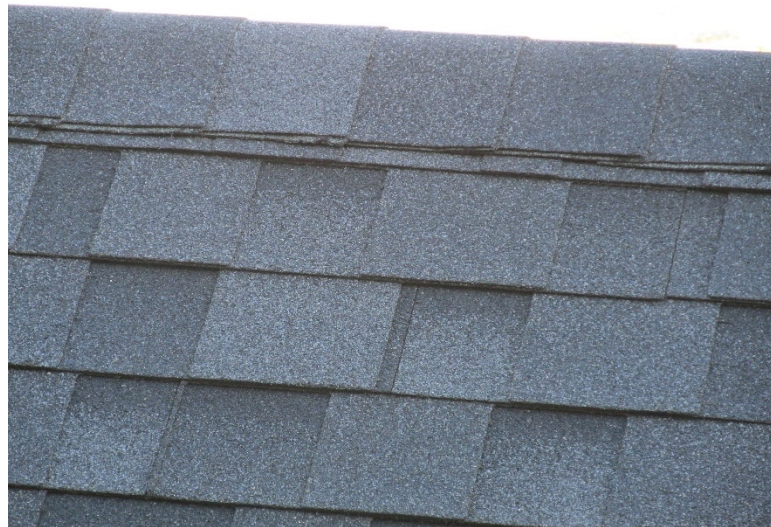
The existing asphalt shingle roof covering system on the Catering Building generally appears to be in good condition, and no deficiencies were noted. It was noted; however, that the roof lacks gutters/downspouts, or any means to control water run-off from the roof surfaces and, as a result, the ground is eroded along a line directly below the roof eaves.

The asphalt shingle roof covering system on the Catering Building generally appears to be in good condition, and it is believed that the building/roof have been in place for approximately 3-4 years.

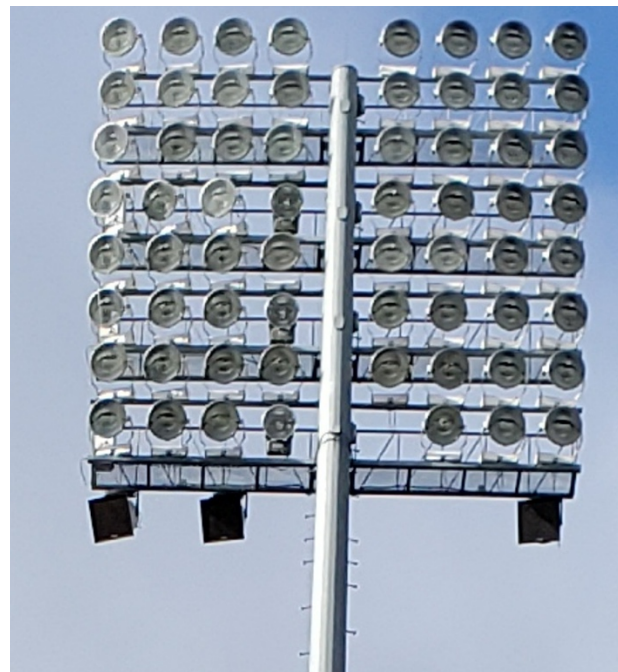
Pole loudspeakers (example)

During our bowl walk, we noted several high frequency driver or cross over issues for one or more loudspeakers at the press box (section 239), and at the light poles covering sections 130, 211, 212, 233. Several loudspeakers at the scoreboard covering the deck area appear to have high frequency loss (not totally failed).

1. Repair defective existing bowl loudspeakers until full replacement can be done.
 - a. If the fidelity and performance of the current bowl loudspeakers (in good repair) are adequate to stakeholders and patrons, then new, updated versions of the loudspeaker product would be a cost effective solution.

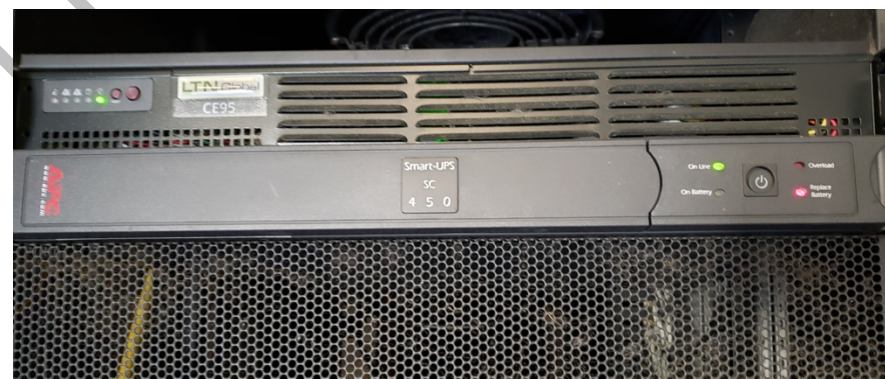
Failed UPS (multiple locations)

During the site visit, we discovered that the entire NE seating and concourse had no sound. The operator discovered a UPS (Battery backup power unit) in the AV closet ER-10 serving that seating, which had failed since the facility was last used the previous fall. He bypassed the UPS to restore power to the processing equipment and return sound to those bowl sections.

We also discovered many other failed UPS units, with several others that had very short backup power sustain time due to tired batteries. The consequence of bypassing the UPS' is even with small blips in mains power, the processing equipment in those equipment racks will power down and require several minutes to reboot, come back online and deliver sound to the loudspeakers they control.

2. Replace all of the bowl AV closet UPS units that power the QSC processing equipment. Load test/replace batteries on no less than 2 year schedule.
3. If the bowl AV closets are not on generator/Emergency power, consider that supplement.

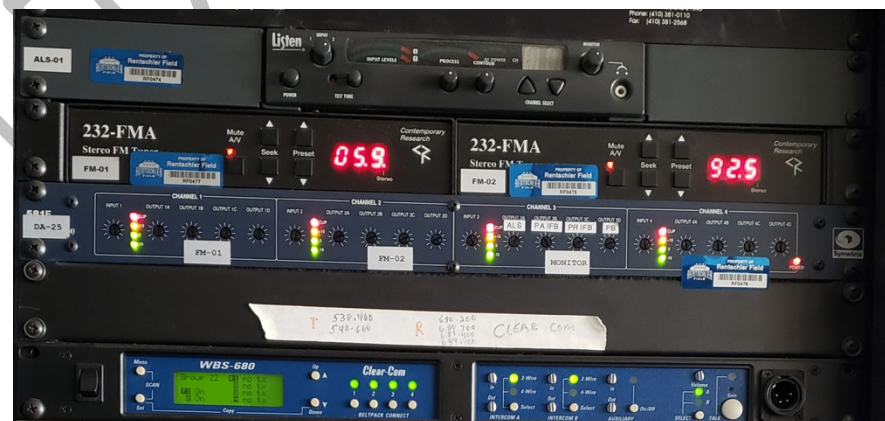
Poorly located FM transmitting equipment

The FM transmitting equipment near the audio patch frames causes interference and should be relocated.

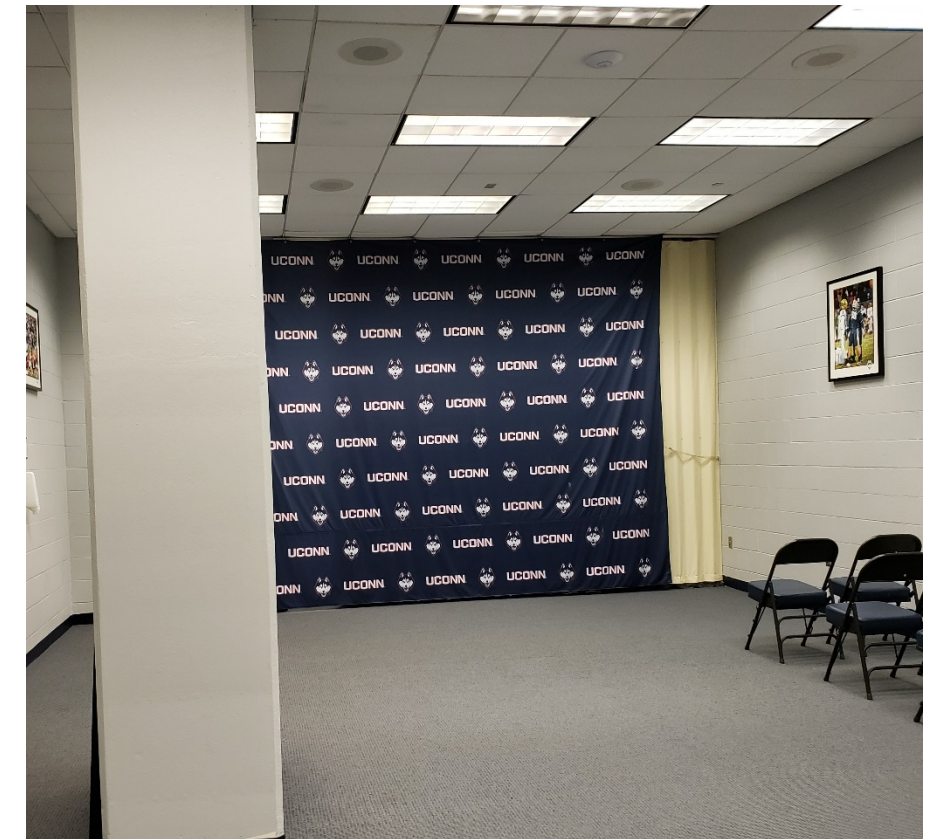
Interview Room

The player interview room has no light bar or permanent fill and key lighting locations for the head table.

The loudspeakers directly over the head table spill into the head table microphone and muddy the broadcast sound.

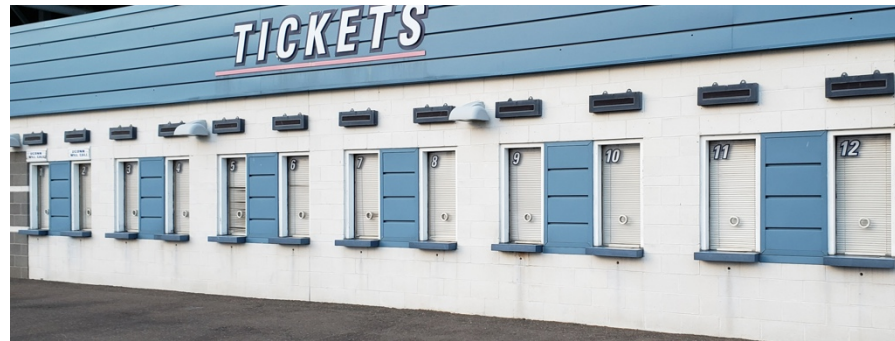
Ticket Windows

None of the ticketing windows appear to have an Assistive Listening inductive loop; a common accommodation for hearing impaired patrons with T-coil equipped hearing aids.

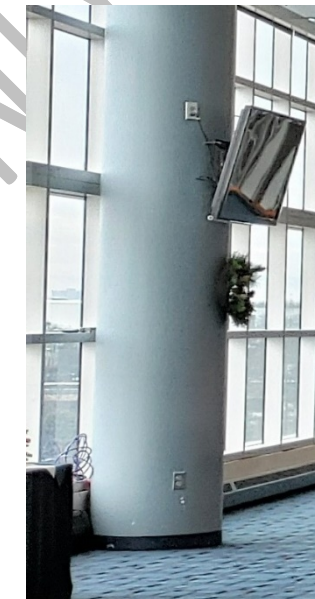
Center column in club room

The operator commented that there is no means to plug in microphones or other devices at the center column, near the windows; a common location for the head table.

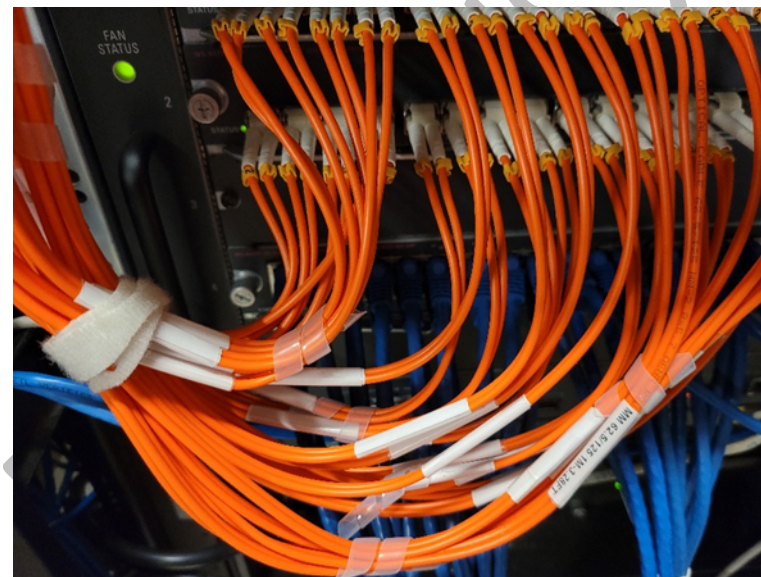
OM1 fiber optic cabling

Being a legacy OM1 multimode cable plant, it limits the entire information technology system to 1GB ethernet. Most similar stadiums operate at 10GB minimum. The 5e horizontal cabling is also another legacy item that limits the capability of connected devices such as IP cameras, network interface cards, and wireless access points.

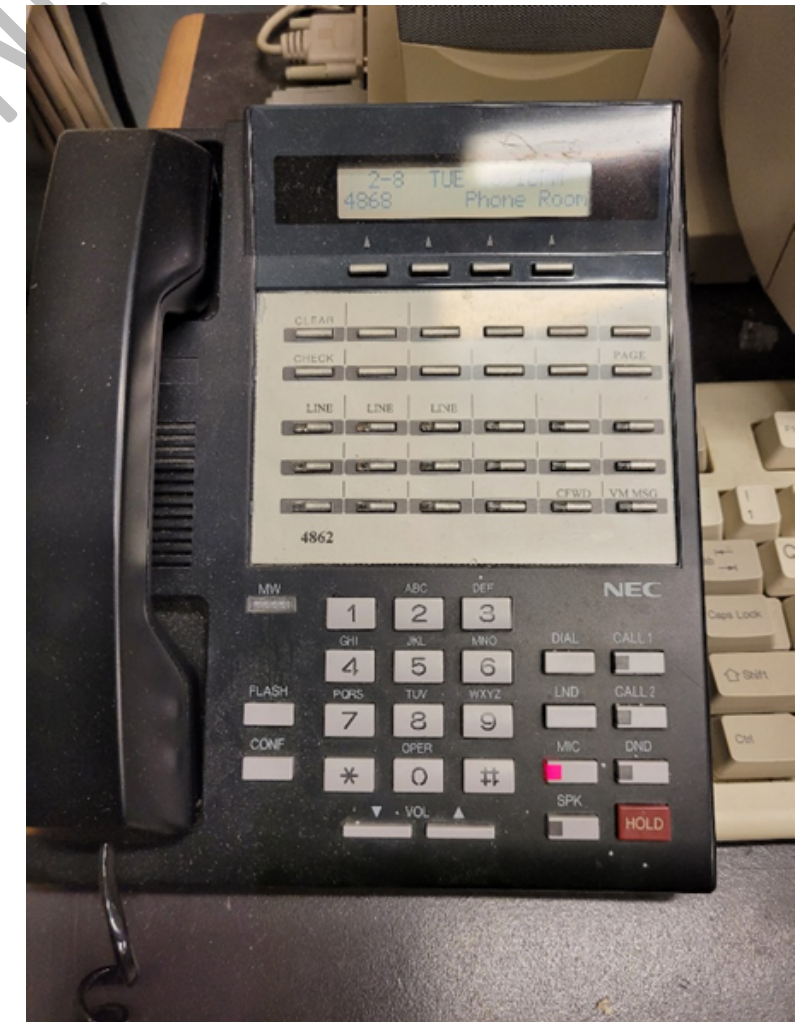
Legacy phone

It appears that the legacy phone system was also installed in 2003 and remains functional; however due to its age it is also limited in its capabilities. More recent installations consolidate the phones to a converged network through voice over internet protocol (VOIP).

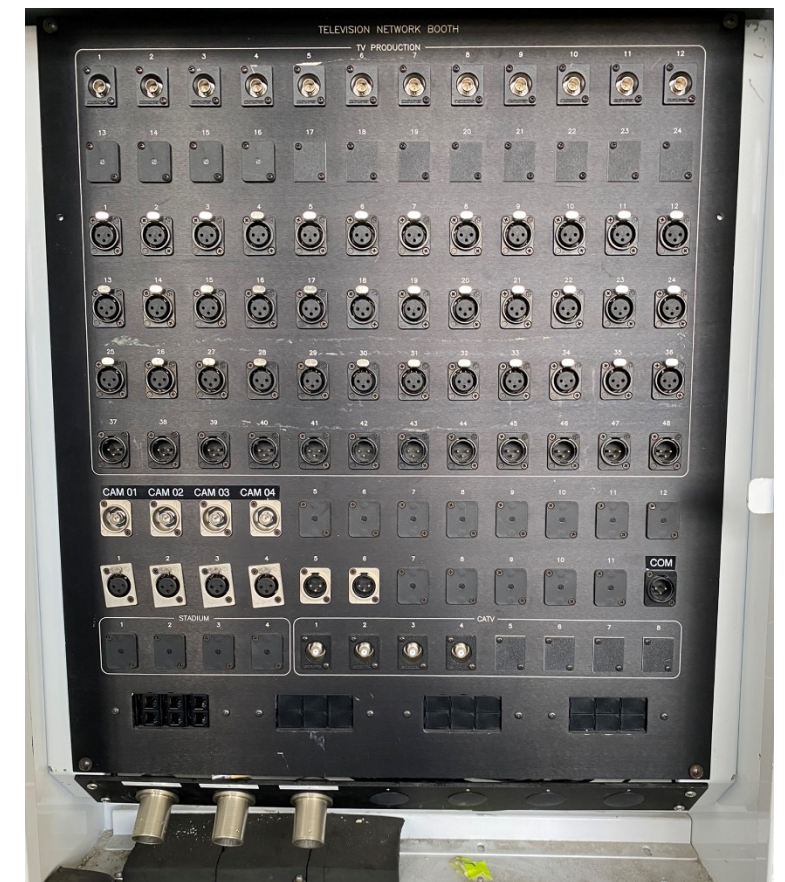
Representative indoor broadcast box position

- Broadcast cable and connections serving the TV truck are original to the building. It is comprised of copper cabling (triax, analog audio, coax video) that is largely outdated and unused. Triax camera cabling, while a standard at the time of the building's opening, is becoming obsolete as TV trucks are more fiber-based in their broadcast transport medium. Most coax video cable is unable to transport HD video due to cable lengths and thus rendered unusable. Some of the existing analog audio connections are serviceable.

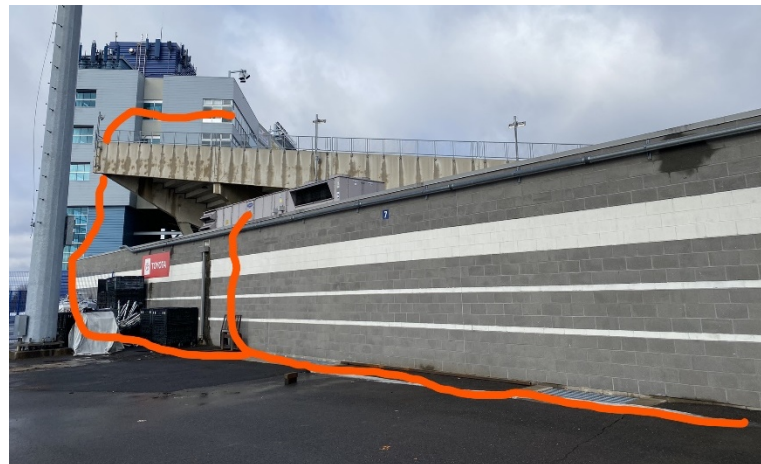
TV truck temporary cable routing

- No SMFO (single mode fiber optic) cabling is installed. When the TV trucks are present, cabling to satisfy their broadcast requirements is run in a temporary fashion up the side of the building, through windows, over concourses, across walkways, etc. to the broadcast camera positions.

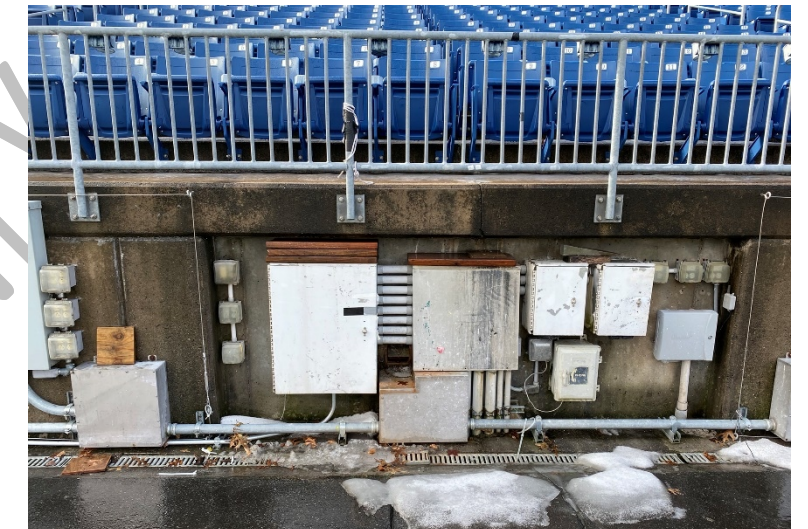
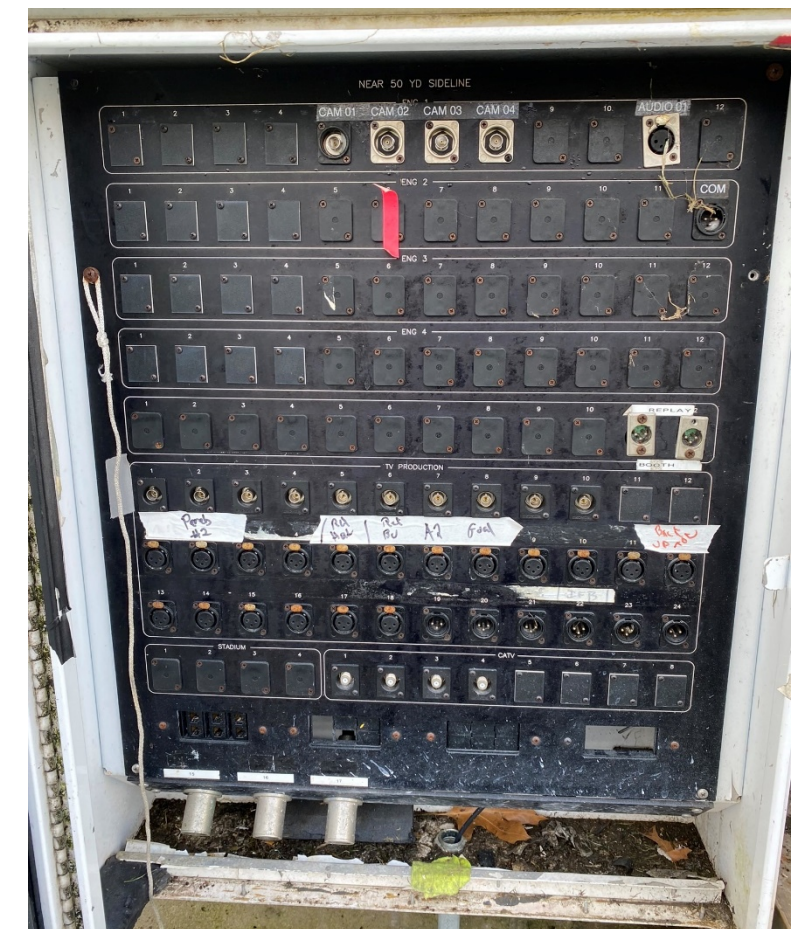
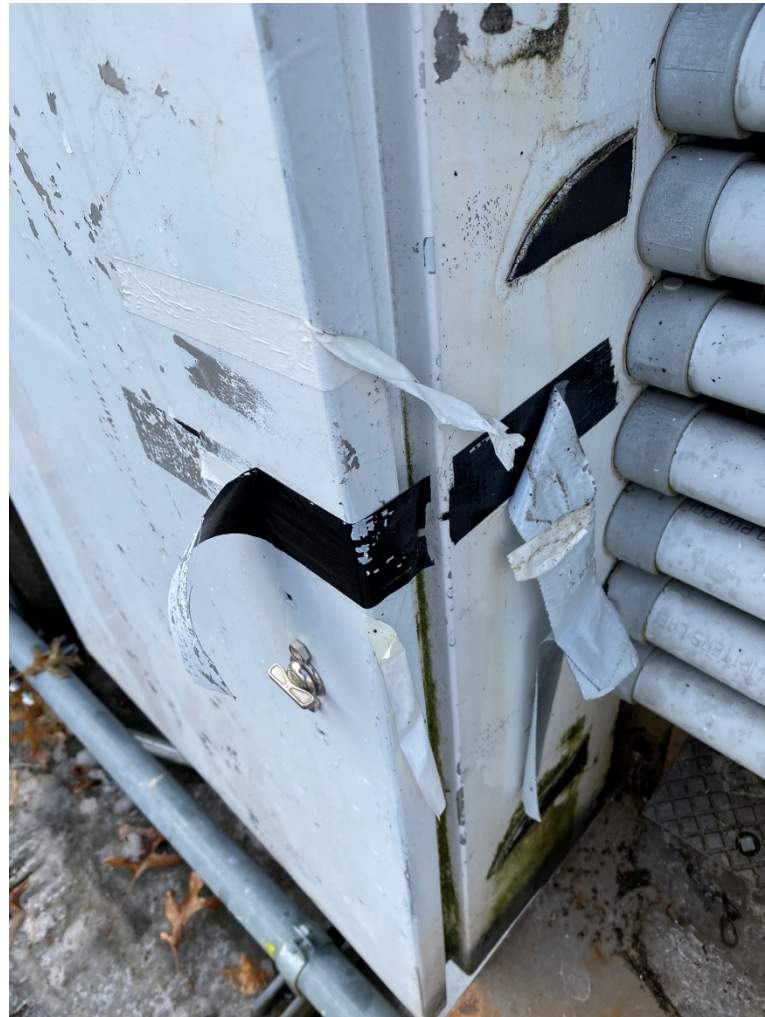
Representative outdoor broadcast box position

- The outdoor broadcast boxes have suffered years of moisture penetration and lack of appropriate operation in opening/closing of the protective doors. The interior of most of the boxes are corroded, rusted, and littered. The only connections that might be used are some of the analog audio connections.

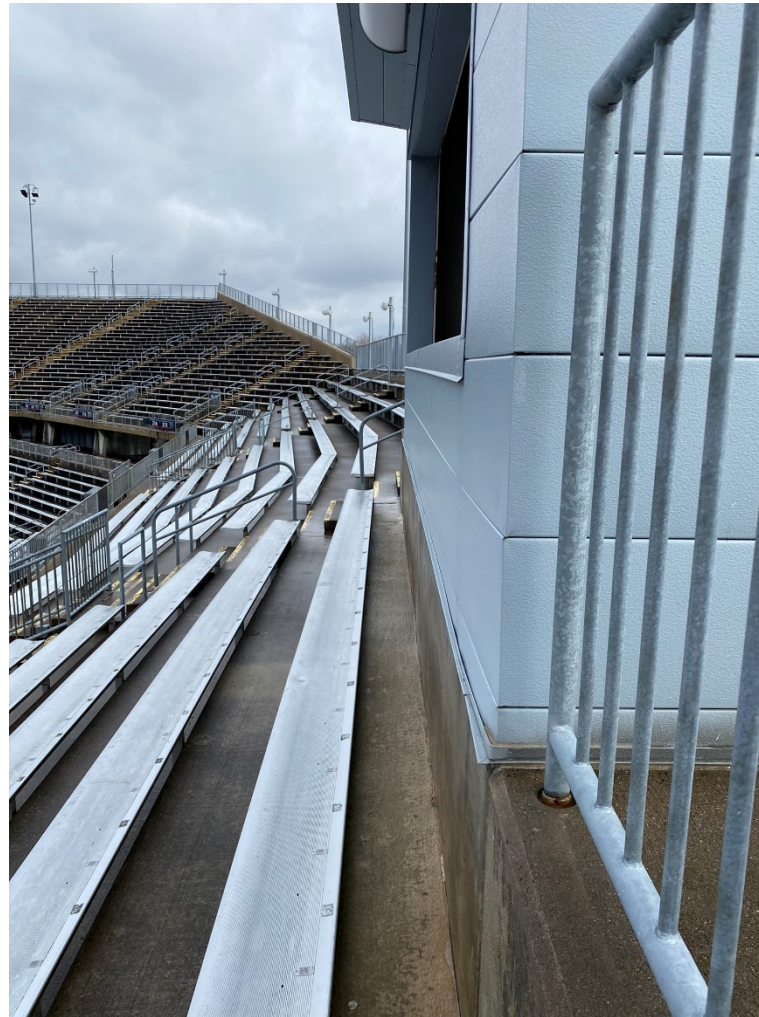
High east camera position

- While the conduit infrastructure supporting the broadcast cable plant is sufficiently sized, there is no cable tray at the Press Level broadcast booths. This is typically seen on most stadium projects for efficiency, flexibility, and ease of adding temporary cables.
- The high east broadcast booth likely experiences inadequate camera shots when patrons are standing. Standing on the bleachers would block camera shots.
