Comprehensive Building Assessment

Rentschler Field at Pratt & Whitney Stadium

September 7, 2022
DRAFT FOR
DISCUSSION ONLY

CRDA | Capital Region
Development Authority

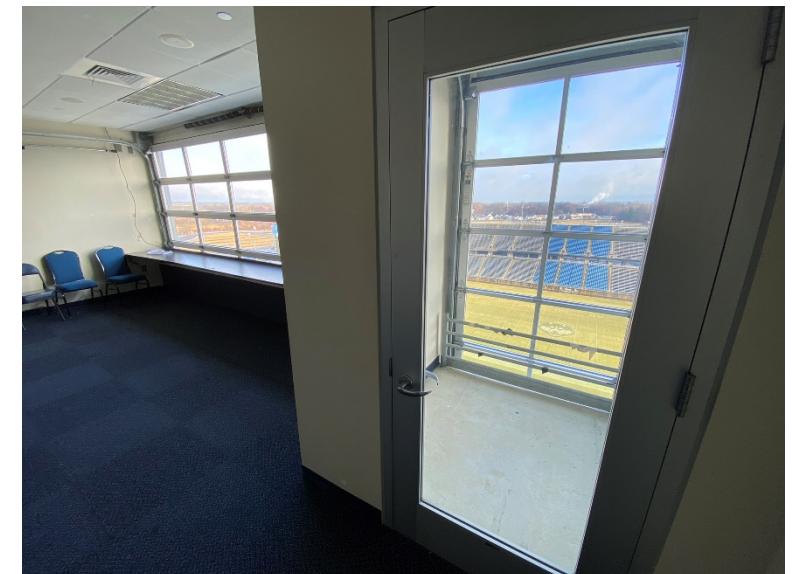
Main follow camera position and broadcast booth

- The main follow camera position is undersized. It is unable to support more than one camera. A typically sized high 50-yard line position will be wide enough to accommodate five positions. Any camera position wanting to be in a main follow position is relegated to the roof which is a different camera angle. At minimum, the main follow position should handle a game follow, tight follow and in-house production position. Those relegated to the roof are two (2) coaching cameras, All-22, in-house and one of the game or tight follow. The roof position is a unique method for accommodating manned cameras. A covered platform and canopy slides towards the parapet. No camera tie downs, and railing was observed. This appears to be a potential safety hazard.

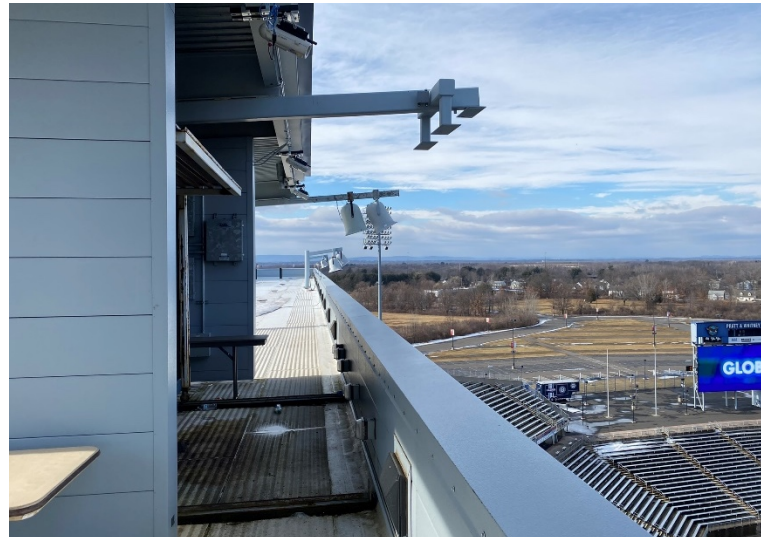
- While the conduit infrastructure supporting the broadcast cable plant is sufficiently sized, there is no cable tray at the Press Level broadcast booths. This is typically seen on most stadium projects for efficiency, flexibility, and ease of adding temporary cables.
- The high east broadcast booth likely experiences inadequate camera shots when patrons are standing. Standing on the bleachers would block camera shots.

It is recommended that the cable plant (cabling, connection, and enclosures) be replaced and upgraded to meet modern broadcasting requirements and remove the requirement for a TV truck to run their own cabling in a temporary fashion.

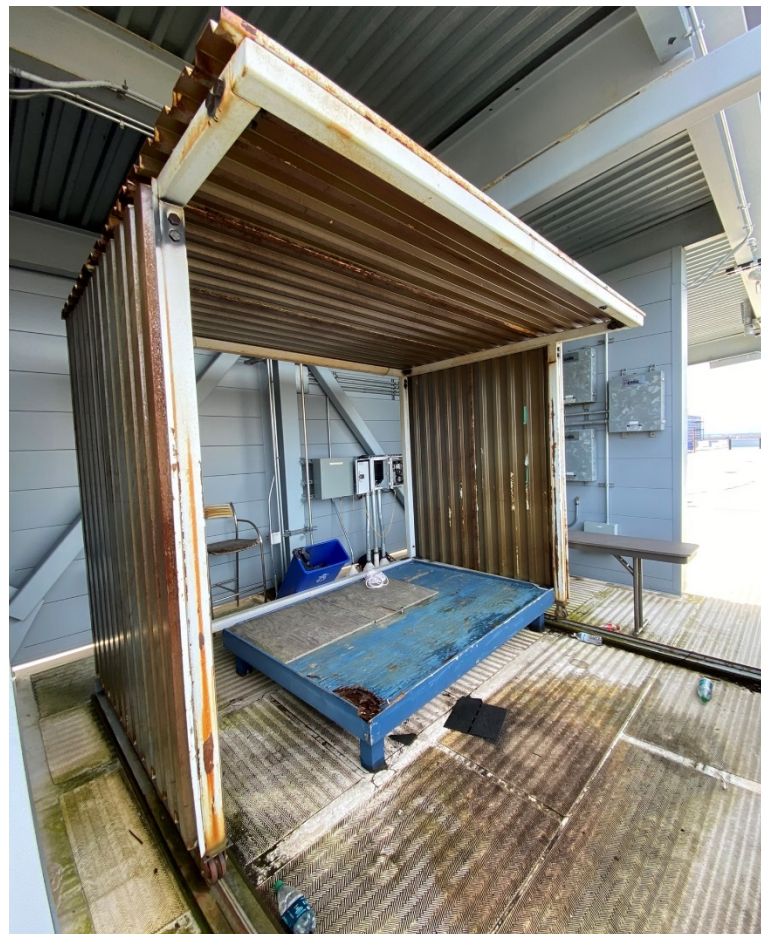
Roof top high 50 camera position

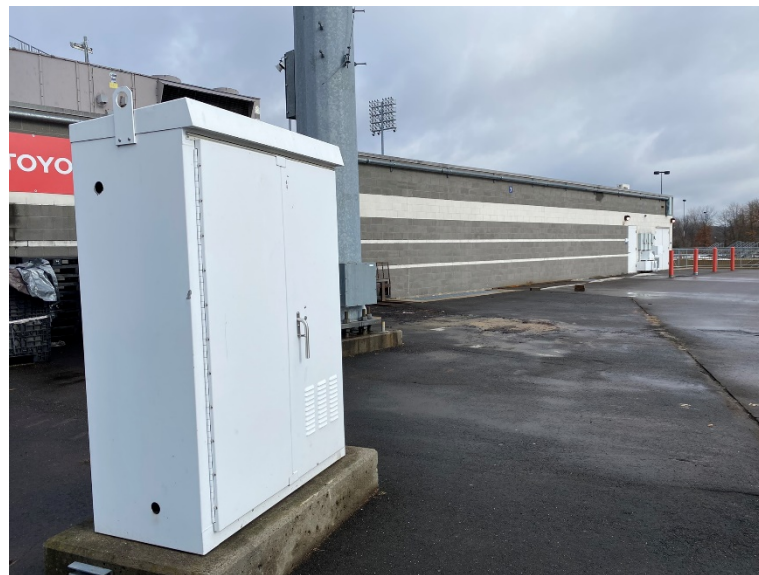
- The TV Announce Booth is not very secluded and secure and offers the potential of noise penetrating the space from the press dining area. It also shares space with the instant replay booth.
- The ENG pedestal at the truck parking area is not used, opening the possibility of removing in lieu of offering more space in the plaza.

Unused ENG pedestal at truck parking plaza

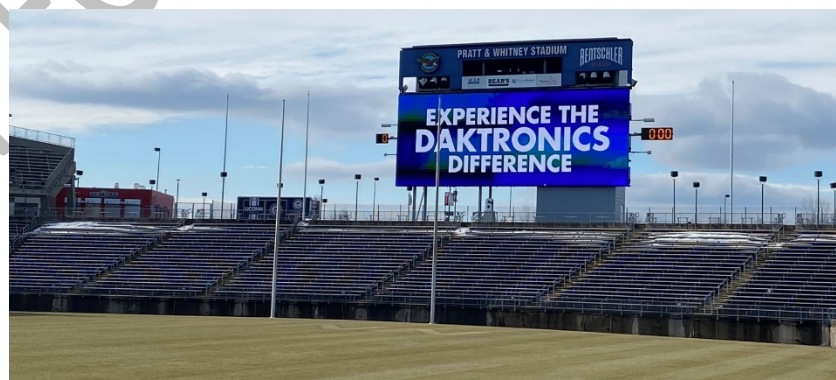
- One noticeably absent broadcast position is behind the east end zone. Any cabling for that position would have to be run from one of the sidelines.

West end zone with no broadcast capabilities

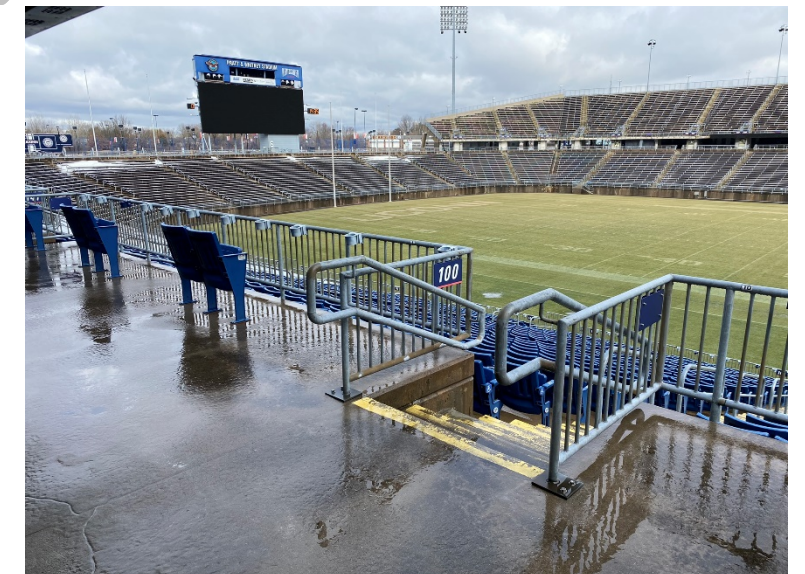
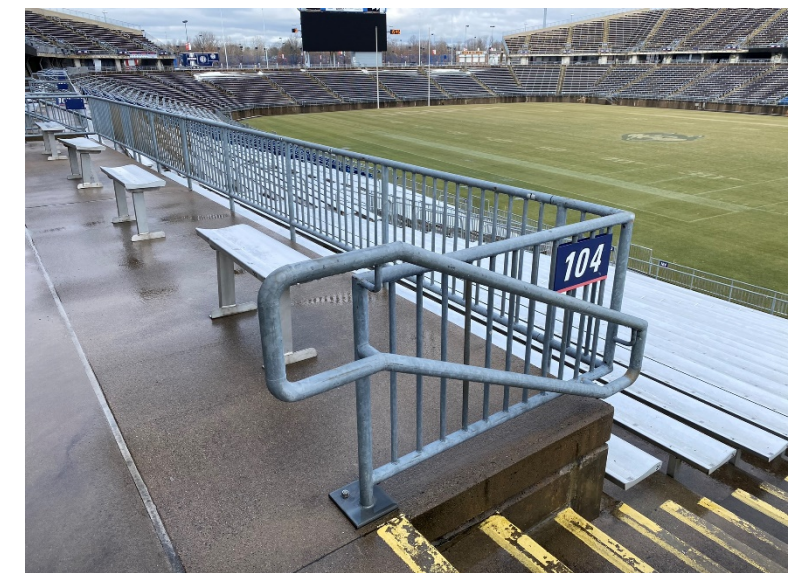
- When hosting soccer and lacrosse events, broadcasters set up camera positions on raised platforms along the concourse due to the inadequacy of the current camera positions in the facility. This causes seat kill (including ADA seating) and possible congestion along those areas of the concourse. There is no power and camera cabling, so all of that is run on a temporary basis.

Soccer/Lacrosse camera position

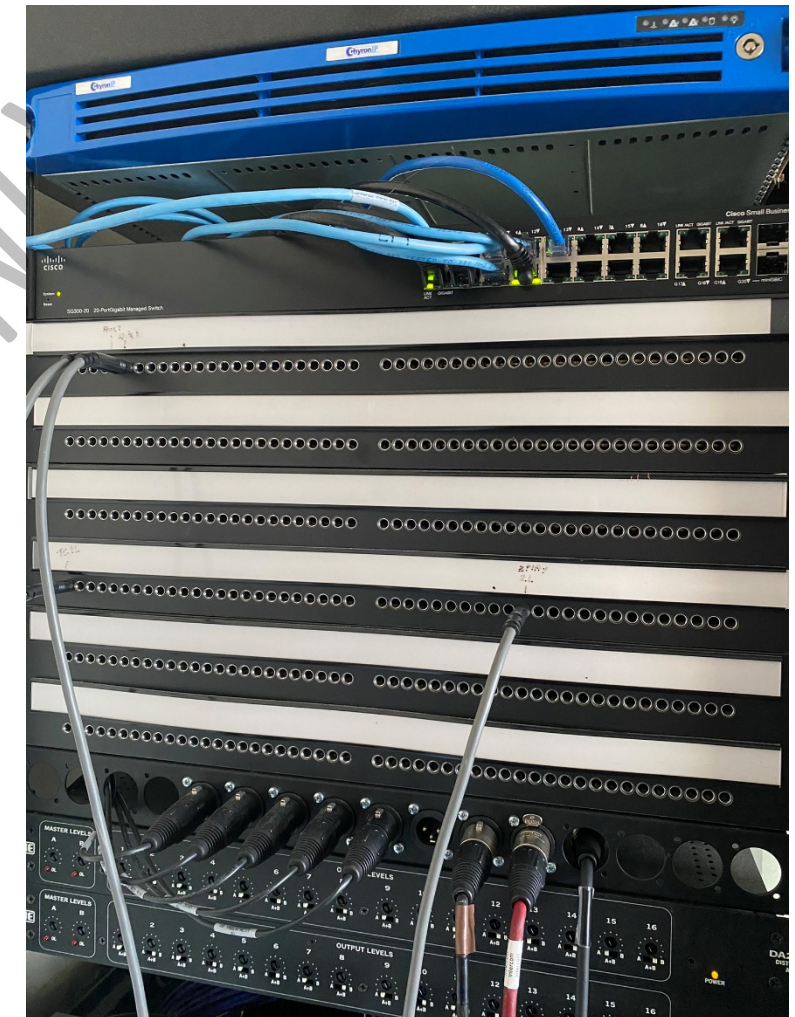
- The Blackmagic router is unreliable as it has broken inputs and outputs and patches become unconnected.
- Not all the fiber patch lines are functional.

Unlabeled patch bays

The system is a hodgepodge of components and functionality on par with A and AA minor league baseball or large high school productions. Some components work and some are broken. Overall, the system is inadequate to meet the in-house production needs of a venue that hosts Division I college events and pro sports events. If a third party is to continue to contract the game production, they should just provide all the components to make it fully functional. If the venue is to provide the game production, an estimated opinion of probable cost would be \$850K-\$1M.

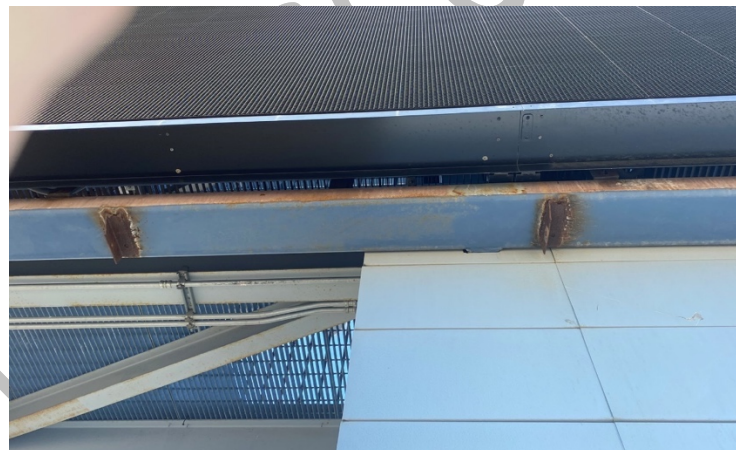
- The system was upgraded in 2012 with control system upgrades currently being completed. While control systems typically last 5-7 years (similar to PCs) the displays themselves typically have a useful life of 9-12 years which means these displays would be candidates for upgrades.
- The main display is a 28' x 73' HD15 product which is arguably Daktronics most popular product. It utilizes pixel sharing technology which allows a perceivable better resolution with less pixels. The structure is exhibiting signs of rust. When the display is replaced, we recommend addressing the rusted areas.

Rust at main display

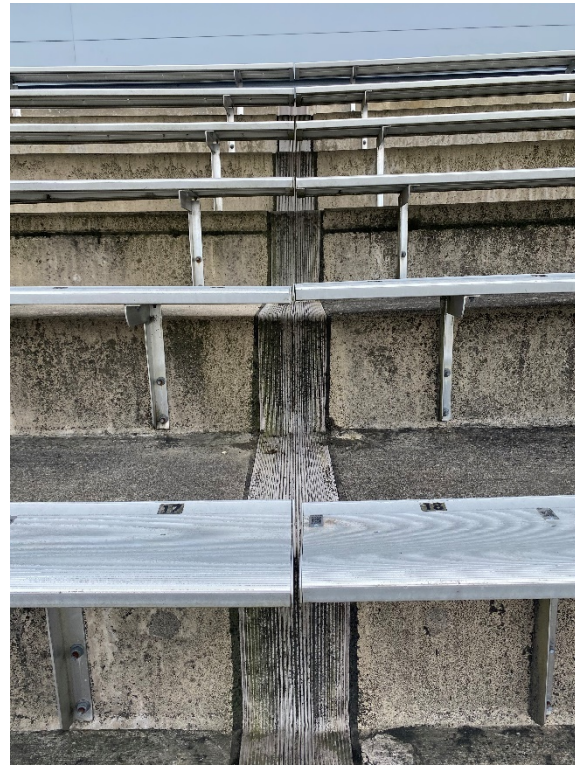
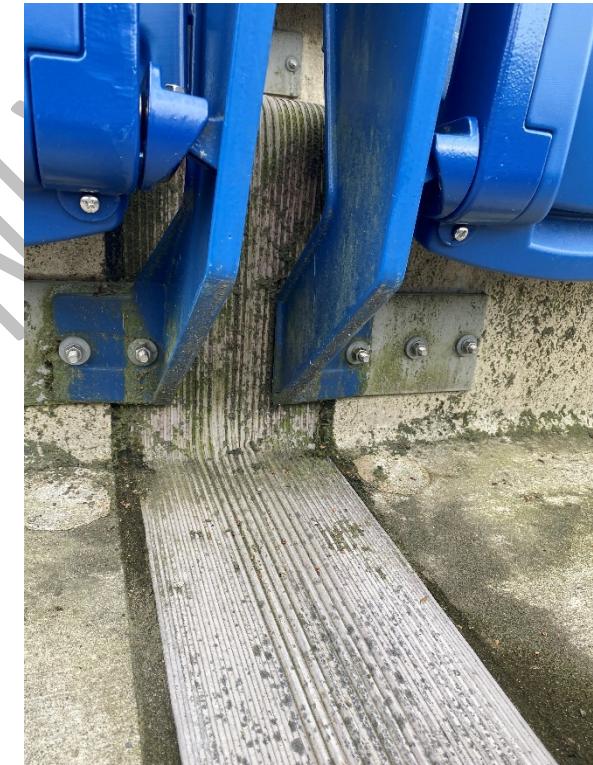
Cracking and separation joints are observed throughout the bowl. These joints were observed on a day when snow was melting. The water is making its way through to the underside of the bowl in areas and should be addressed. Generally, it appears there has been an ongoing maintenance program of exterior sealants.

1. Recommend ongoing maintenance program for expansion joints and sealants.
2. To improve comfort and elevate the fan experience of stadium, the bench seating should be replaced with seats with backs. This will reduce the seat count of the overall stadium. While there is certainly usable life left in the bench seating, consideration for replacement and a replacement schedule should be studied and implemented.

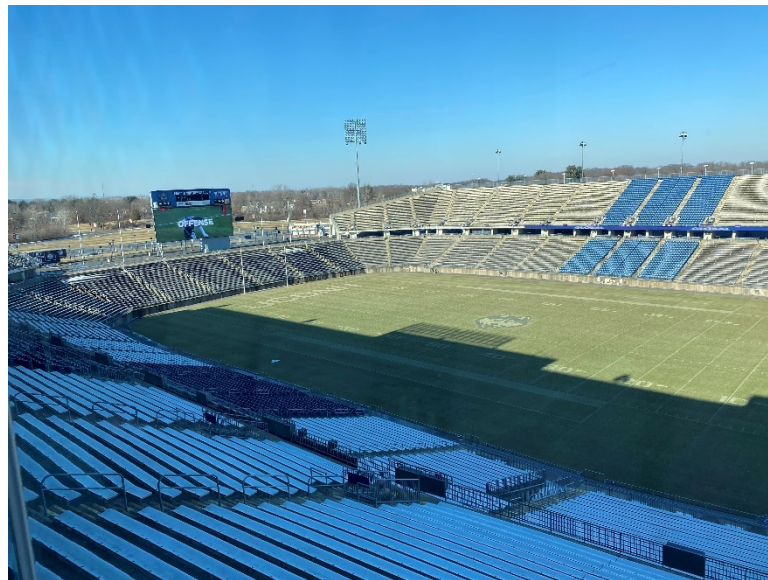
The bowl seating is predominantly aluminum bench seating that is attached to the vertical face of the bow risers. There are a few sections where the bench was warped/bent from abuse and need to be replaced.

Overall view of seating

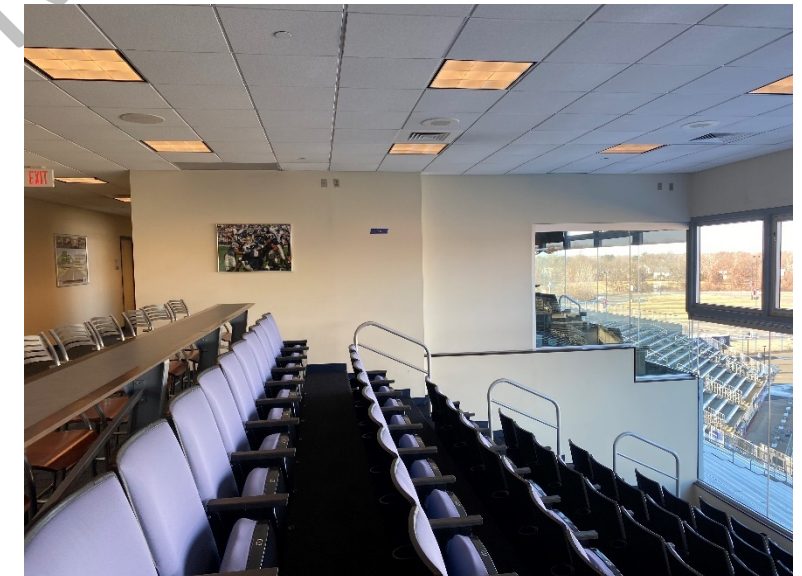
The stadium wayfinding in interior spaces is becoming outdated with additions and modification that may have been made over time. Wayfinding must be clear and should reinforce current brand. The wayfinding for interior club seating was hard to locate and read from a distance.

View of wayfinding signage for club seating section

3. Recommend new wayfinding signage for club seating.
4. Recommend an upgraded POS system, menu boards and some updates to concession front are recommended to speed up transactions and align with industry best practices. Refer to Food Service portion for additional recommendations related to concessions.

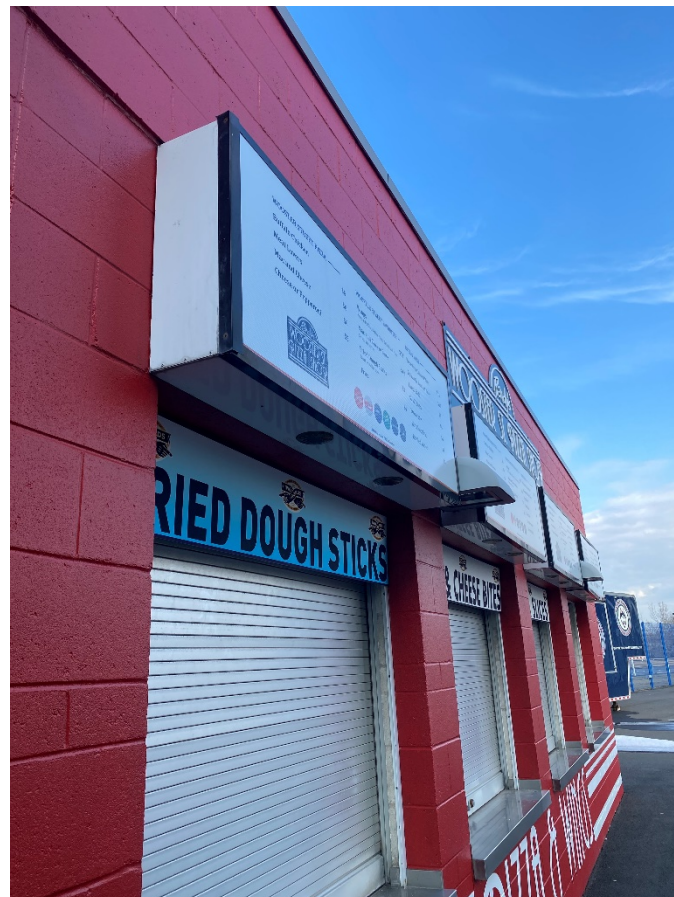
The concession on the main concourse had unique branding for each concession that offered various food options to patrons. The menu boards are fixed menu signs that are back lit above the POS stations. The menu boards are static and are not easily updated and should be replaced. It was observed that coolers are installed on the concourse adjacent to most concessions in full view of patrons.

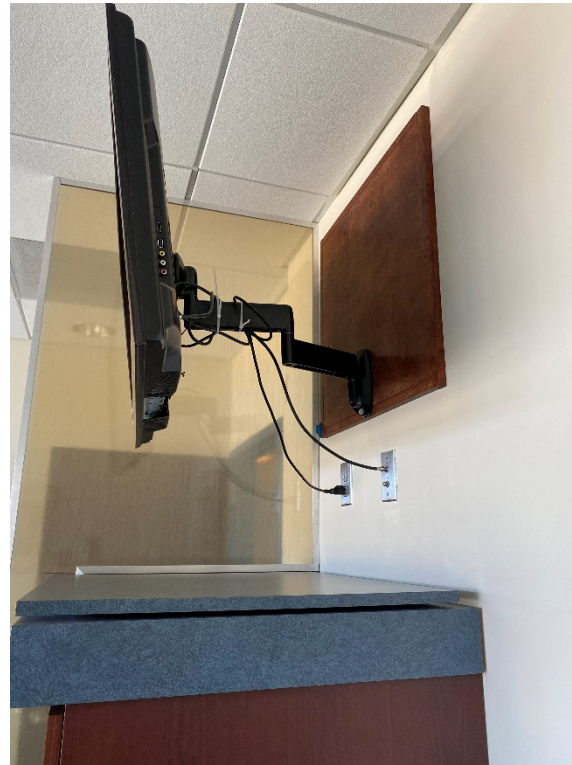
The 46 suites are generally in good condition, but finishes are dated. Carpet and countertops are showing the most wear.

Typical installation of TV's in suites

8. Recommend finish updates to suites. A minimal approach would be to replace carpet, countertop, sink, and faucet. The translucent panels are beginning to show signs of UV damage (yellowing) and should be removed. The TV above the coat closet should be relocated to provide a more cohesive solution. Walls to receive fresh paint. Refer to electrical for lighting upgrades that could require ceiling updates.

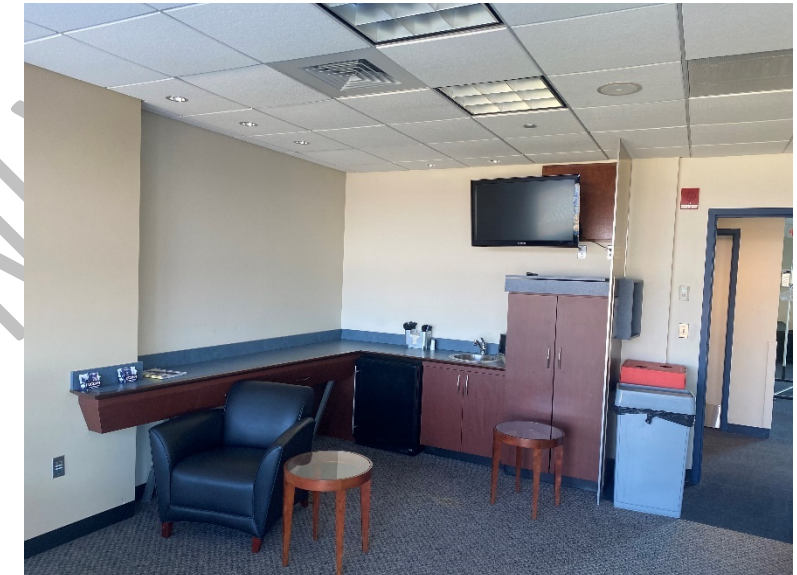
Typical suite

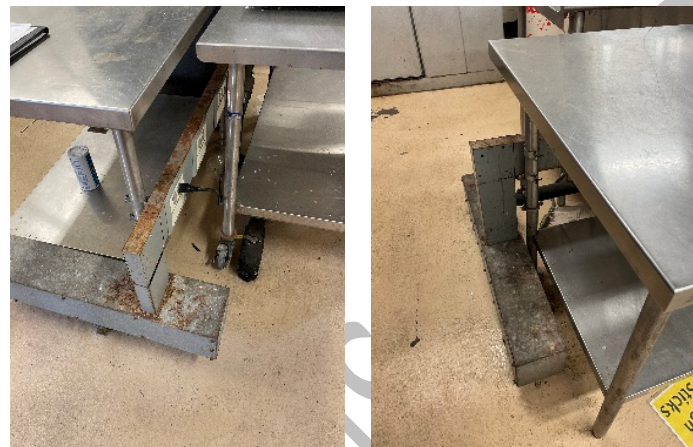
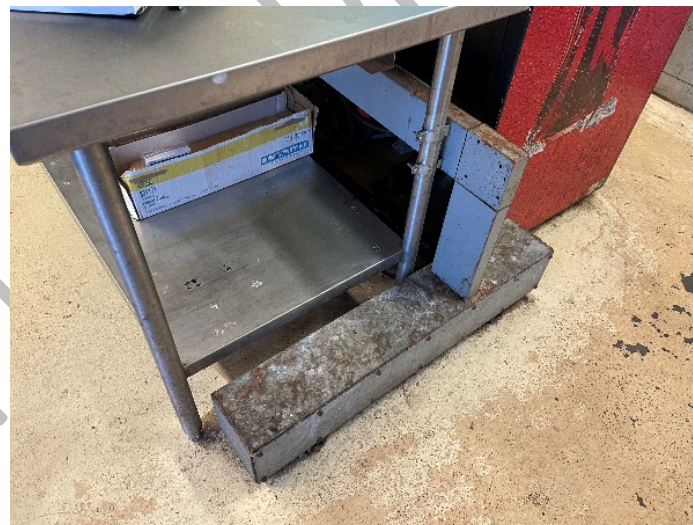
The electrical chases at all the center island tables in all the concession stands are badly rusted as well. These should be painted or sealed to keep water from getting into the electrical components inside.

Sample of rusted electrical chases

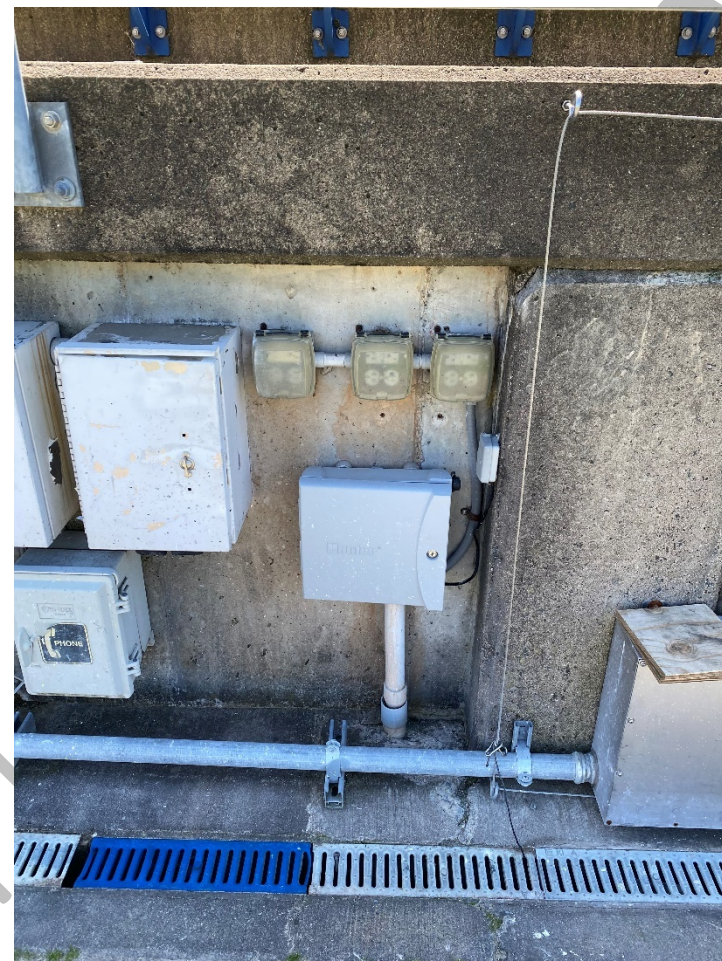
The existing Hunter HCC Hydrawise controller is adequate for the operation of the irrigation system and is Wi-Fi capable, however it is currently placed outside on the field wall and does not achieve strong Wi-Fi signal. It is recommended that

Existing irrigation controller

it be relocated indoors, within the conditioned grounds storage area, where stronger Wi-Fi signal can be achieved. Additionally, it should be converted to a 2-wire function using the Hunter EZ-Decoder system in lieu of the traditional wiring as exists today. This provides for less wire and easier accommodation of expansion should it be required/desired in the future. The existing controller has remote control capability; however the remote control currently does not work, and therefore should be replaced like and kind. A new antenna routing will be required from the new location to the exterior.

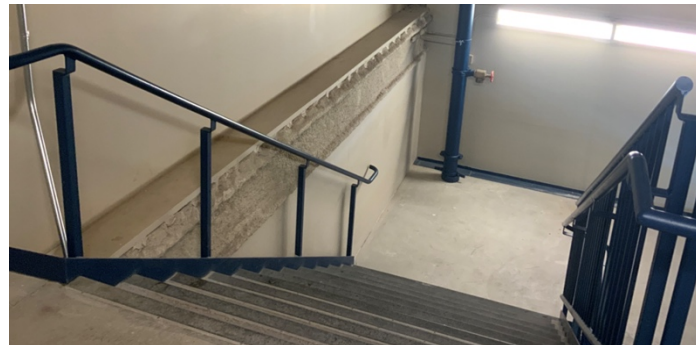
Figure 1: Exit Stair Enclosure

The enclosed exit stairs do not have intermediate handrails. Per the CSBC, intermediate shall be located such that all portions of the stairway's minimum width or required capacity are within 30 inches of a handrail. Without the intermediate handrails, the full width of the stair cannot be utilized which could create capacity issues on some of the levels.

This is an existing condition that may need to be addressed if a Level 2 or 3 alteration occurs in the area.

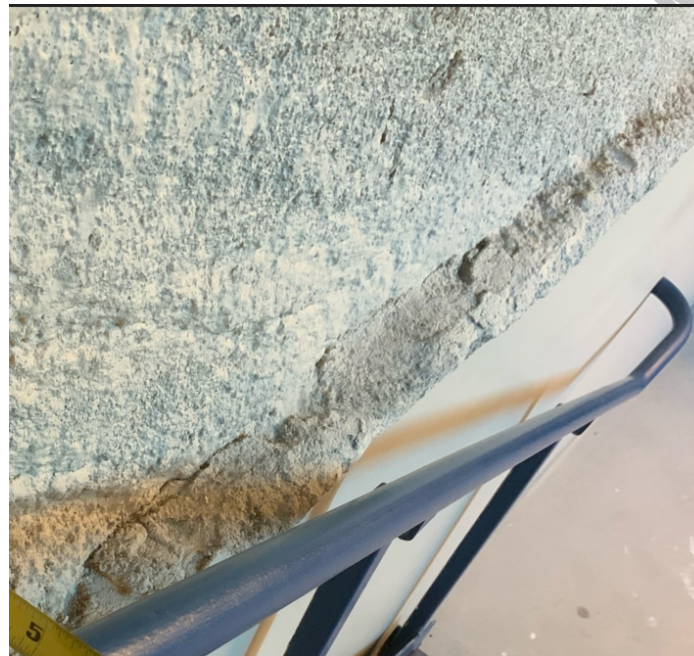
The walls within the enclosed the exit stairs that the handrails are mounted to are not continuously smooth. Per the CSBC, the wall adjacent to the handrail shall be free of any sharp or abrasive elements. The spray foam on the structural steel creates a rough surface and a sharp corner that does not comply with the CSBC.

This is an existing condition and will need to be addressed if a Level 2 or 3 alteration occurs in the area.

Figure 2: Example of wall along railing that is not smooth

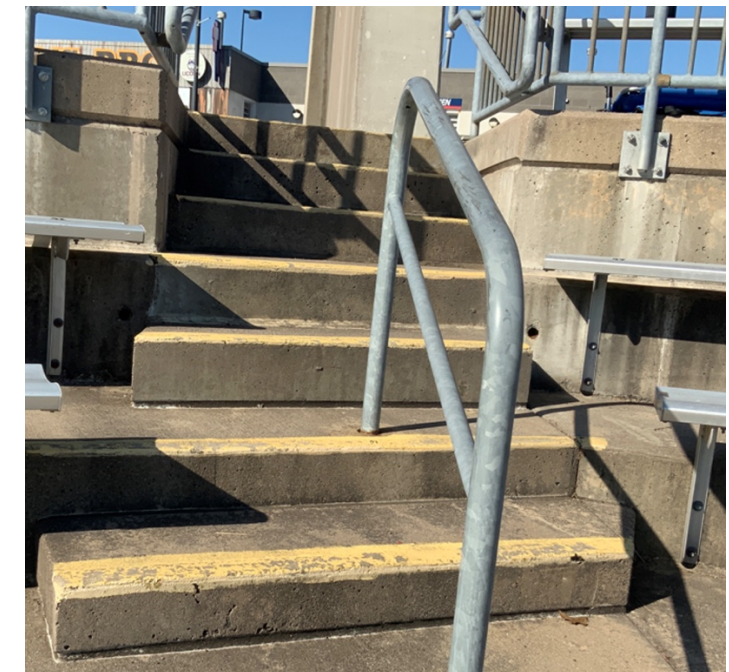
The transition between stepped aisles and stairways is provided with the same marking stripe as the remainder of the stair and aisle. The building code requires a marking stripe be provided on the nosing or leading edge adjacent to each transition that is distinctively different from the stepped aisle marking stripe. This is a typical comment throughout the lower bowl.

This is an existing condition and will need to be addressed if a Level 2 or 3 alteration occurs in the area.

Figure 3: Example of aisle transition striping

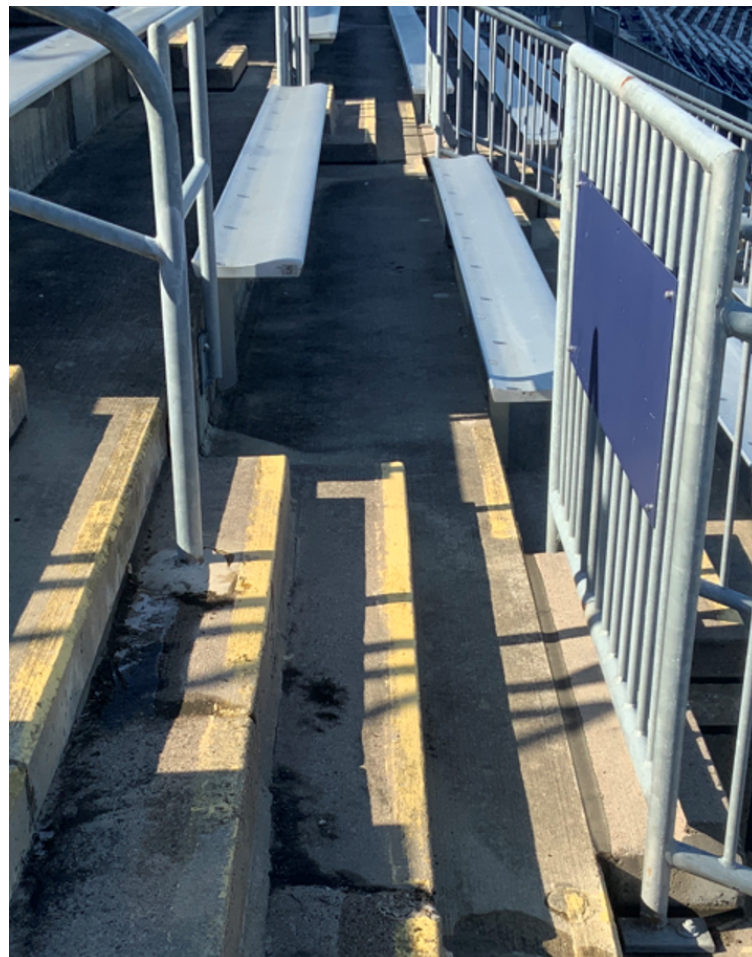
Guards at the end of aisles/top of vomitory shall be not less than 36 inches high and shall provide not less than 42 inches measured diagonally between the top of the rail and the nosing of the nearest tread, per the building code. It was noted that there were several instances around the upper bowl that do not comply with the current requirements.

This is an existing condition and will need to be addressed if a Level 2 or 3 alteration occurs in the area.

Figure 4: Guard at bottom of aisle/top of vomitory

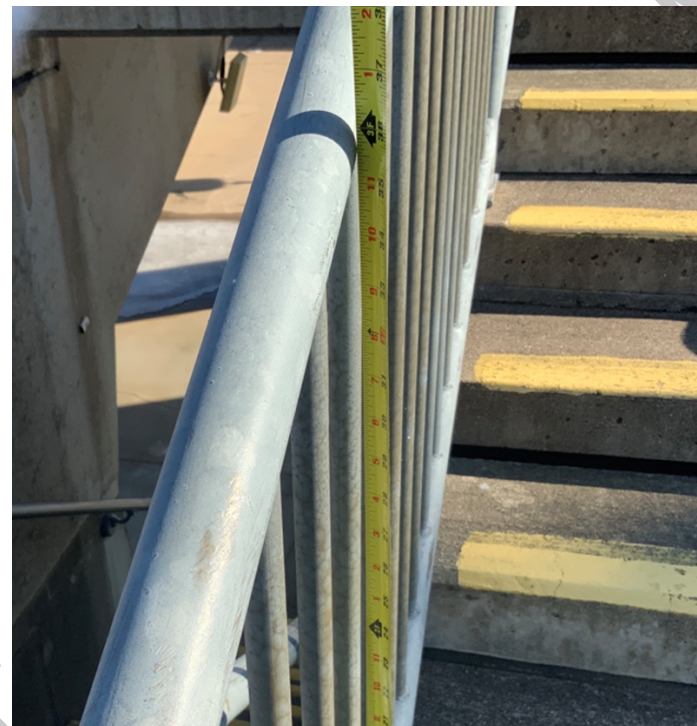
The aisles along the sides of the vomitories are not provided with handrails. This condition is acceptable if provided with a guard that meets the requirements of the building code. It was noted that several instances around the upper bowl where the guards are not a minimum of 42 inches as required by the building code.

This is an existing condition and will need to be addressed if a Level 2 or 3 alteration occurs in the area.

Figure 2: Example of guard along upper bowl vomitory

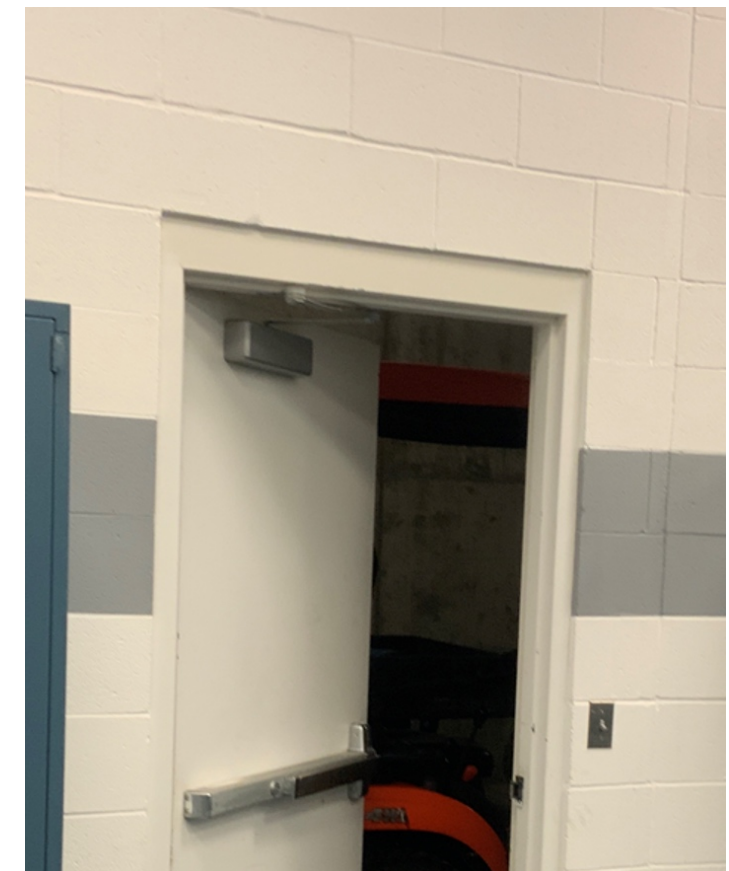
There are a few locations within the locker rooms and corridors where exit signs missing or not readily visible along the egress path.

This is an existing condition and will need to be addressed if a Level 2 or 3 alteration occurs in the area.

Figure 3: Example of egress door without an Exit Sign

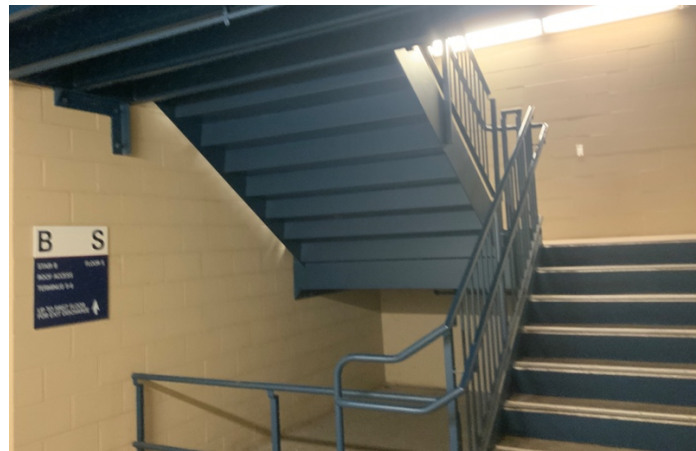
Sprinkler coverage is not currently provided under both exit stairs at the lowest level. NFPA 13 requires sprinkler coverage under the lowest landing.

This is an existing condition and will need to be addressed if a Level 2 or 3 alteration occurs in the area.

Figure 4: Bottom landing of stair without sprinkler coverage

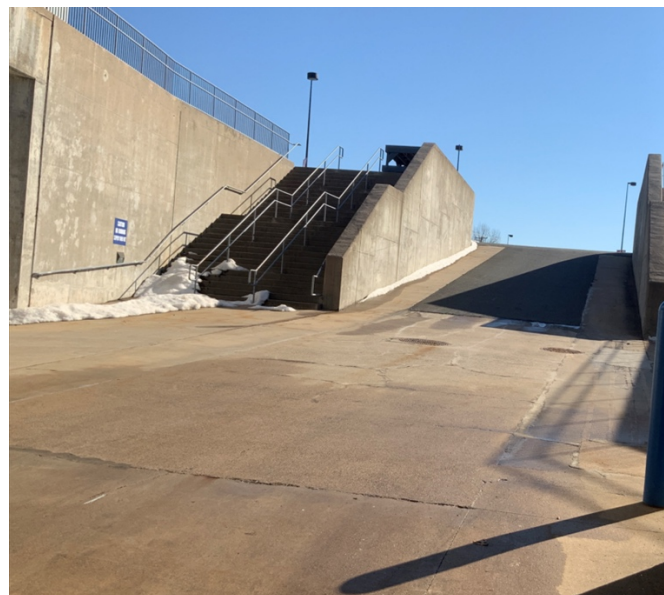
The ramp from the field that leads to the two open stairs appears to be too steep. In accordance with the CSBC, ramps used as a part of a means of egress shall have a running slope not steeper than 1 in 12 (8% slope).

This is an existing condition and will need to be addressed if a Level 2 or 3 alteration occurs in the area.

Figure 5: Ramp leading from field to monumental stairs

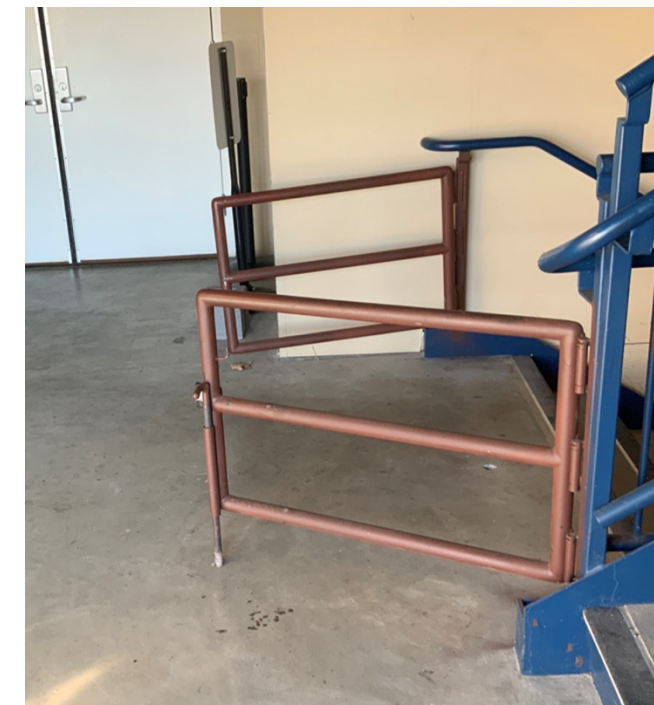
Gates are provided within the stair on the level of exit discharge to prevent persons from unintentionally continuing into levels below. However, the gates are not self-closing and could be an obstruction the clear width of the stair. In addition, the gates are provided with a bar lock that cannot be release upon pushing the gate. Gates and doors serving more than 50 occupants shall be free swinging or be provided with panic hardware.

This is an existing condition and will need to be addressed if a Level 2 or 3 alteration occurs in the area.

Figure 6: Gates at stair discharge level

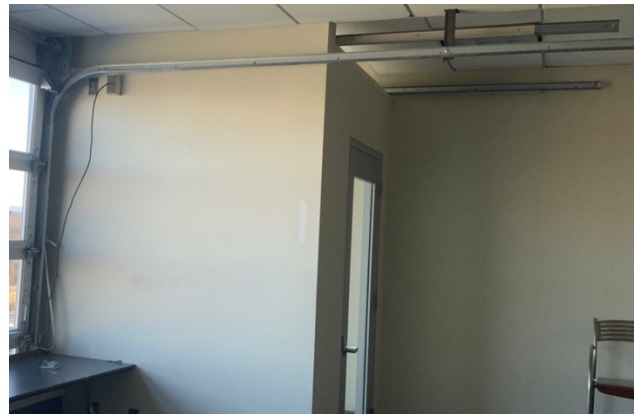
The large garage door within the broadcast booth does not have a sidewall sprinkler under the garage door when it's in the opened position. Per NFPA 13, sprinklers shall be installed under fixed obstructions over 4 ft wide such as overhead doors.

This is an existing condition and will need to be addressed if a Level 2 or 3 alteration occurs in the area.

Figure 7: Overhead garage door with sprinkler coverage

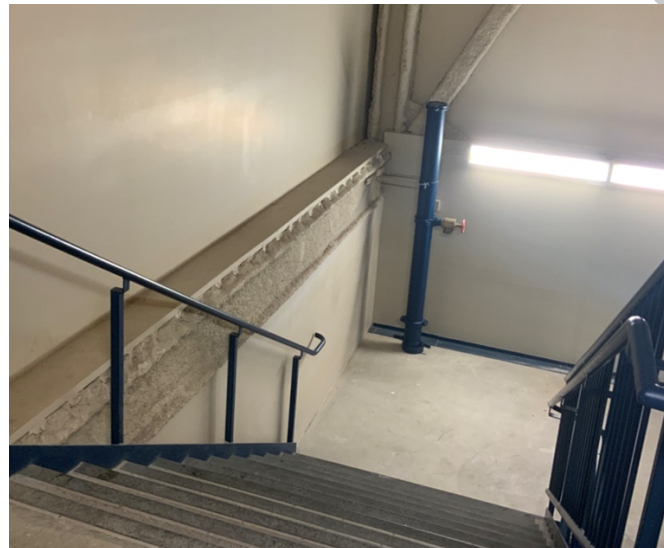
The top of the standpipe stops at the intermediate landing below the roof level. Per NFPA 14, hose connections shall be provided at the highest landing of stairways with stairway access to a roof.

This is an existing condition and will need to be addressed if a Level 2 or 3 alteration occurs in the area.

Figure 8: Top of Standpipe location

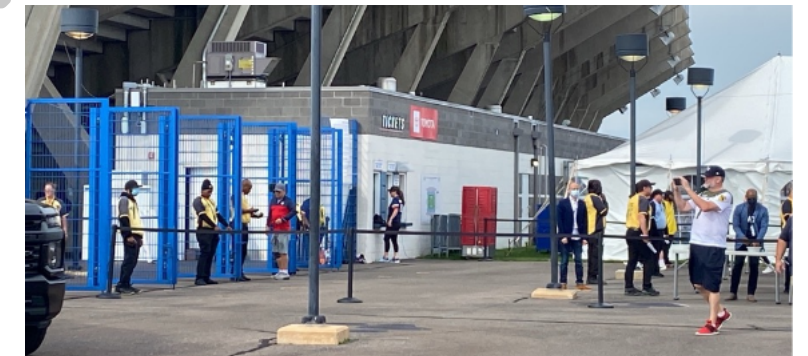
Existing entry gate

3. Permanent canopies could be added at the 4 entrances to protect staff from rain & bright sunshine when trying to scan mobile tickets. Canopies are common at entries to help visually enforce the entry points to the stadium. Graphic messaging (including sponsorships) can be added to help orientate and direct people into the stadium.

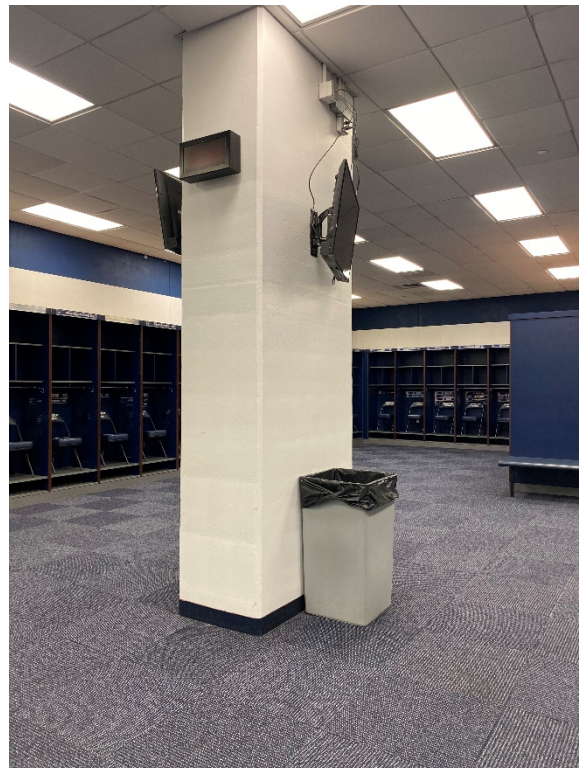
4. The home team locker room is adequate but beginning to show wear. There is a great opportunity to improve the home team locker room branding and elevate the player experience. Improvements should include branding features. Replace lockers with the latest locker fabrication and electronic/outlet options, update finishes and fixtures throughout including all wet areas and ancillary. Training area/medical could be reconfigured to better utilize space and add player amenities like small club/lounge space with smoothie bar, etc. The entrance design of the home locker room includes an entry vestibule and corridor to access home locker room. There is another entry to the home locker room that has direct access to the field. Both could be activated with branding to motivate and inspire players.

Existing Home Team Locker Room

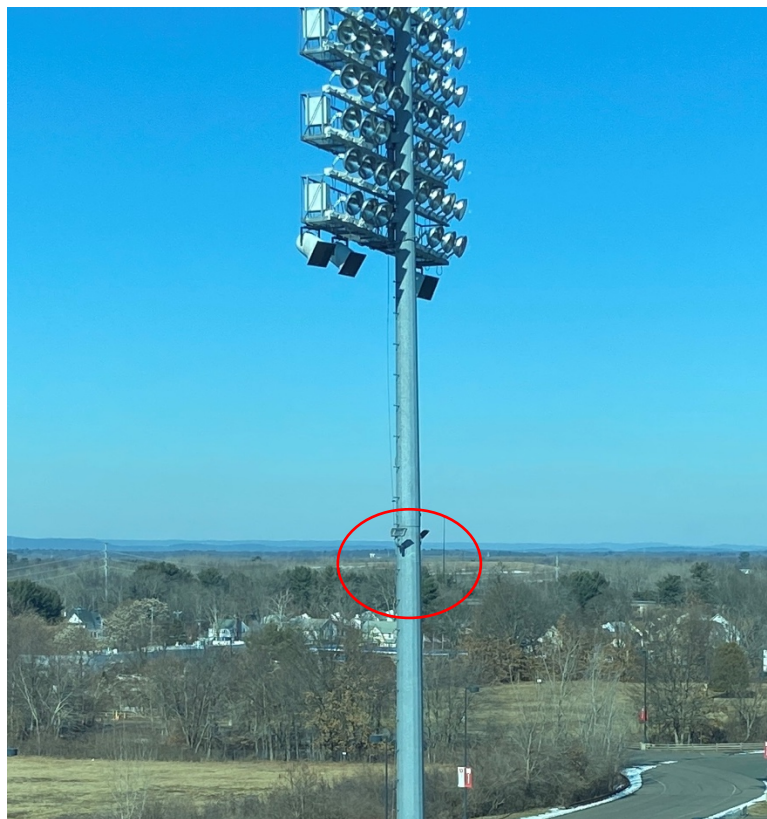
Existing bowl emergency egress lighting fixtures are metal-halide and original to the facility. The lamps themselves have remaining life because of infrequent use, however, the bullhorn attachment brackets holding the fixtures to field lighting poles are failing from high wind loads. There have been ad-hoc mitigation efforts to chain down the fixture housings and prevent rotation, but a more permanent solution is needed.

Original metal-halide emergency lights mounted on sports lighting poles.

1. Replace pole-mounted metal-halide bowl Emergency lighting with new LED luminaires equipped with robust mounting kits.
2. Replace metal-halide bowl event lighting with LED sports lighting system and upgraded controls.

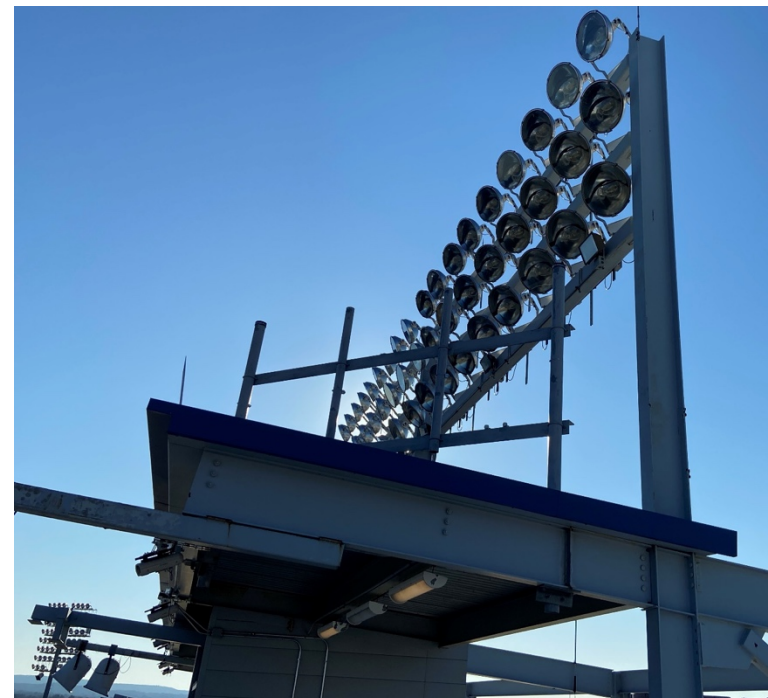
Existing bowl event lighting fixtures are metal-halide and original to the facility. While still operational, these fixtures are nearing end of life and replacement with a new LED sports lighting system would provide enhanced performance with lower energy use, improved controls, and fewer lamp replacements.

Original metal-halide sports lighting

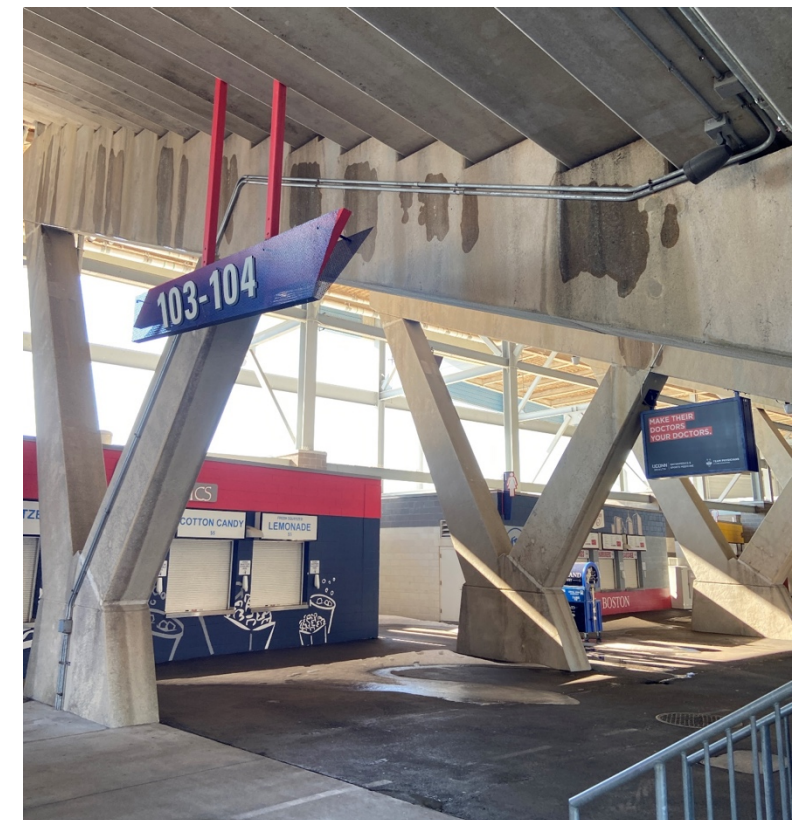
A key limiting factor noted during the facility assessment was the lack of power availability at concourse interior walls. 120V power at these locations is necessary to provide refrigeration and mobile concessions activations as operations move away from keeping ice bins in kiosks. Facilities staff have already been very resourceful in loading up nearby circuits to free up new spares in prior years, but unfortunately the nearby panels have no more available branch circuits. Dealing with the concrete surfaces and large, open-air spans between concessions buildings to the underside of bowl seating is an added challenge.

Limited options for sourcing and routing new concessions power at concourse levels

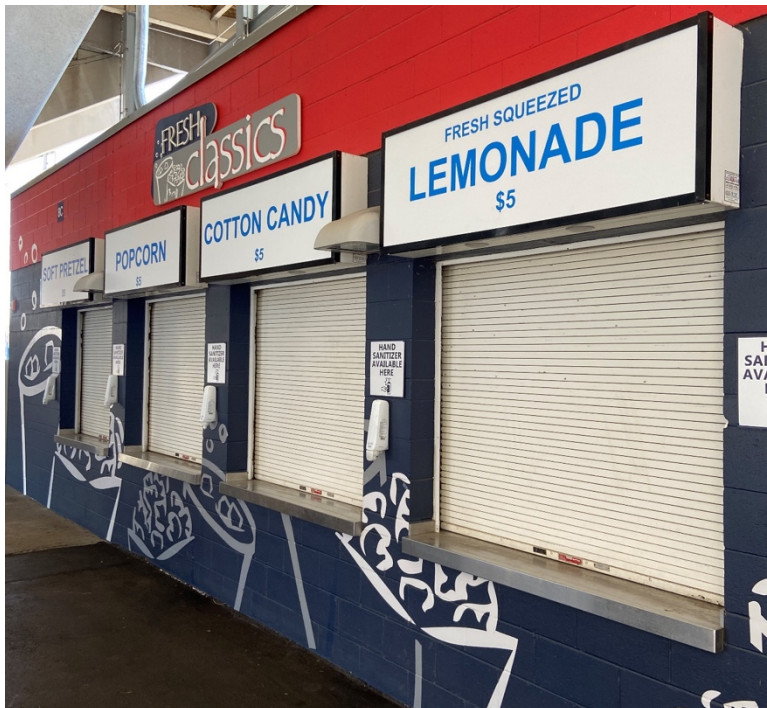
Fluorescent illuminated concessions signage

4. Replace concessions signage with digital monitors.
5. Provide additional dedicated 208V circuits and outlets for food trucks.
6. Expanding on the lighting controls recommendations provided in Phase 2, a few other upgrades to the facility lighting controls are provided below that would improve facility operations as well as reduce energy consumption:

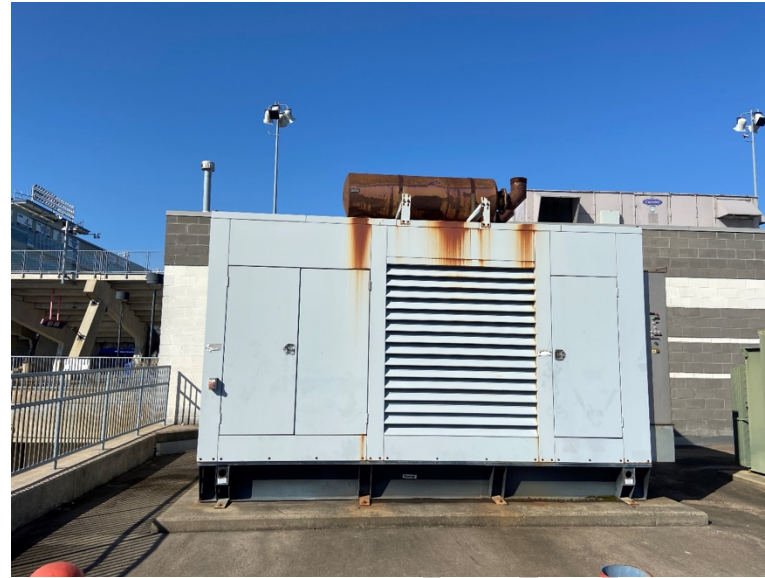
It was noted by maintenance staff that generator testing has not been kept up on an annual basis, as required by NFPA 110.

Unable to access interior of generator enclosure; visible rust runoff from diesel generator muffler on exterior

7. Considering the age of the generator, it is recommended to put in a place a preventative maintenance plan for the facility emergency generator to avoid issues when called upon.

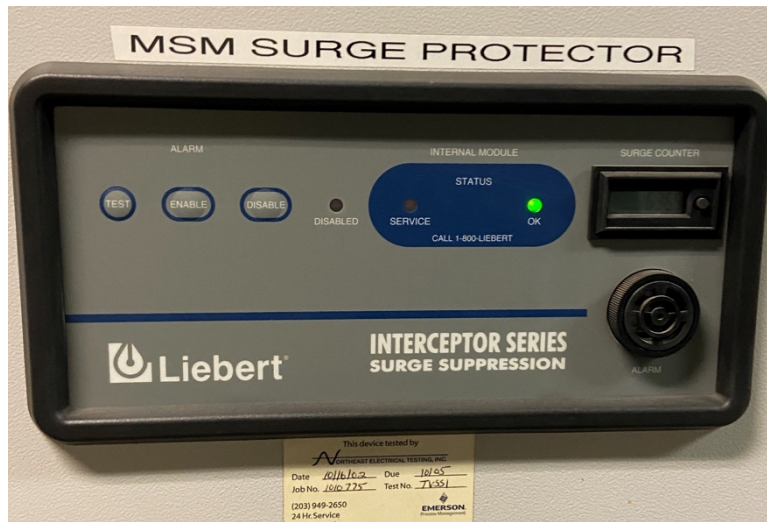
The facility's main utility service entrance switchboards are equipped with surge protection devices (SPDs), and the surge events recorded on switchboard MSM were significantly higher than others. The SPDs are doing their job and protecting the facility, but their lifespan is measured in joules and each surge event reduces the remaining amount of protection. SPD ratings were not able to be visually confirmed during the site visit, but on average, 250kA/phase rated SPDs have a life expectancy >25years.

6,365 surge events recorded at main switchboard MSM
