Comprehensive Building Assessment

Rentschler Field at Pratt & Whitney Stadium

September 7, 2022
DRAFT FOR
DISCUSSION ONLY

CRDA | Capital Region
Development Authority

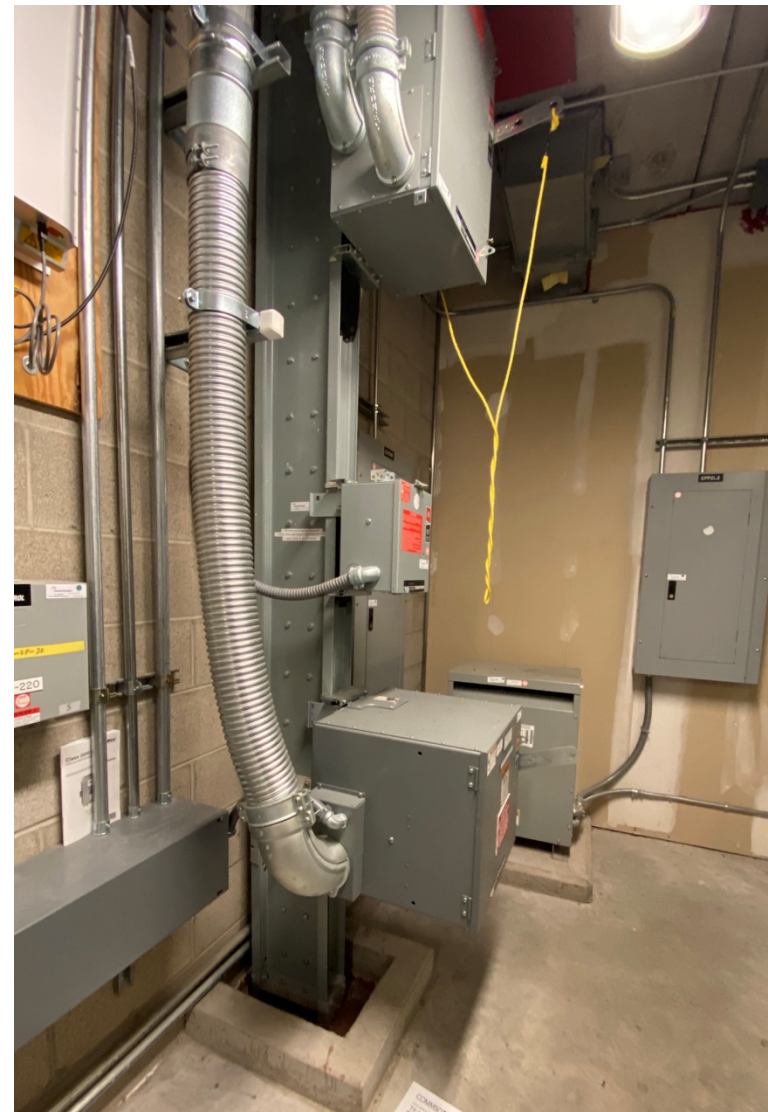
Busway distributes power vertically in the stadium tower.

Recommend including infrared thermal scanning and re-torquing of all busway joints (and busplugs) for hotspots as part of annual preventative maintenance and IR scanning of other points in the electrical distribution system (e.g., switchboards).

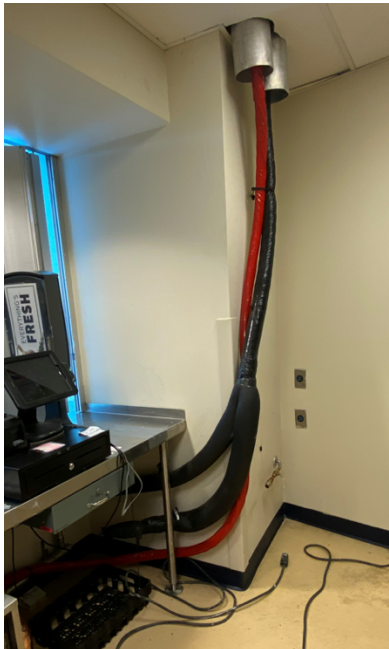
A refresh on the club concession would be good, and it already has a digital menu board. Additionally, something should be done to hide the beverage conduit as it comes down from overhead.

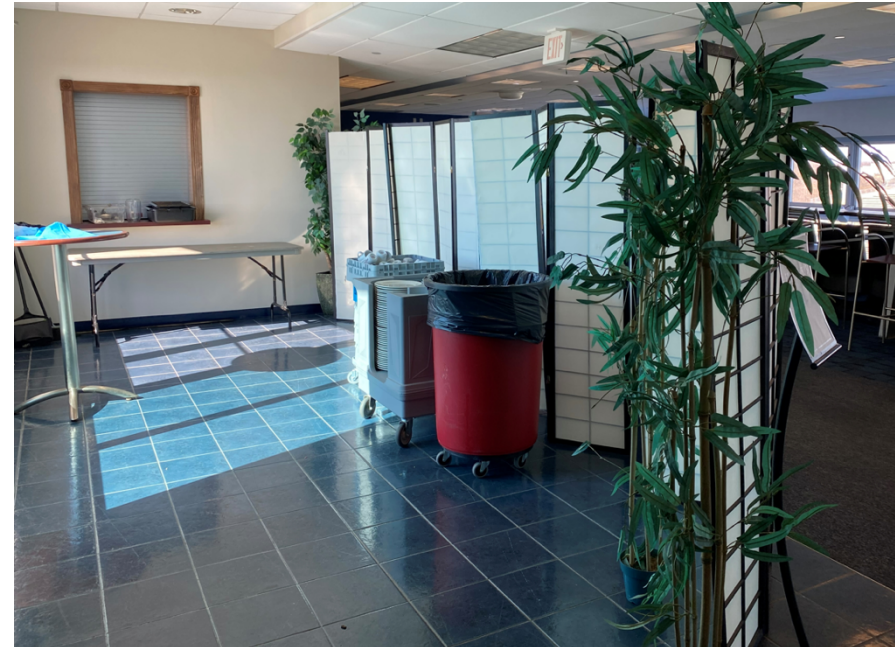
Someone has set up a nice screen partition with some plants to hide what appears to be a staging area for foodservice.

This particular area should really have a wall and door and permanent plumbing fixtures to keep issues with the Health Department at a minimum.

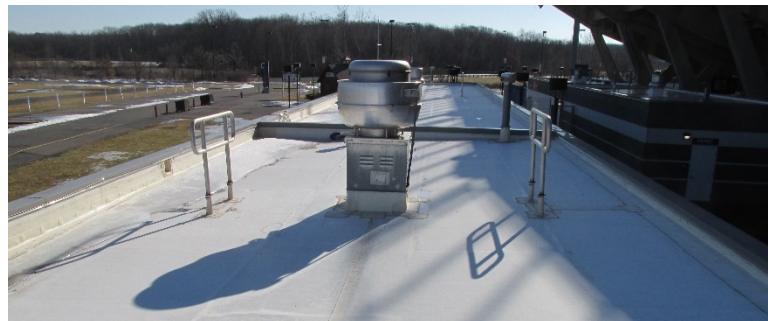
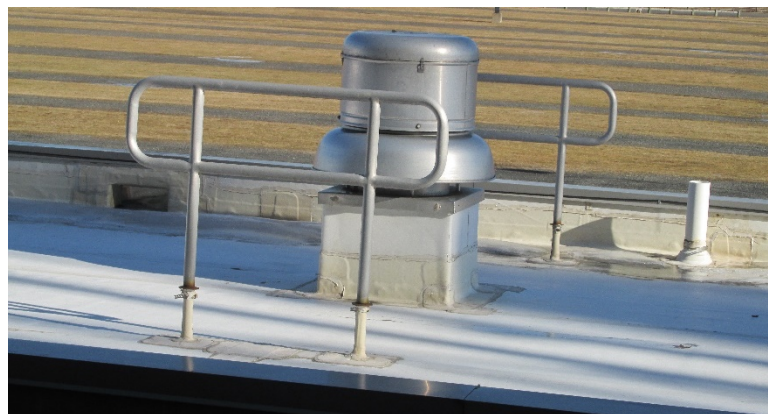
Sections of safety railings are installed adjacent to some rooftop mechanical units, as fall protection (photos above/below); the railings are anchored to metal pipe stanchions that are flashed with EPDM membrane

There are also a number of areas where stanchions for fall protection railings are installed on the roofs; however, no railings are currently in place.

It is recommended that facility management contract the services of a qualified safety/design consultant in the State of Connecticut to inspect the roofs, project-wide to note existing conditions and to recommend all needed alterations and/or additions to the existing rooftop safety/fall protection equipment, to ensure that the facility is in full compliance with all current OSHA/Connecticut/local building safety codes and requirements.

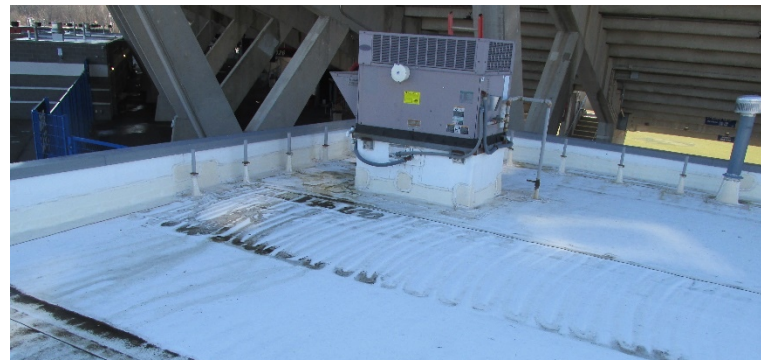
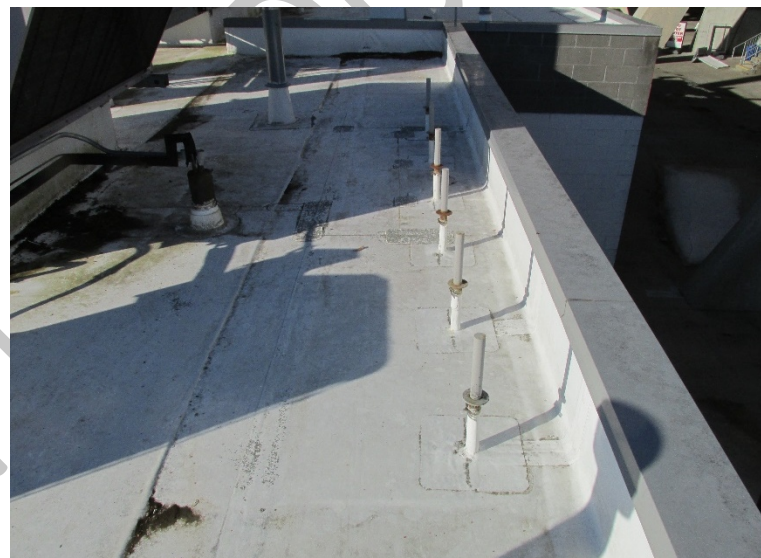
There are numerous rows of metal pipe stanchions, for anchorage of rooftop safety railings on the roofs (Buildings 1-9), that have no safety railings attached (photos above/below)

It is likely that codes and requirements for safety and fall protection associated with rooftop equipment access have been updated/changed in the time period since original construction of the facility.

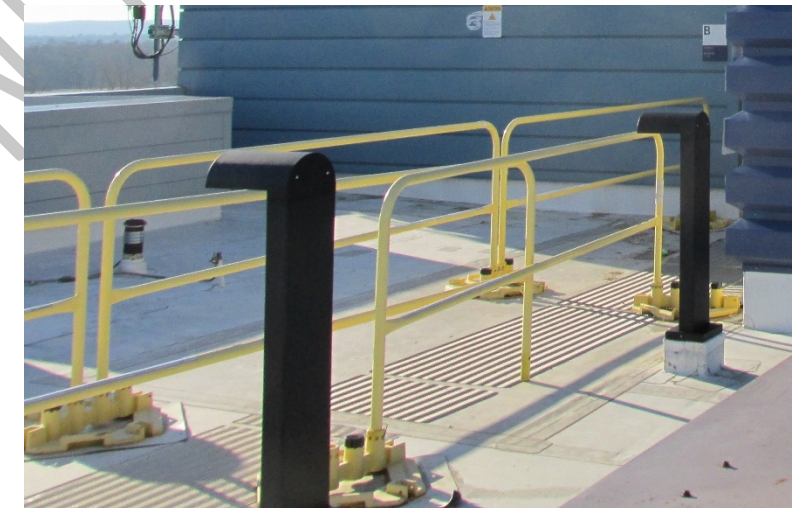
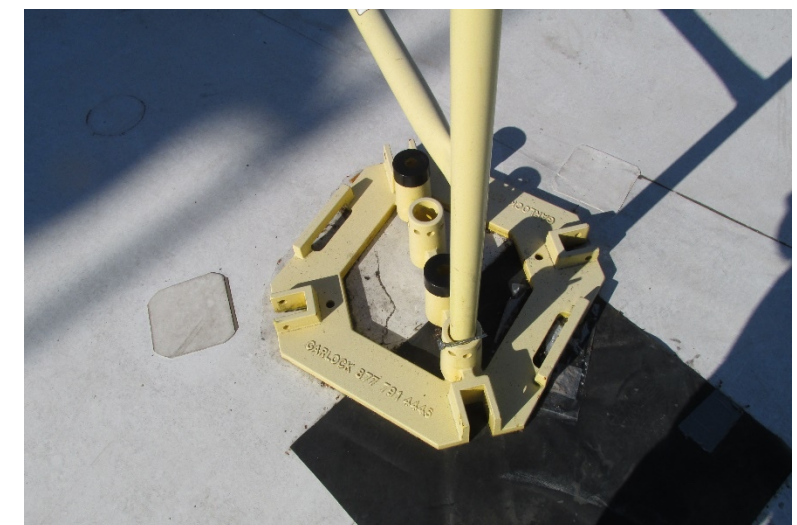
It was noted that some portable surface-mounted safety railings are installed on the main roof of the Tower Building. These railings utilize metal pipe rails that are inserted into heavy steel pedestals that are resting directly atop the roof membrane surface.

Portable, surface-mounted safety railings are utilized in one area on the main roof of the Tower Building (photo above); the metal pipe rails are attached to heavy steel bases that rest directly atop the surface of the roof membrane (photo below)

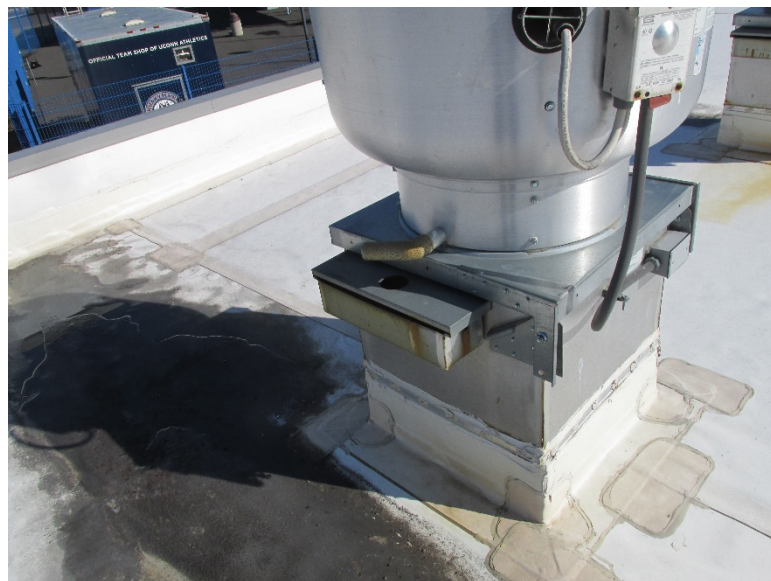
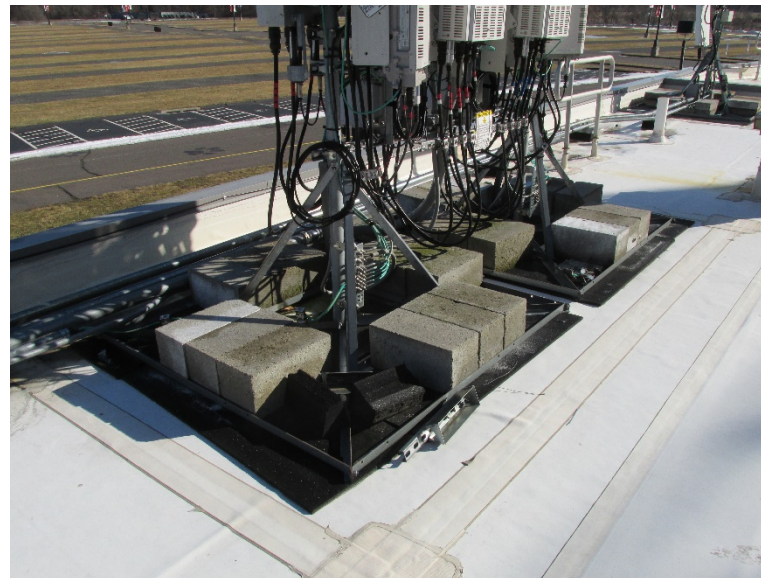
Based upon visual observations of the roofs, including Buildings 1-9 and the Tower Building, there are numerous additional rooftop mechanical units and pieces of telecom equipment on the roofs that are installed in close proximity to roof perimeters, yet they lack any type of fall protection equipment. It generally appears that installers/maintainers of the rooftop telecom equipment have made little or no efforts to place any type of fall protection around their equipment.

Numerous rooftop mechanical units, as well as pieces of rooftop telecom equipment are installed relatively close to roof edges; however, they lack any type of safety railings/fall protection equipment

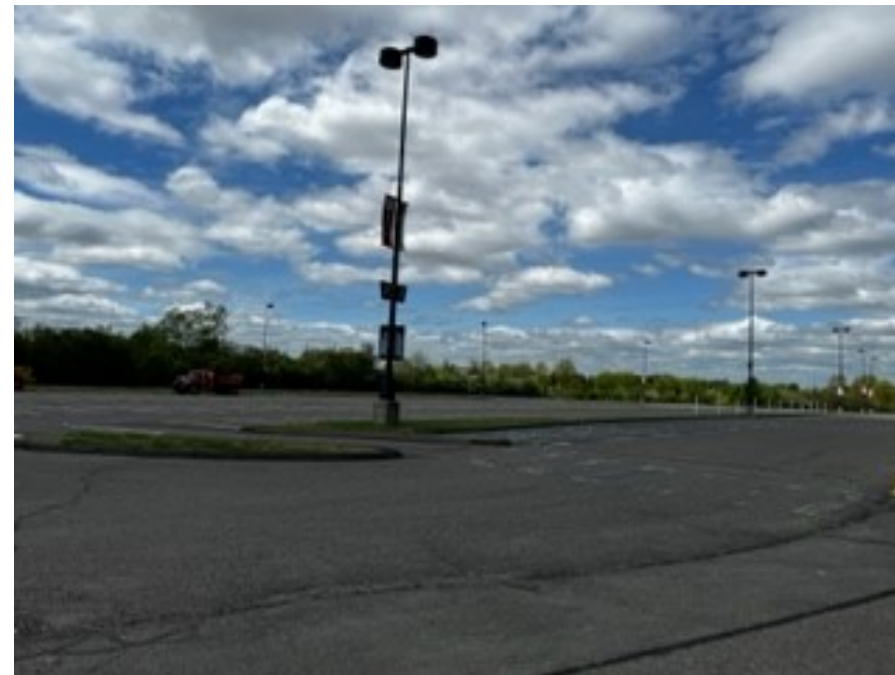
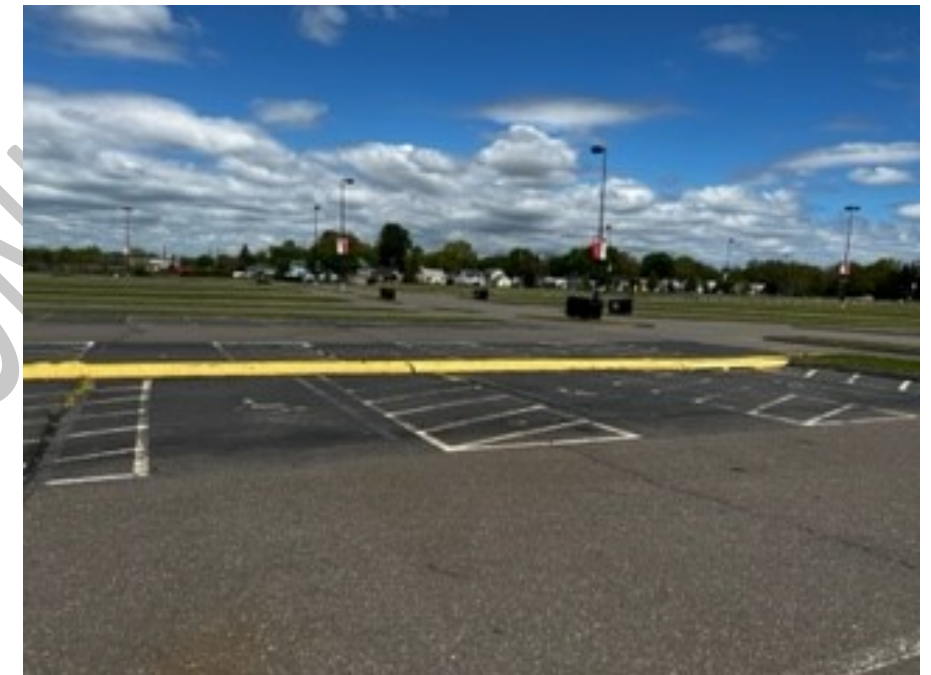
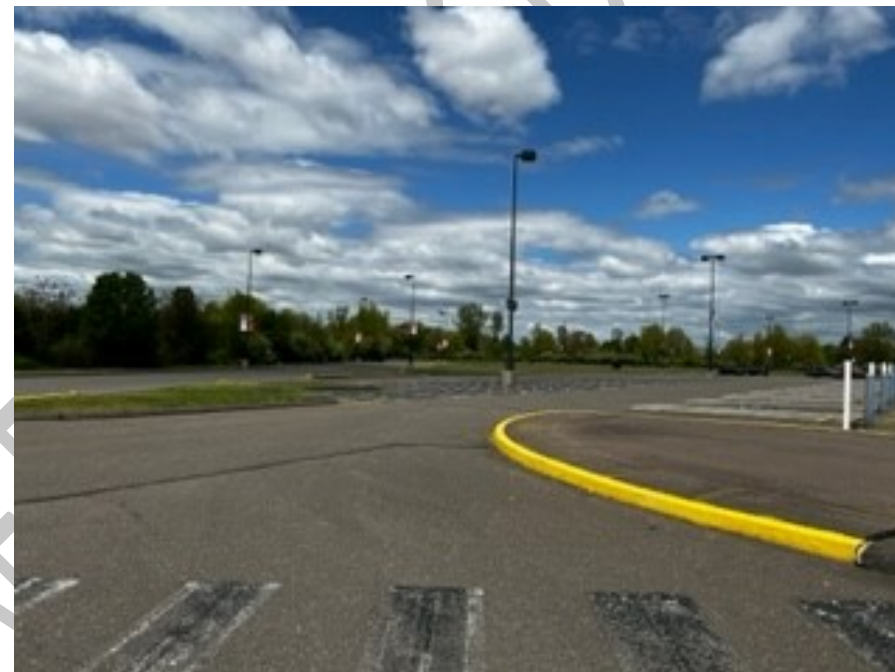
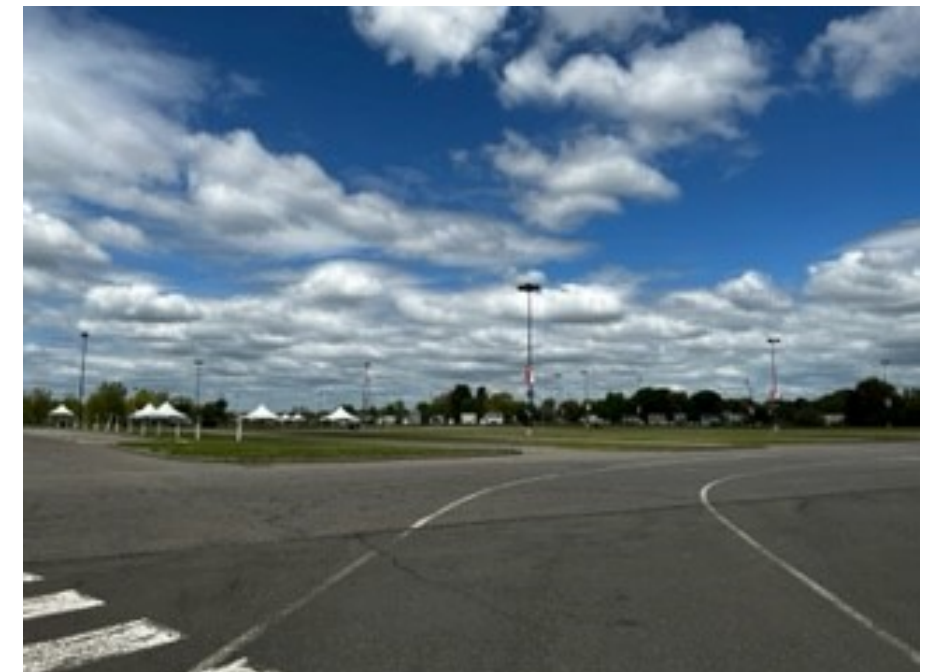
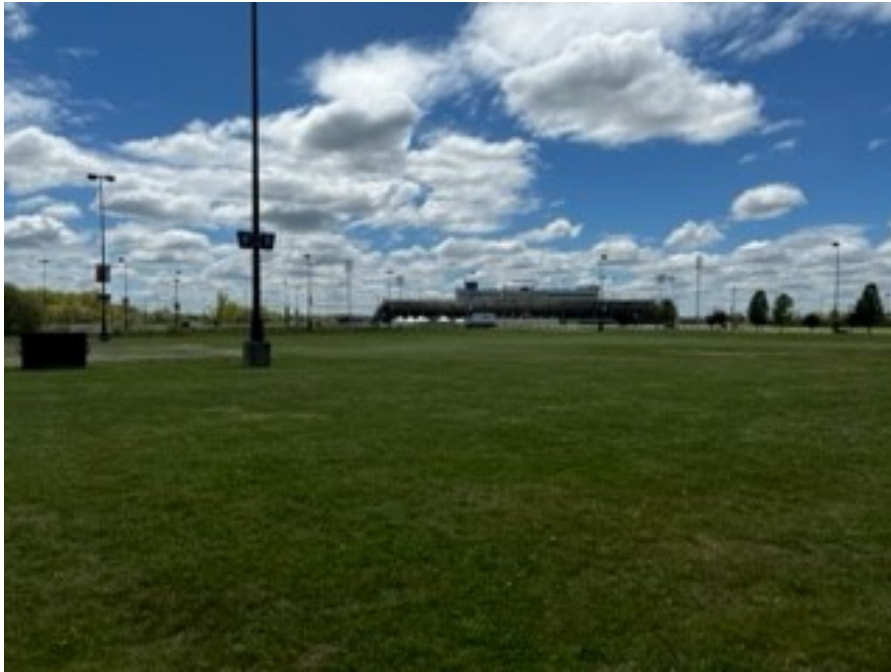
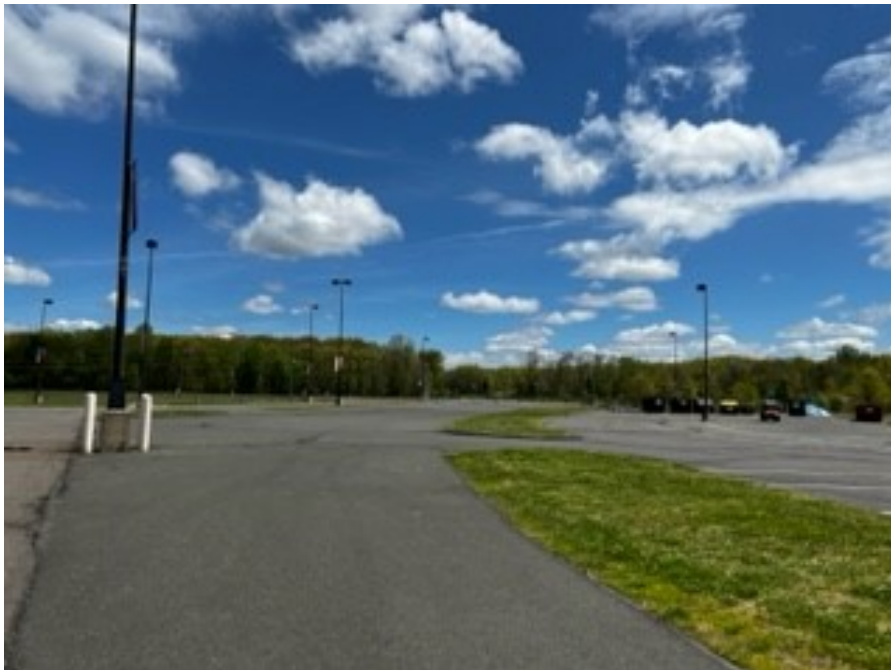
Site Landscaping is non-existent. The entire site, particularly those areas directly adjacent to the stadium, are turfgrass areas that have become overrun with weeds and trampled from pedestrian and vehicular traffic. There are no trees adjacent to the stadium, nor in the parking areas, giving the site the appearance of a barren landscape of weedy turfgrass and pavement.

The site pavement is all asphalt pavement that is significantly deteriorated. Much of the pavement is cracked and needing replacement.

We also recommend that shade trees be added within the parking areas and along access drives as to break up the current wide-open space and to highlight the main vehicular paths.

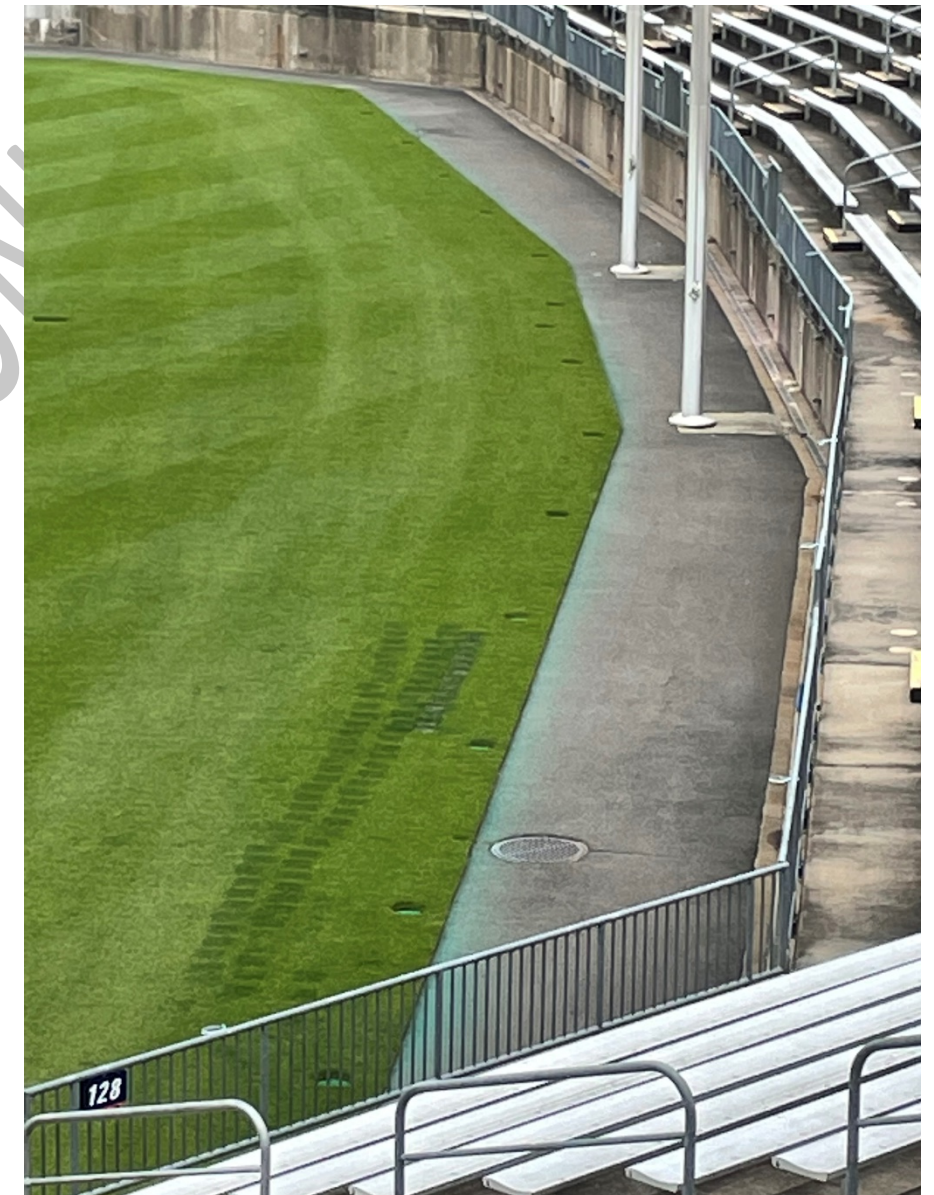
Existing irrigation and subdrainage enclosures within turf area (north)

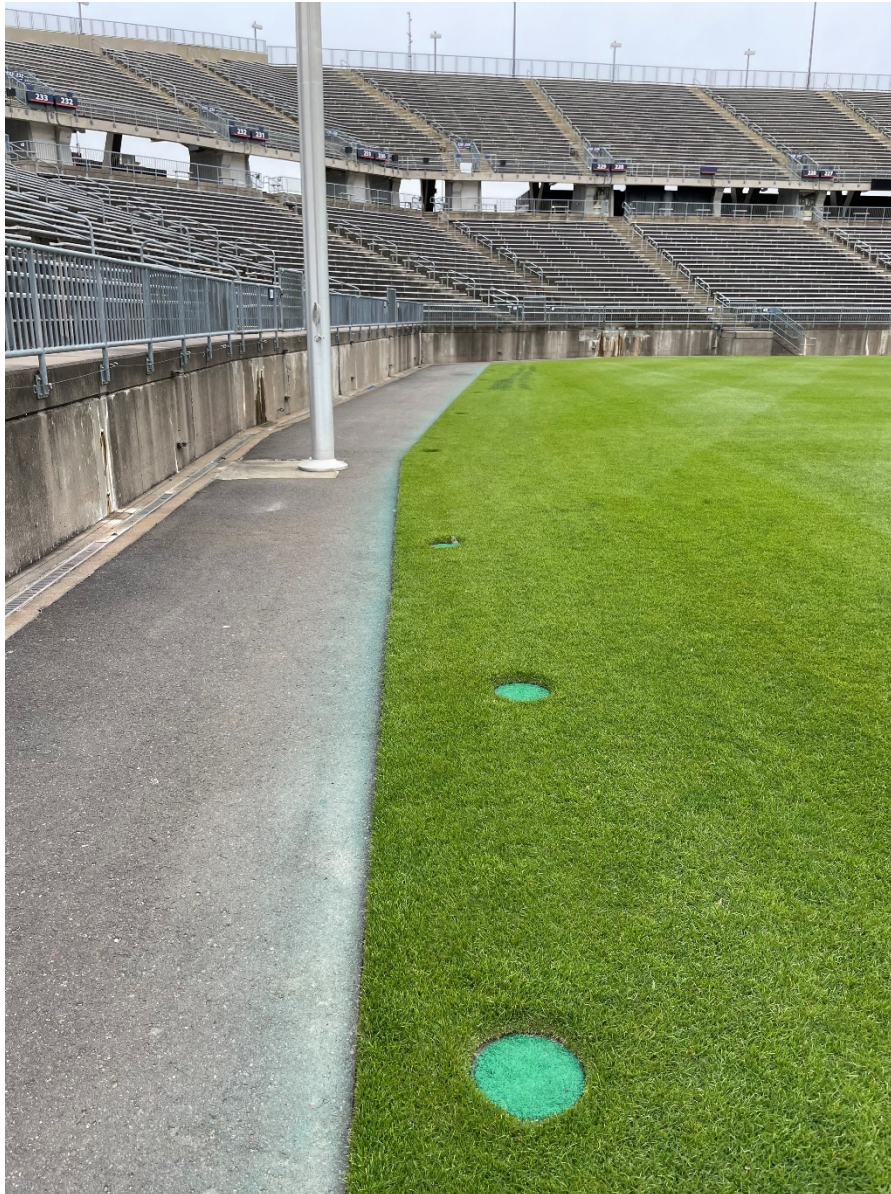
Existing irrigation and subdrainage enclosures within turf area

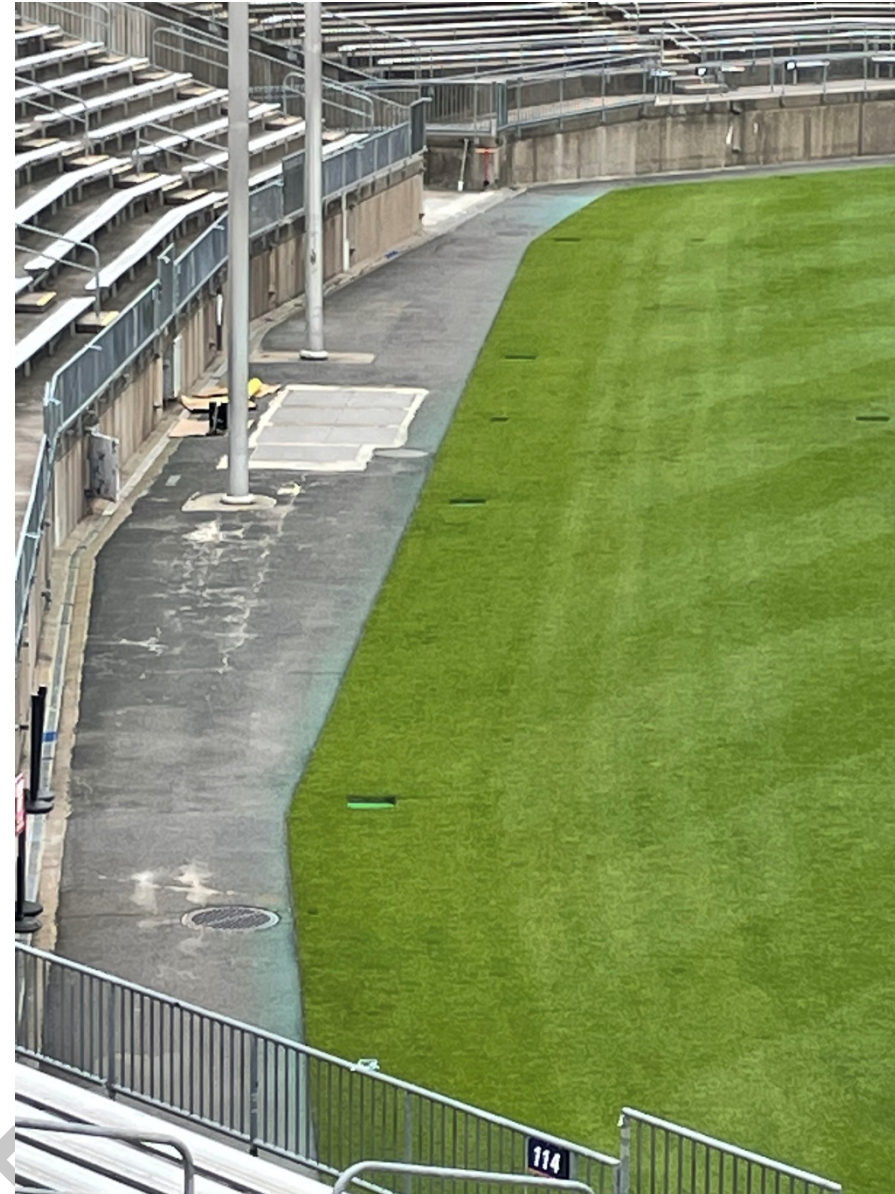
Existing irrigation and subdrainage enclosures within turf area (south)

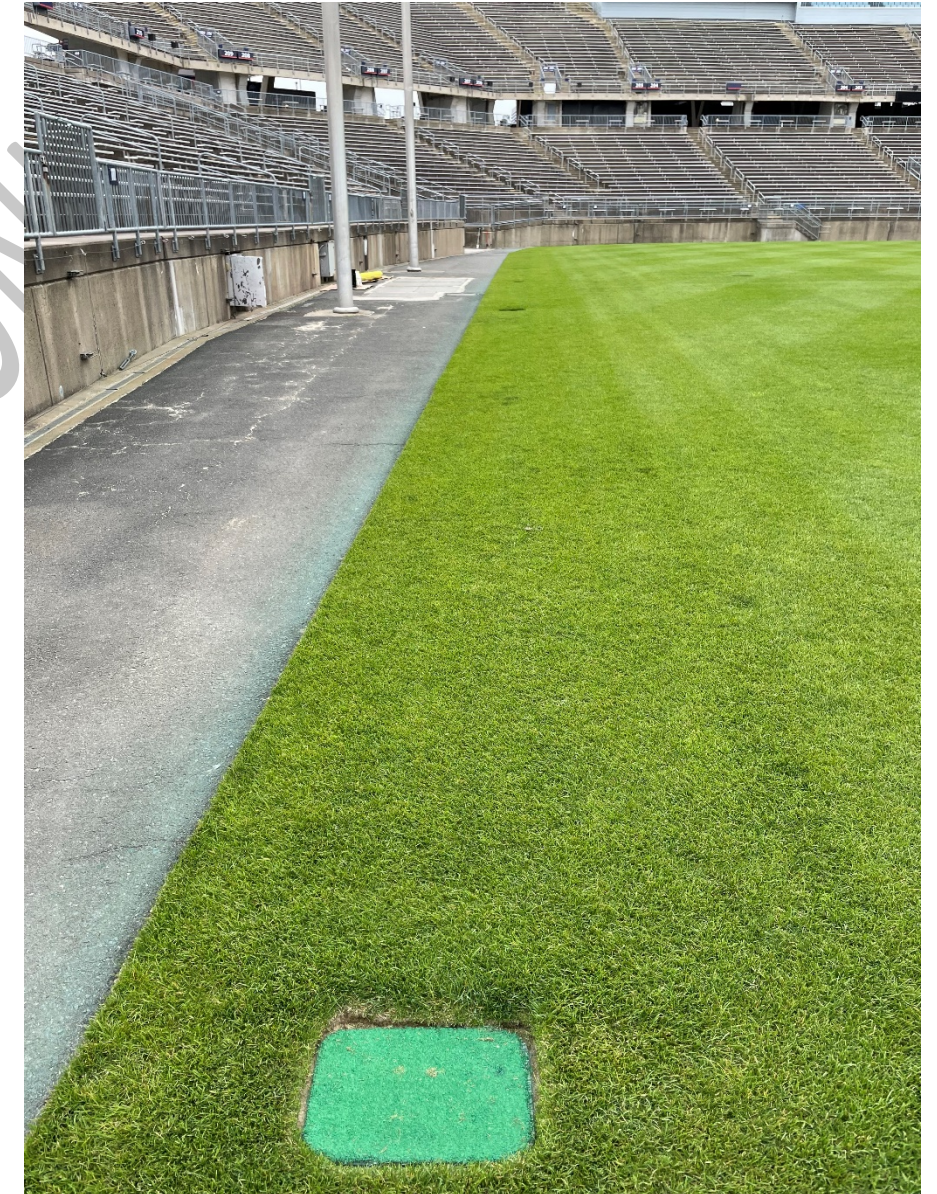
Existing irrigation and subdrainage enclosures within turf area

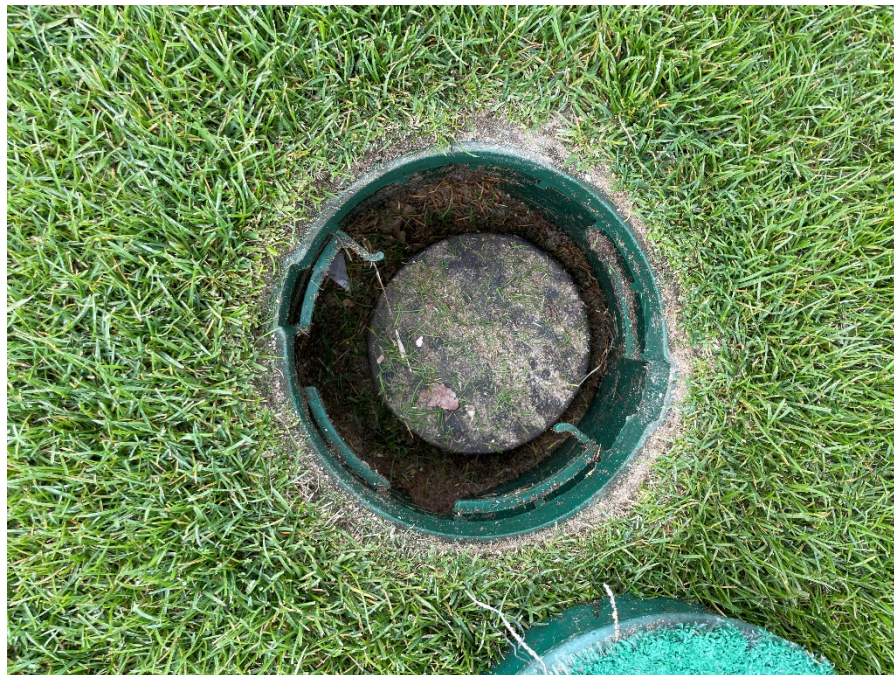
Existing subdrainage cleanout within turf area

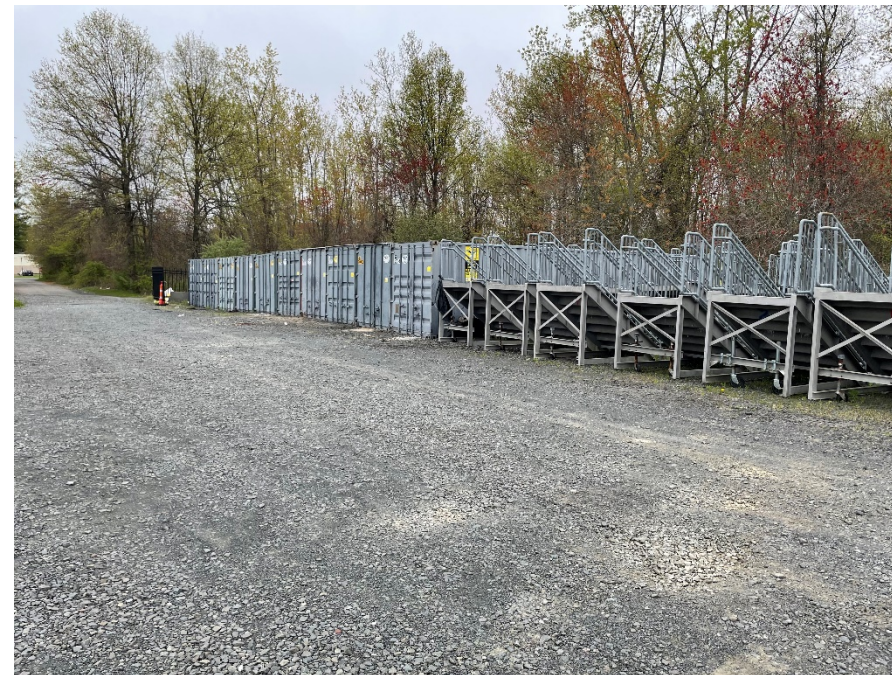
Existing satellite grounds storage area

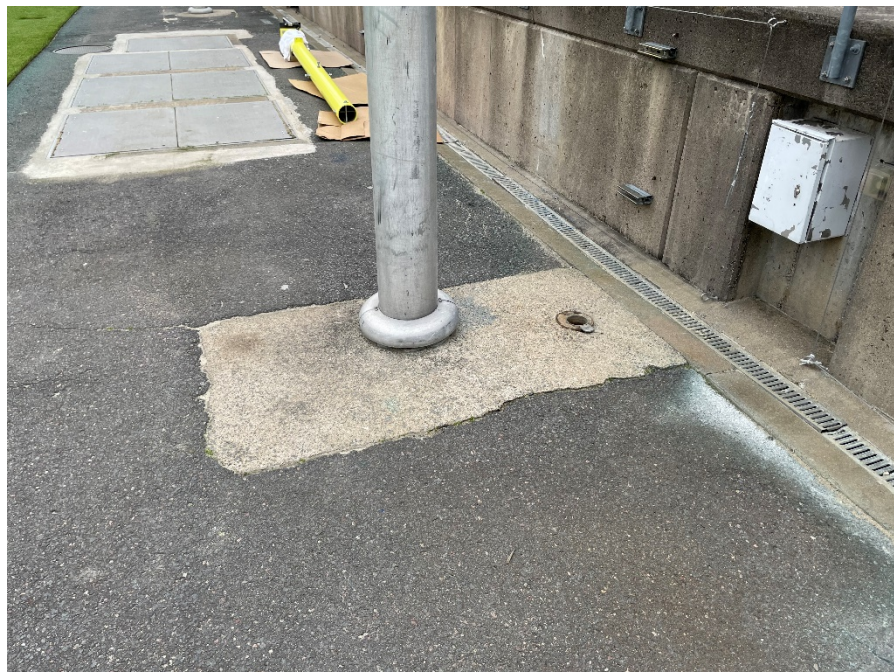
Existing netting post footing
