# **Comprehensive Building Assessment** Rentschler Field at Pratt & Whitney Stadium

Capital Region Development Authority

Populous was engaged by the Capital Regional Development Authority (CRDA) to provide a comprehensive building system assessment for Pratt & Whitney Stadium at Rentschler Field that benchmarks the current condition of the facility. As part of the assessment, Venue Solutions Group, in partnership with the consultant team, has developed a 20-year capital expense matrix to assist the CRDA in establishing priorities for major repairs, potential upgrades and maintaining the facility in a professional manner. The ability to plan and maintain the stadium as it transitions from years 19 to 30 is crucial in extending the life of the facility as well as its relevance in the competitive and ever evolving regional and national marketplace.

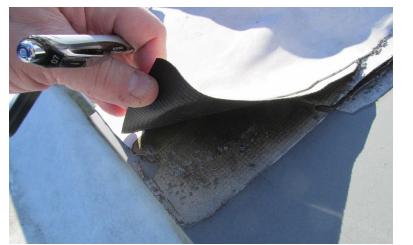
TPO membrane, at ends of an expansion joint cover, is loose/detached/ non-watertight.

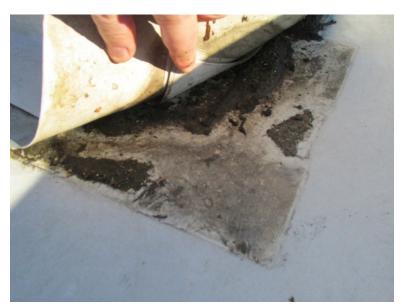
TPO membrane base flashings surrounding an equipment curb are delaminated from the roof membrane, and non-watertight.

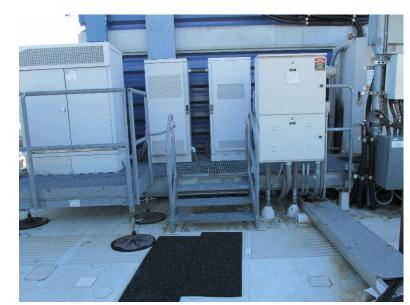
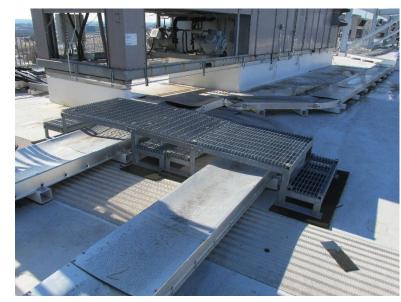
A labyrinth of telecom equipment/cabling is installed atop the Tower Building roofs. The equipment is installed, operated, and maintained by several independent cellular carriers, and much of this equipment is installed directly atop the surface of the roof covering system, often with little or no protection of the roofing/flashing membrane.

Cable trays transverse the main roof on the Tower Building in several areas, impeding access to areas of the roof and other rooftop equipment.

2. Tower Building: Coordinate with all telecom carriers with equipment/cabling on the roofs, for temporary removal/reinstallation of their equipment from the roofs, so as to provide full access to all areas of the roofs, for removal/replacement of the roof covering systems. Completely remove the existing roof covering systems, including all membrane, insulation/underlayments, sheet metal flashings, etc., down to the concrete roof deck. Make all necessary repairs to any damaged/deteriorated roof deck/ substrates. Allow the concrete roof deck to properly dry, prior to applying new insulation/roofing materials. Make repairs to the existing drainage elements or remove/replace the roof drains/overflow drains. Install a new roof insulation assembly, to meet current codes for thermal efficiency and wind uplift. Install a new single-ply membrane roof covering system that is fully-adhered to the roof insulation assembly/substrate, and to comply with current wind uplift requirements. Install all new prefinished sheet metal flashings associated with the roof replacement. Design and install new fall protection equipment (that may also include reinstallation of exiting equipment, to meet current codes/safety requirements. Install safety/fall protection equipment, to comply with current codes/regulations.

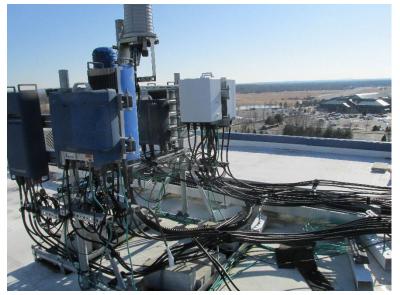
Much of the east elevator penthouse roof surface is covered with telecom equipment.

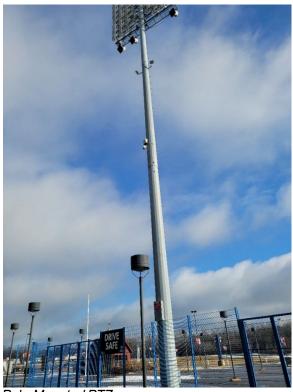
Pole-Mounted PTZ camera

The video surveillance has been updated over the years in an ad hoc manner. It is comprised of both analog and IP-based cameras of which 18 of the 35 cameras on site are not currently functioning properly. This is due to either damage to the camera or cabling infrastructure to the camera. The parking lot cameras, which were installed in 2016, are configured as a "wireless-mesh" network and do not have reliable connectivity to the building network for monitoring. The four pole-mounted PTZ cameras are utilized the most, however they are mounted approximately 25'-30' above grade and sway with the light pole to which they are affixed causing visibility and imagery issues.

- 2. Recommend manufacturer consolidation and replacement of cameras. At the stadium, this work would include camera replacement and physical cabling plant replacement as required. For the parking lot areas, this work would include new pole-mounted cameras, new exterior underground raceways, new composite fiber optic cable plant, as well as new combination POE/Media conversion equipment.

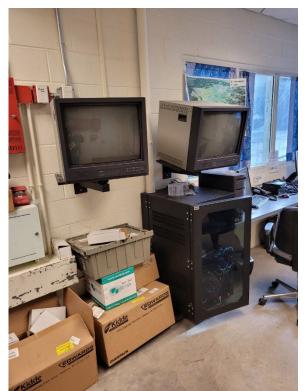
Room Security/Fire CMND S113 monitors

Also, there is no active video recording system for surveillance, which poses an issue in operational functionality. Room Security/Fire CMND S113 houses the original camera monitoring system, however the monitors are no longer in use. Also, an existing PC operated Veracity Coldstore video surveillance storage recorder is located within IDF 5B. however it is outdated and not used in daily operations.

- 1. Recommend replacing video surveillance system management and adding new Network Video Recording (NVR). This scope of work would include the replacement of existing equipment, software, licensing, as well as providing new physical cabling plant as required.

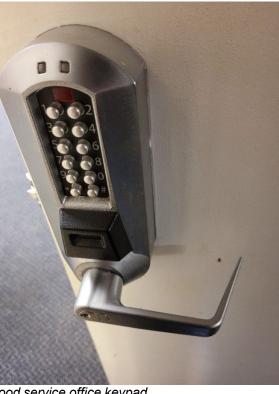
Food service office keypad

The access control system is original (2003) and used as a local means of access and not monitored. Lobby elevators on floors one and two have readers intended for "after hours" access, however they do not appear to be functioning allowing access at any time. The primary locking system is done through a "master" physical key. The facility maintenance contractors, police, and fire department all have physical master keys as means of access. The main offices for food service access are via a stand-alone non-networked keypad doorknob.

- 5. Recommend adding intrusion detection at (2) locations with safes and at concession stands around concourse.
- 6. Recommend replacing access control panels, card readers, door switches, cables, and monitoring as the existing systems age exceeds the recommended "endof-life" cvcle.

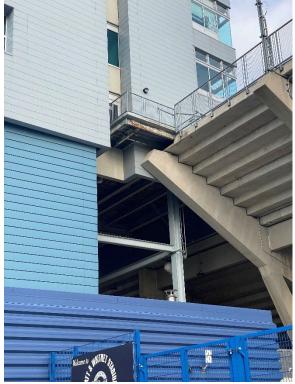
Club Level stair landing is showing signs of rust and water damage.

South/east exterior club level stair landing and exit door bowl facing; the steel support is showing rust and deterioration of concrete and sealant joints

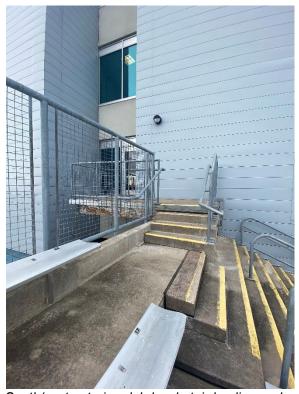
South/east exterior club level stair landing and exit door bowl facing; the steel support is showing rust and deterioration of concrete and sealant joints

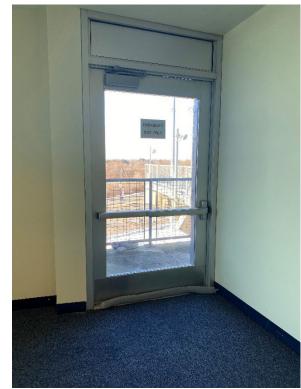
Exit door has air gaps to exterior at SE Club Level

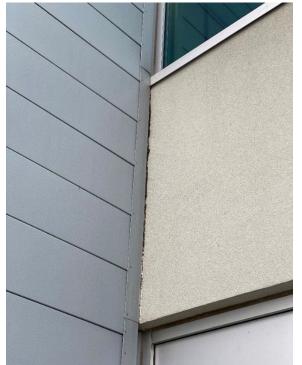
Above SE Club Level Exit -gap at exterior finish system most likely allowing water to infiltrate.

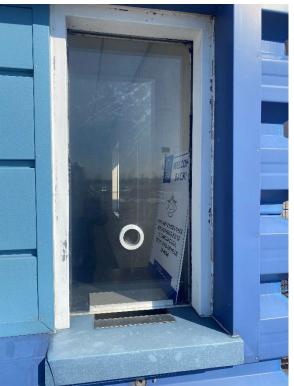
Ticket window at end of life.

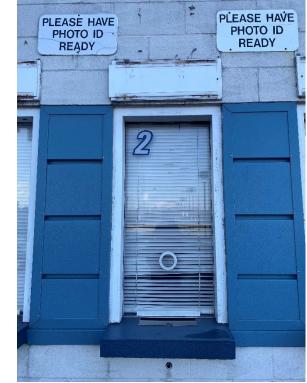
Ticket window at end of life - rust observed; window shades at end of life

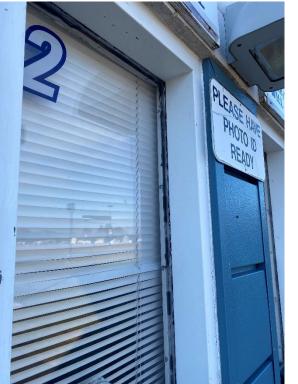
Windows are rusted, rotting and sealant and signage is deficient

Determine current ticket office requirements; windows are rusted, rotting and sealant and signage is deficient and at end of life

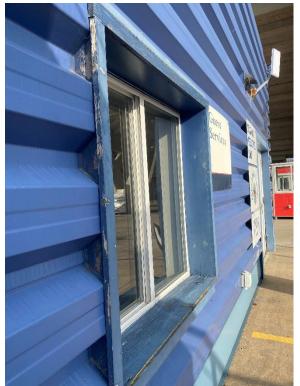
Guest Service window- wood is rotting and paint is faded

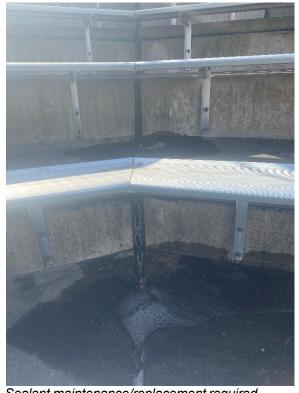
Sealant maintenance/replacement required

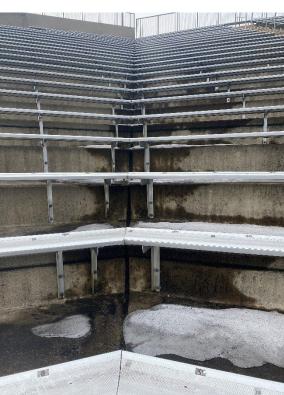
Sealant maintenance/replacement required

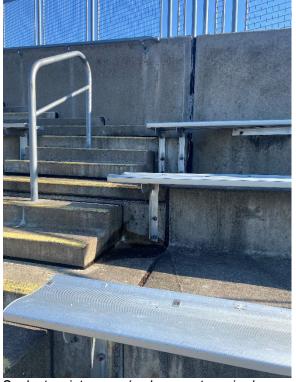
Sealant maintenance/replacement required

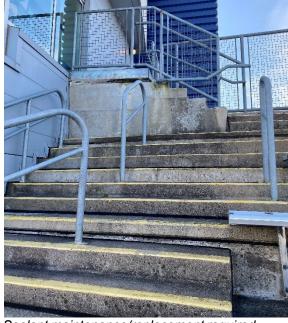
Sealant maintenance/replacement required

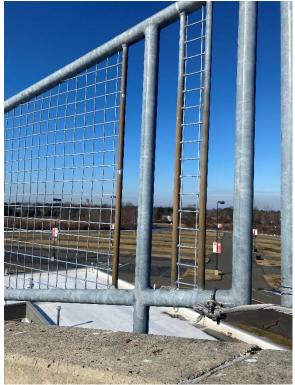
Rust observed on guardrail at back of bowl

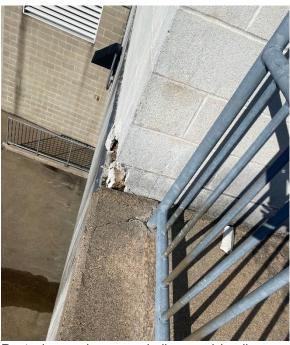
Rust observed on guardrail around loading area; damage to concrete masonry above loading dock area

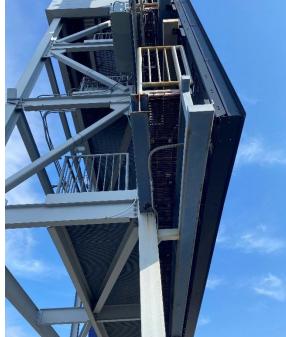
Guardrails and steel rust at scoreboard

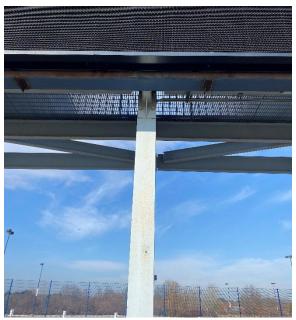
Guardrails and steel rust at scoreboard

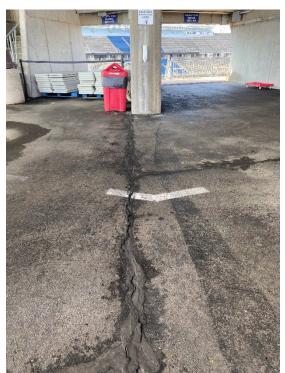
Asphalt crack on concourse

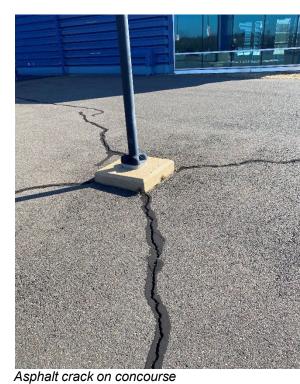
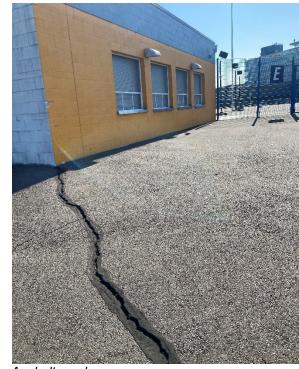
Asphalt crack on concourse

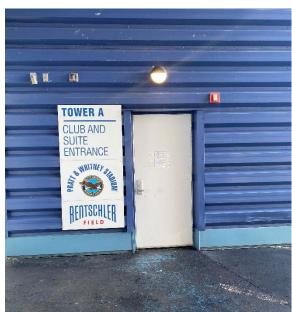
The club entry is currently very underwhelming.

Club Entry and signage need an update

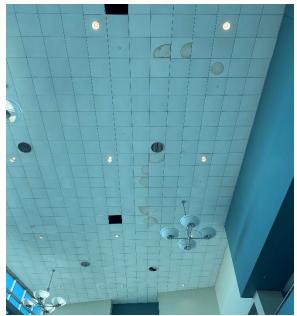
Water-stained ceiling tiles

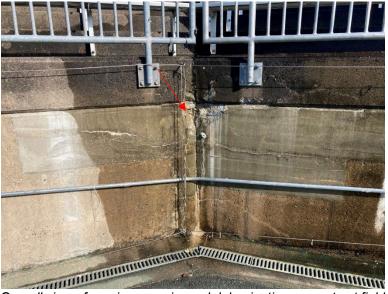
Concrete wall and column cracks at isolated locations throughout the Service Level and Main Concourse as well as concrete wall cracks and delaminations throughout the below-grade field wall with water staining, including failure of previous concrete repairs at some locations. These cracks did not appear to be a result of overloading, but rather a result of differential movements (due to shrinkage and temperature) that are not properly accommodated by the structure.

Overall view of previous repairs and delaminating concrete at field wall

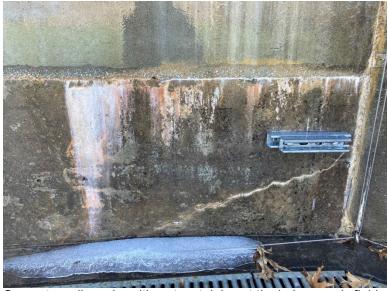
Concrete wall cracks with water staining at the below-grade field wall

Recommendation: Epoxy inject cracks greater than 1/32-inch in width.

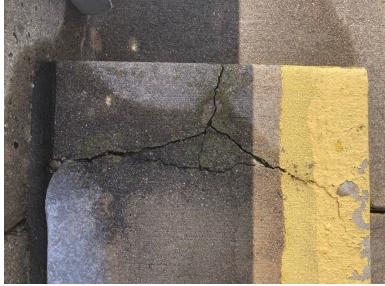
Cracked, delaminated, and spalled concrete steps at • multipole locations throughout Upper and Lower Bowls. Spalled concrete will result in trip hazards.

Cracked and delaminated concrete step in seating bowl (typical throughout)

Recommendation: Replace deteriorated concrete in steps in accordance with ICRI standards.

Alternatively, replace entire step with a new precast concrete step.

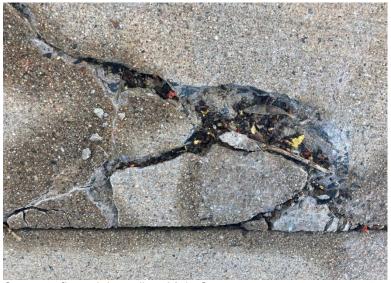
• Concrete floor slab delaminations and spalls at several locations on the Main Concourse. As mentioned above, concrete delaminations and spalls will likely result in trip hazards and will lead to faster deterioration of the concrete elements.

Concrete floor slab spall on Main Concourse near ramp on east end

Recommendation: Replace deteriorated concrete in steps in accordance with ICRI standards.

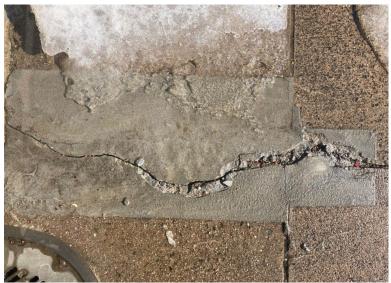
Previous concrete floor slab repair, failed/delaminating, on Main Concourse near ramp on east end

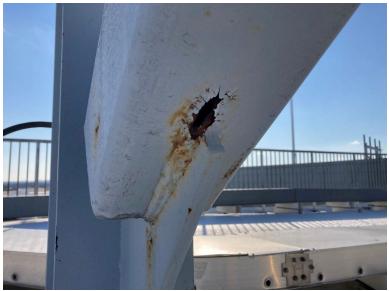
**POPULOUS**<sup>™</sup> Solutions group • Corroded steel framing below Club Level, at Scoreboard, and at Roof Level structures. There was no evidence of significant section loss due to corrosion.

Corroded steel framing at Roof Level canopy

Recommendation: Clean and recoat structural steel with evidence of corrosion.

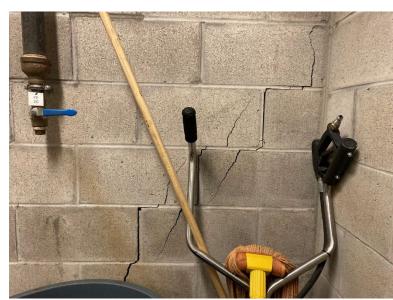
Evidence of settlement through step cracking at CMU wall near transition referenced above (within storage area of Restroom)

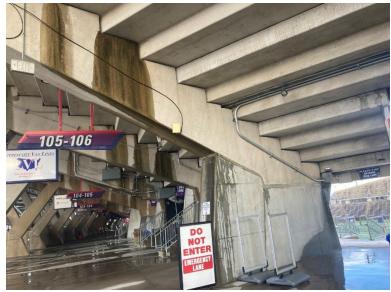
• Active water is leaking below the Upper Bowl throughout the Main Concourse. The active water leaking is a result of failed sealant at the horizontal and vertical joints between the precast seating units, and failed expansion joint. Water penetration through the joints may lead to accelerated deterioration of the concrete elements

Active water leaking from upper bowl to main concourse (typical throughout)

Recommendation: Replace failed sealant joints and expansion joint systems.

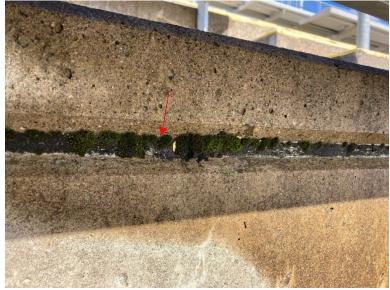
Deteriorated horizontal precast joint sealant (with vegetation growth) at upper bowl (typical throughout)

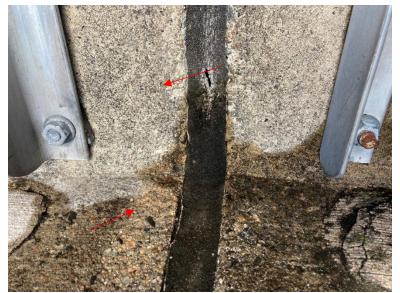
Deteriorated vertical precast joint sealant at upper bowl (cohesive and adhesive failure - typical throughout)

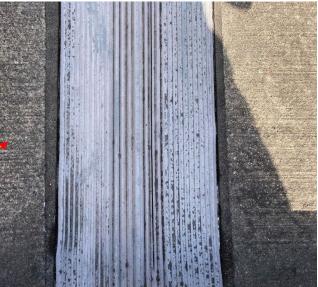
Deteriorated expansion joint at upper bowl (adhesive failure, typical

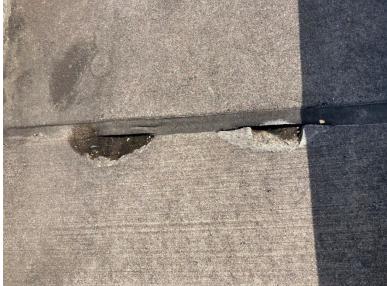
• Deteriorated joint sealants at control joints throughout Lower Bowl.

Deteriorated joint sealants in lower bowl (typical throughout)

Recommendation: Replace failed sealant joints and expansion joint systems.

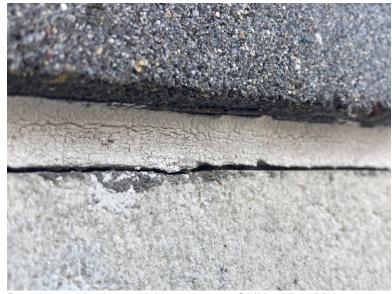
• Deteriorated joint sealants on CMU walls on Main Concourse. Deteriorated joint sealants will result in water infiltration through the walls.

Deteriorated horizontal joint sealant on CMU wall on Main Concourse (typical throughout)

Recommendation: Replace deteriorated joint sealants.

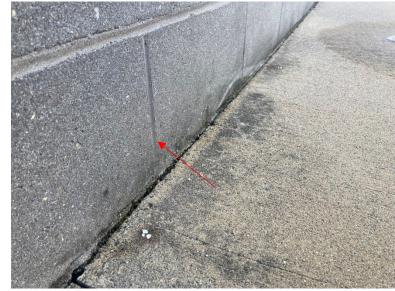
No cove joints installed on Main Concourse above Service Level at base of Concession and Restroom walls

Recommendation: Install cove sealants.

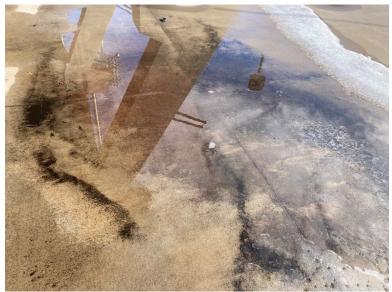
• Evidence of water ponding at isolated locations on the Main Concourse. Ponding water may result in trip hazards in the winter due to freezing water. In addition, it may lead to accelerated deterioration of the concrete surfaces.

Active water ponding and staining on Main Concourse near east end

Recommendation: Provide concrete wash to properly slope slab towards drains.

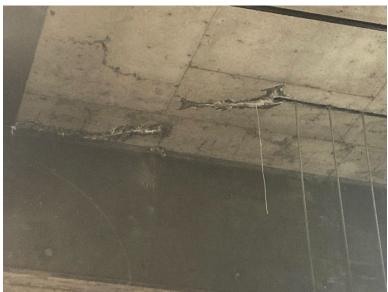
• Overhead concrete slab cracks and overhead construction joints with efflorescence staining throughout Service Level in Rooms S107, S108, S109, and in tunnel/hallway areas. Properly sealing any cracks on level above will limit water intrusion through concrete slab.

Overhead concrete slab crack with efflorescence in Room S108

Recommendation: Rout and seal slab cracks above.

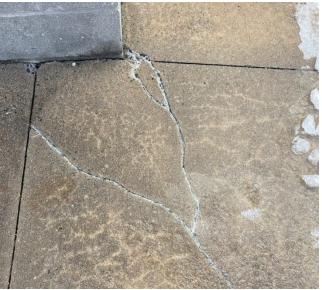
• Concrete cracks on elevated floor slab of Main Concourse, above the Service Level. Cracks in the concrete slab may lead to water infiltration into lower levels and may also lead to future delaminations of the concrete.

Concrete cracks in elevated slab on Main Concourse above Service

Recommendation: Rout and seal slab cracks.

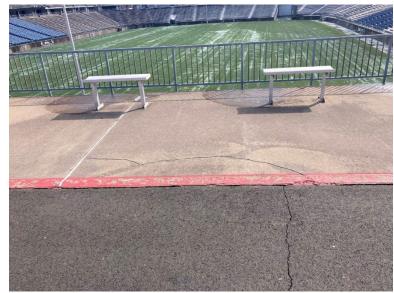
• Cracking of slab-on-grade concrete slab and asphalt pavement on the Main Concourse.

Slab-on-grade cracking on Main Concourse near scoreboard on west end (typical throughout)

Recommendation: Rout and seal cracks in pavement that exceed approximately 1/8-inch to avoid potential trip hazards.

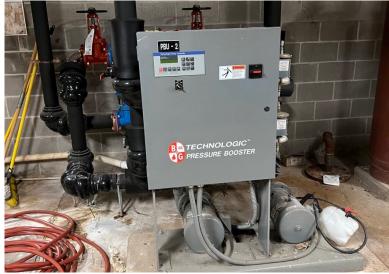
Domestic Booster pump not in use

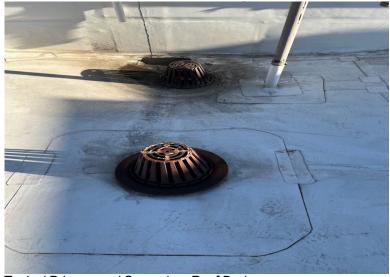
The building is equipped with a primary and secondary overflow scupper system where necessary. All primary storm water drainage piping is routed down through the building to discharge city storm sewer. All secondary overflow scupper spill to daylight. The ceiling in levels below appear to have leaks from the roof. Overall, roof drainage system appear to be in good condition.

Ceiling leaks from roof above

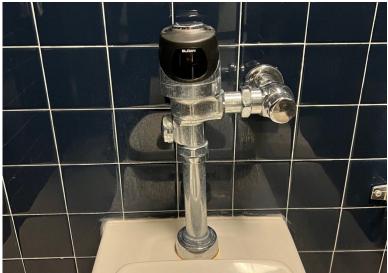
Overall, plumbing fixtures appear to be in good condition. Sloan Sensor Flush Valves were referred as constant maintenance. The failure can be caused by water quality, high water pressure or manufacturer assembly.

Typical Sloan Flush valve

- 1. Recommend removal of booster pump not in use. The current mechanical room appears to be congested; removal of pump would allow for clear floor space.
- 2. Recommend replacing sensor valves with manual valves or installing different manufactured valves at different areas of facility to test for failure.
- 3. Recommend replacing all hose bibbs at field level.
- 4. Replace grease interceptor at Club level with similar "Big Dipper" provided at concessions. We also recommend using New Age cast iron pipe or similar product for future p-trap replacements. The piping product is epoxy lined and would greatly increase the life of the fitting.

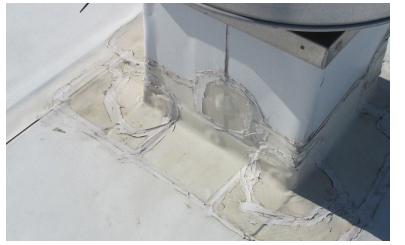
When the 2020 overlay roof covering systems were installed (Buildings 1, 3, and 9), the original TPO membrane parapet and curb flashings were left in place, and new self-adhering membrane was turned up vertically onto curbs, and flashed with a strip of self-adhering flashing membrane. Edges of the flashing membrane are caulked with elastomeric sealant.

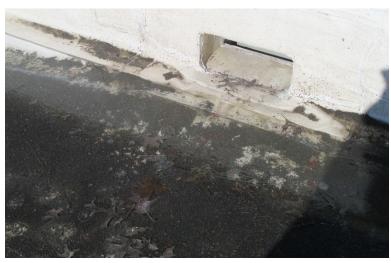
When the overlay roof covering systems were installed in 2020, some deficiencies that existed in the original TPO roof covering system were left in place, and covered over with the new EPDM membrane system, such as through-wall scuppers not being properly sumped below the surface of the roof membrane (photo above). As a result, the roof continues to retain water at the scuppers.

As a result of through-wall scupper openings not being sufficiently sumped below the surface level of the roof membrane, water is ponding on the roofs around many of the scuppers. Water retention on roofs can potentially cause premature deterioration of the roofing/flashing

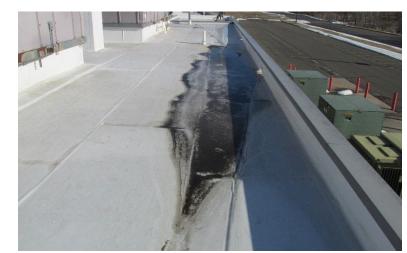
Through-wall scuppers (Buildings 1-7 and 9) are not properly sumped below the roof surface level and, as a result, water is retained (ponding) on the roof at many of the scuppers. This deficiency was not corrected when the new overlay roof membranes were installed on Buildings 1, 3, and 9, and can contribute to premature aging of the roof covering system.

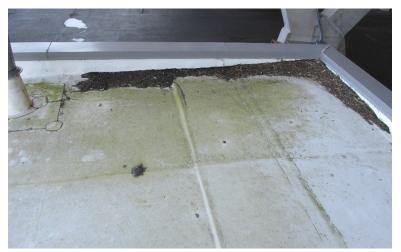
It was noted that the height of the parapets along the up-slope roof perimeters does not meet the minimum industry-standard height of 8 inches above the finished roof surface.

Perimeter parapets, along the up-slope perimeters of some roofs, do not meet the minimum industry-standard height of 8 inches above the finished roof surface. As a result, water/snow/ice may enter beneath the metal coping, potentially damaging the roof covering system and structural/interior elements below.

When the roof covering systems are replaced (Buildings 2 and 4-8), it is recommended that, in lieu of simply recovering the roofs (and existing deficiencies) with a new single-ply membrane system, the existing roof covering systems be completely removed, down to the concrete roof deck, that any necessary repairs be made to the roof decks/substrates, and installation of all new TPO single-ply membrane roof covering systems be installed. It is also recommended that the new roof covering systems include correction of existing deficiencies, such as lowering through-wall scuppers to provide positive drainage of the roofs, raising parapets to the minimum height of 8 inches above the finished roof surface.

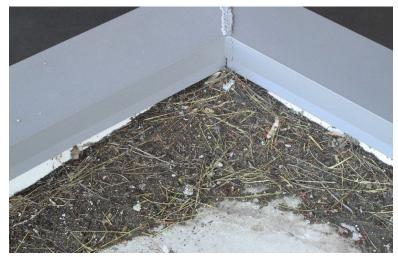
The parapet height in this corner appears to be no more than 5-6 inches, less than the minimum industry-standard 8 inch height.

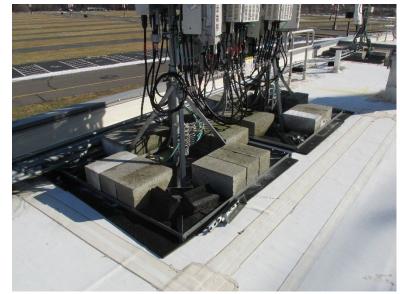
Supports for many pieces of telecom equipment, and associated cables and conduits, are surface-mounted on the roofs. Most equipment is placed atop some type of protection course, such as walk pads or an additional layer(s) of membrane, to protect the underlying roof membrane from damage. It was noted that some equipment or cable/conduit supports lack any type of protection course, or the protection

Numerous roof areas have telecom equipment that is mounted onto a support frame that is installed atop the roof surface. Typically, some type of protection course, such as walk pads, rubber padding, or extra plies of membrane are installed beneath the equipment/support frames.

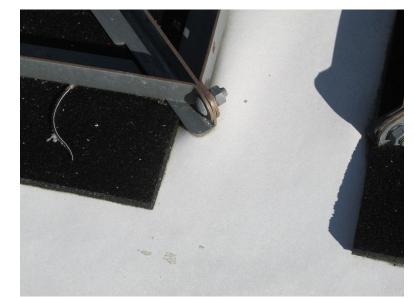
This support frame for rooftop telecom equipment is not properly placed atop the protection mat and, as a result, part of the steel frame is bearing directly on the surface of the roof membrane, potentially damaging and/or puncturing the roof membrane.

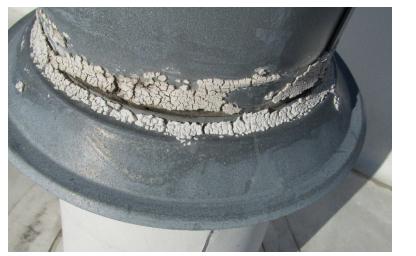
It was generally noted that many sealant joints, associated with rooftop equipment and flashings, are deteriorated, and some are not watertight. It was also noted that existing sealants are more severely deteriorated around flashing membrane terminations and metal storm collars on metal flue stacks ("hot pipes"); it is possible that common sealant materials are utilizes around the flue stacks, rather than sealants that are formulated to withstand the high temperatures of metal flue stacks.

Sealants surrounding some roof penetrations, such as metal flue stacks, are severely deteriorated and non-watertight. Flue stacks and other roof penetrations that reach high temperatures typically require sealant materials that are specifically formulated for high-temperature applications.

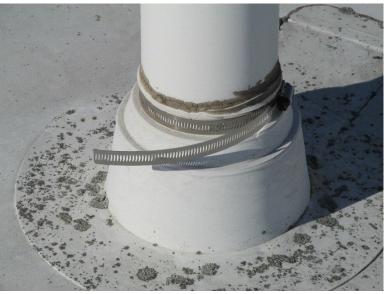
Pipes, conduits, and other round items that penetrate the roof are flashed with a premanufactured TPO flashing boot that is heat-welded to the roof membrane, and terminated at the top with a metal draw band and an application of elastomeric sealant. The existing sealant on some roof penetrations is poorly installed and/or deteriorated, and potentially nonwatertight.

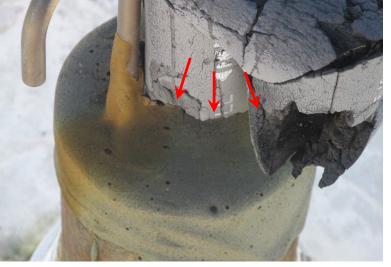
It appears that some type of elastomeric sealer/coating material is applied around this insulated roof penetration/flashing. It appears that the sealant is not properly bonded to the roof penetration insulation, and does not appear to be watertight (see arrows).

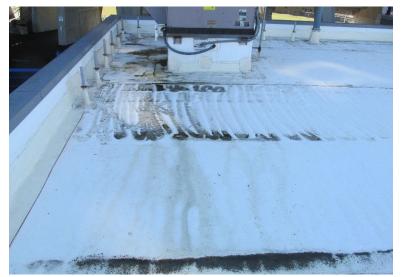
Building 1: There are several wrinkles in the roof membrane, and some areas where it appears that the roof membrane was not properly embedded in the adhesive at the time of original installation. The wrinkled membrane can impede the flow of water to the drainage elements, and is also vulnerable to damage from foot/equipment traffic on the roof, and if the wrinkled membrane is not properly adhered, and may potentially become susceptible to wind uplift/damage.

The EPDM overlay roof membrane (Building 1) is significantly wrinkled in this area. This area of roof membrane generally appears to have been improperly installed.

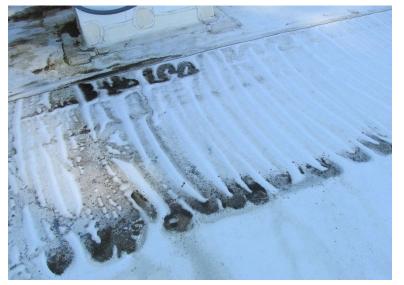
It appears that the wrinkling in the overlay roof membrane (Building 1) is the result of a workmanship deficiency during installation, and/or the roof membrane/adhesive being installed at a time when atmospheric conditions were not suitable for roofing application.

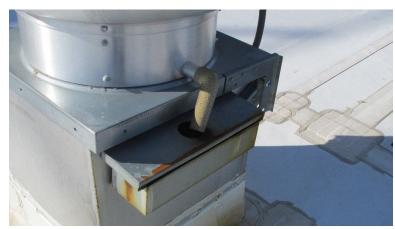
Building 3: Rooftop exhaust fan units above cooking areas (such as kitchens for concession stands) typically are equipped with collector systems for kitchen grease, to help prevent food grease contamination of the roofing materials surrounding the fan unit. Kitchen grease can potentially damage the roofing/flashing membrane. It was observed that the grease collector on one such exhaust fan is improperly installed/aligned, and may allow grease onto the roof surface.

The outflow pipe for the kitchen grease collector on this rooftop exhaust fan is displaced (Building 3), potentially allowing grease contamination/ damage to the roof membrane.

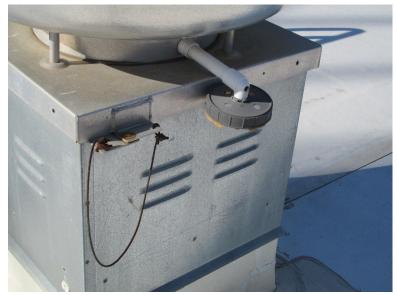
Another rooftop exhaust fan above a concession stand kitchen is equipped with a grease collector; however, the container (presumably some type of screw-on plastic receptacle) is broken/missing. As a result, kitchen grease may drop directly onto the roof surface, causing damage to the roofing/ flashing membrane.

This type of rooftop exhaust fan is typically fitted with a container/receptacle to hold the kitchen grease effluent; however, the grease receptacle appears to be broken or missing from this fan (Building 3).

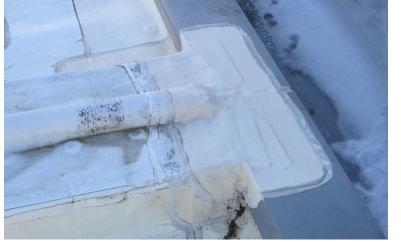
A membrane expansion joint cover is installed over an opening where two parapets meet. The expansion joint cover appears to be fabricated of single-ply membrane that is adhered to a foam backer rod spanning the expansion joint opening. The flashing membrane is not extended fully across the perpendicular parapets at the ends. The flashing membrane is vulnerable to delaminating from the painted metal coping.

The flashing membrane atop an expansion joint cover is terminated on a flat surface atop a metal parapet coping (Building 3); however, the membrane is not extended over the edge and onto the face of the coping, so as to shed water from stop the membrane.

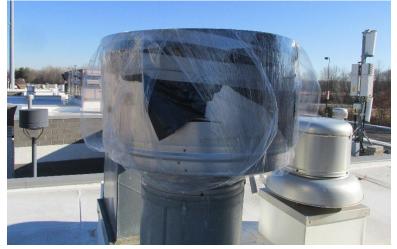
Building 6: A metal flue stack is apparently leaking or otherwise faulty, and is covered with polyethylene sheeting. The exact deficiency could not be determined.

A metal flue stack (Building 6) appears to be leaking moisture or is faulty in some other manner, as evidenced by it being covered over with polyethylene sheeting.

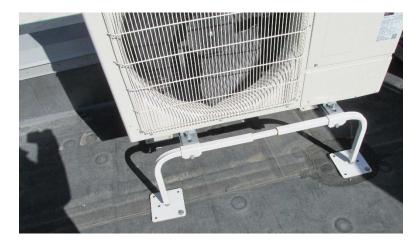
A steel support frame for a rooftop mechanical unit is installed directly atop the (unprotected) surface of the EPDM roof membrane, and secured with screws installed directly through the roof membrane. There is no sealant or other means to waterproof the fastener holes through the roof membrane and, as a result, the roof is non-watertight in this area.

Flanges of a steel support frame, for a rooftop mechanical unit, are installed directly atop the (unprotected) surface of the EPDM roof membrane, and secured to the roof with screws installed directly through the roof membrane. There is no sealant or any other means to protect the fastener holes from moisture infiltration/leakage (see next 2 photos).

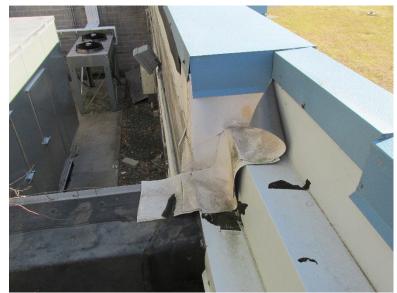
A section of TPO flashing membrane is loose/detached/nonwatertight, at the junction of parapets/walls along the south building perimeter (Roof Area 8-D). It appears likely that the membrane may have never been properly adhered to the substrates at the time of original installation. It was also noted that this section of membrane appears to be TPO; however, the adjacent roof covering system is constructed with EPDM membrane, which is incompatible with TPO, unless the TPO were to be simply adhered (rather than heat-welded) to the EPDM membrane.

A section of TPO membrane is loosely installed in a corner at the junction of a wall and two perpendicular parapets (Roof Area 8-D). The TPO membrane is not adhered in place, and is not watertight. The roof covering system on this area utilizes EPDM membrane, which is not compatible with TPO for heat-welded seams.

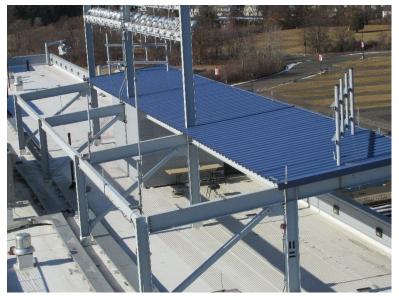
The Video Platform Canopy is constructed above the main roof of the Tower Building. The roof utilizes steel framing, a fluted metal roof deck, and a pre-manufactured, pre-finished metal panel roof covering system.

The existing metal panel roof covering system on the Video Platform Canopy Roof generally appears to be in fair-to-good condition. There was no visible damage to the metal roofing panels, nor was there any visible rusting or deterioration of the paint/coating on the metal panels.

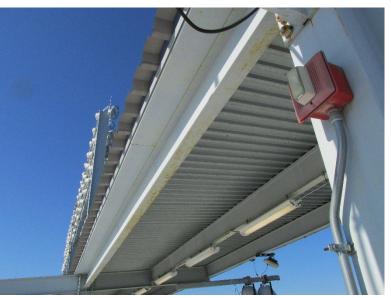
The underside of the Video Platform Canopy Roof shows the fluted metal roof deck (to the right), and the metal panel roof covering system (to the left).

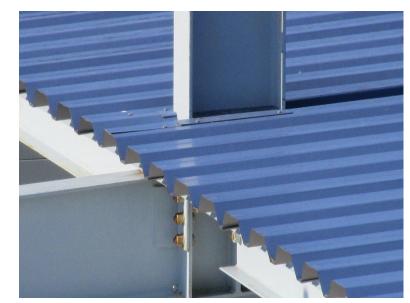
The paint/finish on the top surface of the pre-manufactured metal panel roof covering system generally appears to be in fair-to-good condition. There was no visible rusting or deterioration of the metal or the paint/finish.

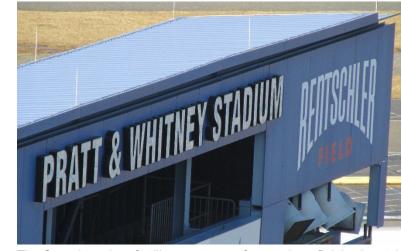
The Scoreboard roof utilizes pre-manufactured pre-finished metal roofing panels that are mechanically fastened to the roof framing.

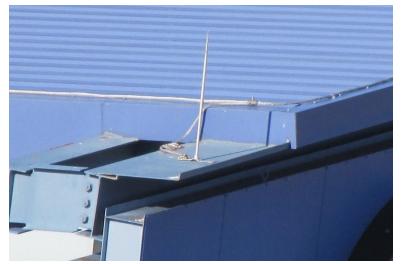
The paint/finish on the Scoreboard roof generally appears to be in fair-togood condition. Based upon a visual observation from a distance, there is no visible rust or other damage to the metal panel roof covering system.

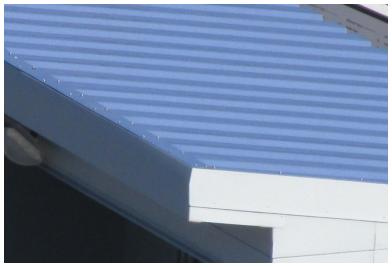
As viewed/photographed from a distance, the existing paint/coating on the Video Booth roof generally appears to be in fair-to-good condition, and no rusting, damage, or other deficiencies were noted.

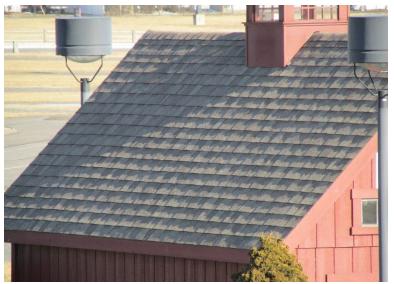
The asphalt shingle Radio Broadcasting Building roof generally appears to be in good condition. The roof has a steep slope, to shed water. There were no visible deficiencies.

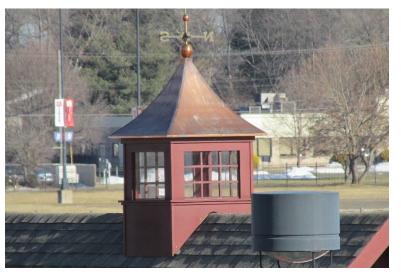
The metal-clad cupola, at the center of the Radio Broadcasting Building roof utilizes a copper roof covering system. The cupola and copper roof generally appear to be in good condition.

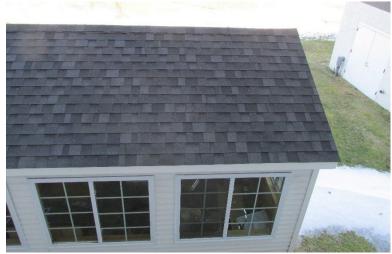
The existing asphalt shingle roof covering system on the Catering Building generally appears to be in good condition, and no deficiencies were noted. It was noted; however, that the roof lacks gutters/downspouts, or any means to control water run-off from the roof surfaces and, as a result, the ground is eroded along a line directly below the roof eaves.

The only item noted that, in our opinion, needs attention, is that the roofs on these two buildings lack gutters/downspouts, or other means to control water run-off from the roofs. As a result, it was noted that the ground surface is eroded along lines directly beneath the eaves of the Catering Building. Shrubbery is planted along the base of the Radio Broadcasting Building so any existing ground erosion there may not be readily visible.

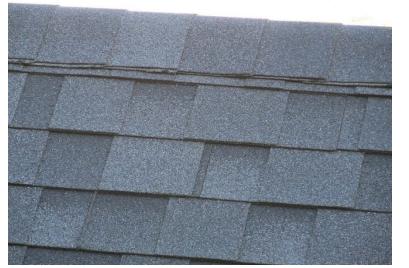
The asphalt shingle roof covering system on the Catering Building generally appears to be in good condition, and it is believed that the building/roof have been in place for approximately 3-4 years.

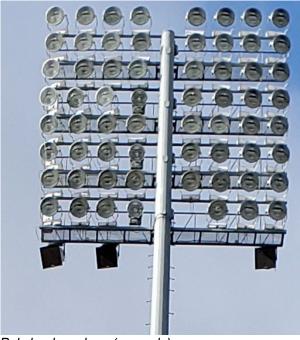
Pole loudspeakers (example)

During our bowl walk, we noted several high frequency driver or cross over issues for one or more loudspeakers at the press box (section 239), and at the light poles covering sections 130, 211, 212, 233. Several loudspeakers at the scoreboard covering the deck area appear to have high frequency loss (not totally failed).

- 1. Repair defective existing bowl loudspeakers until full replacement can be done.
  - a. If the fidelity and performance of the current bowl loudspeakers (in good repair) are adequate to stakeholders and patrons, then new, updated versions of the loudspeaker product would be a cost effective solution.

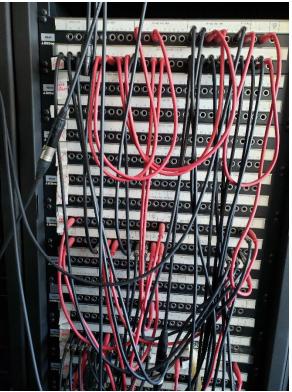
The audio patch frame has development significant signal crosstalk, making sections of it unreliable.

Aging audio patch frame

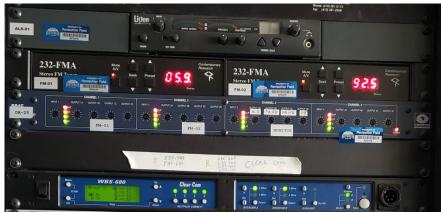
The FM transmitting equipment near the audio patch frames causes interference and should be relocated.

Poorly located FM transmitting equipment

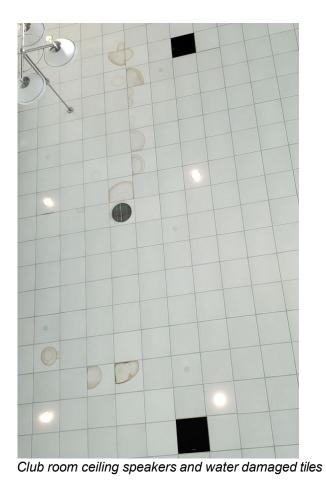
In the main club room, the three large ceiling speakers provide clear speech and good music quality but aesthetically don't blend with the ceiling. There are a series of water-stained ceiling tiles near the loudspeakers. We were unable to inspect the loudspeaker enclosures for any water damage.

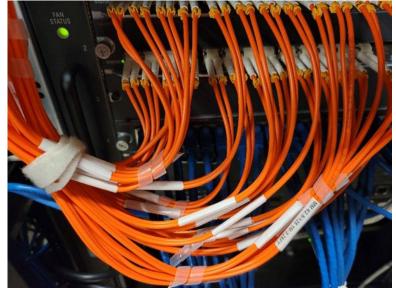
Being a legacy OM1 multimode cable plant, it limits the entire information technology system to 1GB ethernet. Most similar stadiums operate at 10GB minimum. The 5e horizontal cabling is also another legacy item that limits the capability of connected devices such as IP cameras, network interface cards, and wireless access points.

OM1 fiber optic cabling

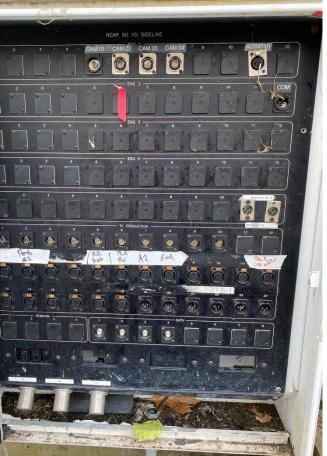
• The outdoor broadcast boxes have suffered years of moisture penetration and lack of appropriate operation in opening/closing of the protective doors. The interior of most of the boxes are corroded, rusted, and littered. The only connections that might be used are some of the analog audio connections.

Representative outdoor broadcast box position

It is recommended that the cable plant (cabling, connection, and enclosures) be replaced and upgraded to meet modern broadcasting requirements and remove the requirement for a TV truck to run their own cabling in a temporary fashion.

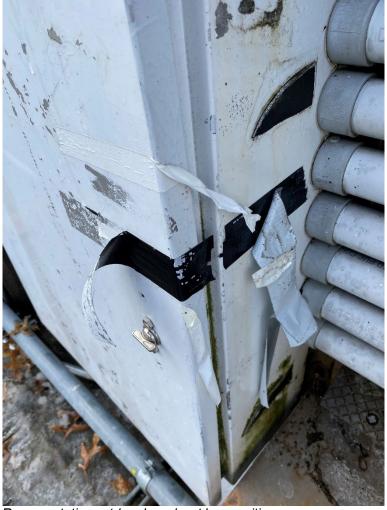
Representative outdoor broadcast box position

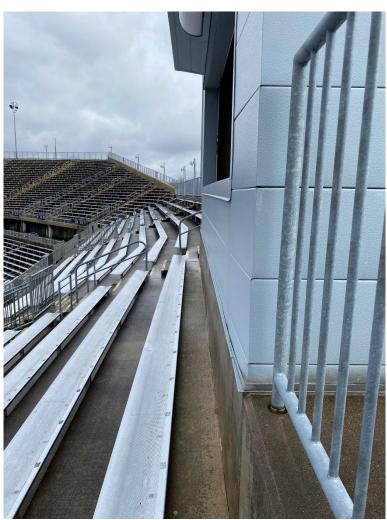
- While the conduit infrastructure supporting the broadcast cable plant is sufficiently sized, there is no cable tray at the Press Level broadcast booths. This is typically seen on most stadium projects for efficiency, flexibility, and ease of adding temporary cables.
- The high east broadcast booth likely experiences inadequate camera shots when patrons are standing. Standing on the bleachers would block camera shots.

High east camera position

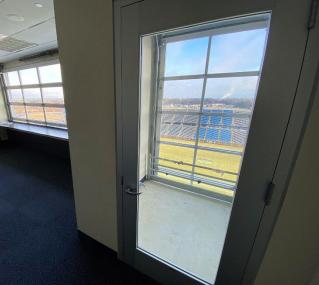
• The main follow camera position is undersized. It is unable to support more than one camera. A typically sized high 50-yard line position will be wide enough to accommodate five positions. Any camera position wanting to be in a main follow position is relegated to the roof which is a different camera angle. At minimum, the main follow position should handle a game follow, tight follow and in-house production position. Those relegated to the roof are two (2) coaching cameras, All-22, in-house and one of the game or tight follow. The roof position is a unique method for accommodating manned cameras. A covered platform and canopy slides towards the parapet. No camera tie downs, and railing was observed. This appears to be a potential safety hazard.

Main follow camera position and broadcast booth

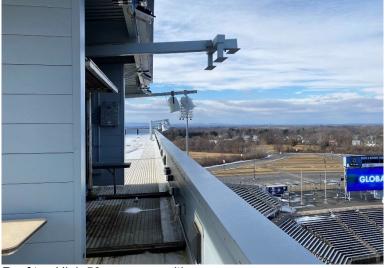
Roof top High 50 camera position

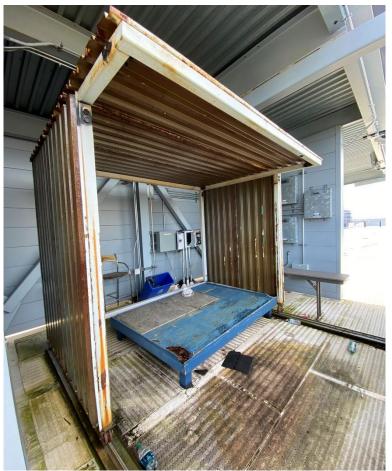
Roof top high 50 camera position

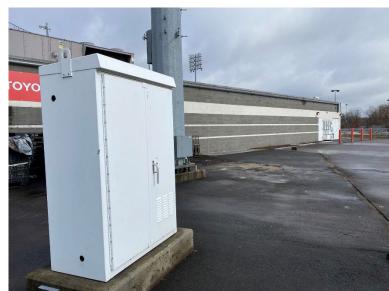
- The TV Announce Booth is not very secluded and secure and offers the potential of noise penetrating the space from the press dining area. It also shares space with the instant replay booth.
- The ENG pedestal at the truck parking area is not used, opening the possibility of removing in lieu of offering more space in the plaza.

Unused ENG pedestal at truck parking plaza

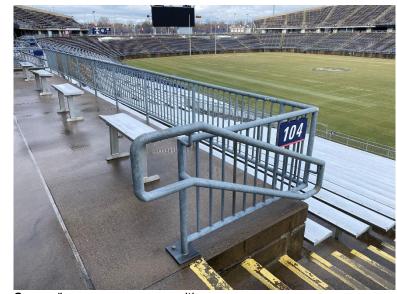
Soccer/Lacrosse camera position

• When hosting soccer and lacrosse events, broadcasters set up camera positions on raised platforms along the concourse due to the inadequacy of the current camera positions in the facility. This causes seat kill (including ADA seating) and possible congestion along those areas of the concourse. There is no power and camera cabling, so all of that is run on a temporary basis.

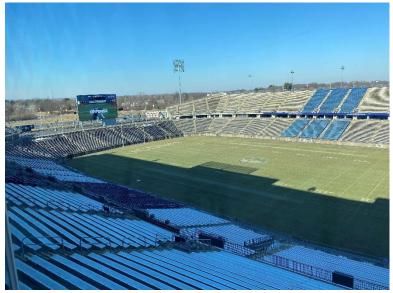
The bowl seating is predominantly aluminum bench seating that is attached to the vertical face of the bow risers. There are a few sections where the bench was warped/bent from abuse and need to be replaced.

Overall view of seating

- 1. Recommend ongoing maintenance program for expansion joints and sealants.
- 2. To improve comfort and elevate the fan experience of stadium, the bench seating should be replaced with seats with backs. This will reduce the seat count of the overall stadium. While there is certainly usable life left in the bench seating, consideration for replacement and a replacement schedule should be studied and implemented.

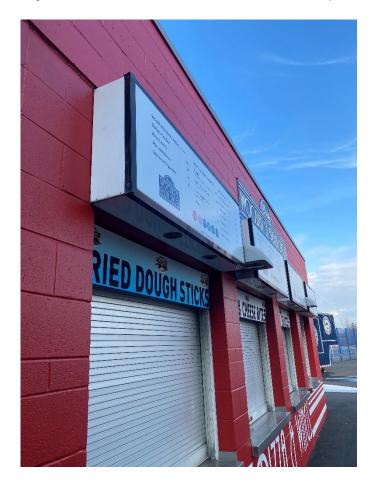
The concession on the main concourse had unique branding for each concession that offered various food options to patrons. The menu boards are fixed menu signs that are back lit above the POS stations. The menu boards are static and are not easily updated and should be replaced. It was observed that coolers are installed on the concourse adjacent to most concessions in full view of patrons.

- 3. Recommend new wayfinding signage for club seating.
- 4. Recommend an upgraded POS system, menu boards and some updates to concession front are recommended to speed up transactions and align with industry best practices. Refer to Food Service portion for additional recommendations related to concessions.

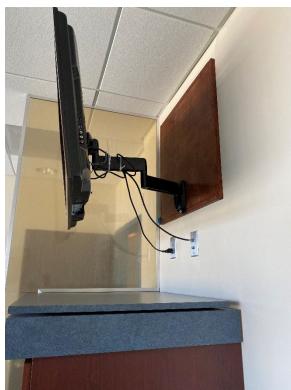
The 46 suites are generally in good condition, but finishes are dated. Carpet and countertops are showing the most wear.

Typical installation of TV's in suites

- 8. Recommend finish updates to suites. A minimal approach would be to replace carpet, countertop, sink, and faucet. The translucent panels are beginning to show signs of UV damage (yellowing) and should be removed. The TV above the coat closet should be relocated to provide a more cohesive solution. Walls to receive fresh paint. Refer to electrical for lighting upgrades that could require ceiling updates.

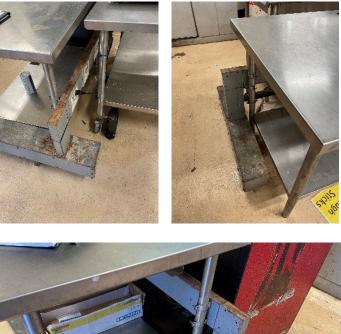
The electrical chases at all the center island tables in all the concession stands are badly rusted as well. These should be painted or sealed to keep water from getting into the electrical components inside.

Sample of rusted electrical chases

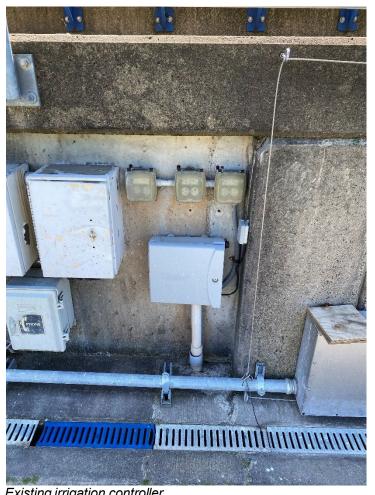
The existing Hunter HCC Hydrawise controller is adequate for the operation of the irrigation system and is Wi-Fi capable, however it is currently placed outside on the field wall and does not achieve strong Wi-Fi signal. It is recommended that

Existing irrigation controller

it be relocated indoors, within the conditioned grounds storage area, where stronger Wi-Fi signal can be achieved. Additionally, it should be converted to a 2-wire function using the Hunter EZ-Decoder system in lieu of the traditional wiring as exists today. This provides for less wire and easier accommodation of expansion should it be required/desired in the future. The existing controller has remote control capability; however the remote control currently does not work, and therefore should be replaced like and kind. A new antenna routing will be required from the new location to the exterior.

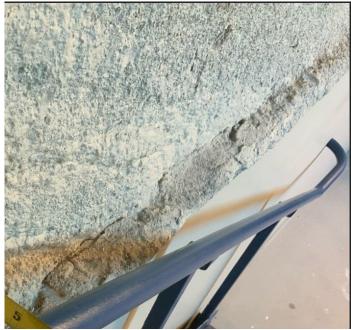
The walls within the enclosed the exit stairs that the handrails are mounted to are not continuously smooth. Per the CSBC, the wall adjacent to the handrail shall be free of any sharp or abrasive elements. The spray foam on the structural steel creates a rough surface and a sharp corner that does not comply with the CSBC.

This is an existing condition and will need to be addressed if a Level 2 or 3 alteration occurs in the area.

Figure 2: Example of wall along railing that is not smooth

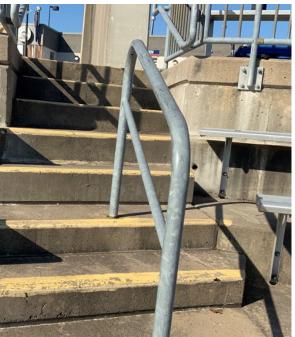
The transition between stepped aisles and stairways is provided with the same marking strip as the remainder of the stair and aisle. The building code requires a marking stripe be provided on the nosing or leading edge adjacent to each transition that is distinctively different from the stepped aisle marking stripe. This is a typical comment throughout the lower bowl.

This is an existing condition and will need to be addressed if a Level 2 or 3 alteration occurs in the area.

Figure 3: Example of aisle transition striping

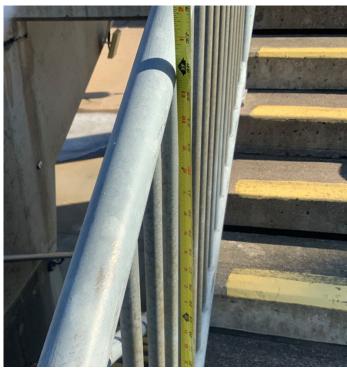
The aisles along the sides of the vomitories are not provided with handrails. This condition is acceptable if provided with a guard that meets the requirements of the building code. It was noted that several instances around the upper bowl where the guards are not a minimum of 42 inches as required by the building code.

This is an existing condition and will need to be addressed if a Level 2 or 3 alteration occurs in the area.

Figure 2: Example of guard along upper bowl vomitory

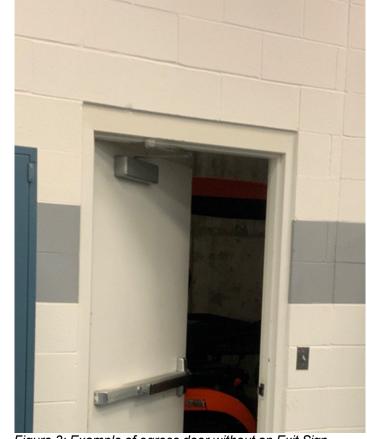
There are a few locations within the locker rooms and corridors where exit signs missing or not readily visible along the egress path.

Figure 3: Example of egress door without an Exit Sign

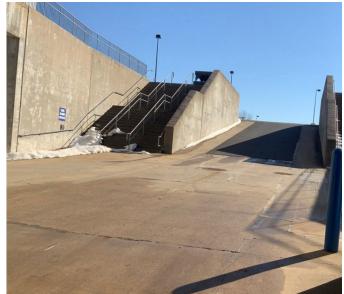
The ramp from the field that leads to the two open stairs appears to be too steep. In accordance with the CSBC, ramps used as a part of a means of egress shall have a running slope not steeper than 1 in 12 (8% slope).

This is an existing condition and will need to be addressed if a Level 2 or 3 alteration occurs in the area.

Figure 5: Ramp leading from field to monumental stairs

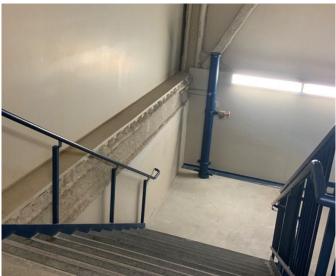
The top of the standpipe stops at the intermediate landing below the roof level. Per NFPA 14, hose connections shall be provided at the highest landing of stairways with stairway access to a roof.

This is an existing condition and will need to be addressed if a Level 2 or 3 alteration occurs in the area.

Figure 8: Top of Standpipe location

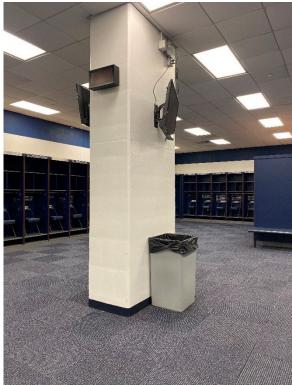
4. The home team locker room is adequate but beginning to show wear. There is a great opportunity to improve the home team locker room branding and elevate the player experience Improvements should include branding features. Replace lockers with the latest locker fabrication and electronic/outlet options, update finishes and fixtures throughout including all wet areas and ancillary. Training area/medical could be reconfigured to better utilize space and add player amenities like small club/lounge space with smoothie bar, etc. The entrance design of the home locker room includes an entry vestibule and corridor to access home locker room. There is another entry to the home locker room that has direct access to the field. Both could be activated with branding to motivate and inspire players.

Existing Home Team Locker Room

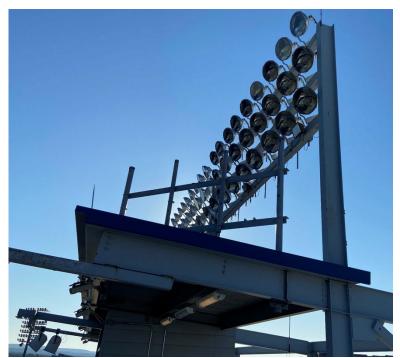
Existing bowl event lighting fixtures are metal-halide and original to the facility. While still operational, these fixtures are nearing end of life and replacement with a new LED sports lighting system would provide enhanced performance with lower energy use, improved controls, and fewer lamp replacements.

Original metal-halide sports lighting
