# **Comprehensive Building Assessment** Rentschler Field at Pratt & Whitney Stadium

Capital Region Development Authority

Populous was engaged by the Capital Regional Development Authority (CRDA) to provide a comprehensive building system assessment for Pratt & Whitney Stadium at Rentschler Field that benchmarks the current condition of the facility. As part of the assessment, Venue Solutions Group, in partnership with the consultant team, has developed a 20-year capital expense matrix to assist the CRDA in establishing priorities for major repairs, potential upgrades and maintaining the facility in a professional manner. The ability to plan and maintain the stadium as it transitions from years 19 to 30 is crucial in extending the life of the facility as well as its relevance in the competitive and ever evolving regional and national marketplace.

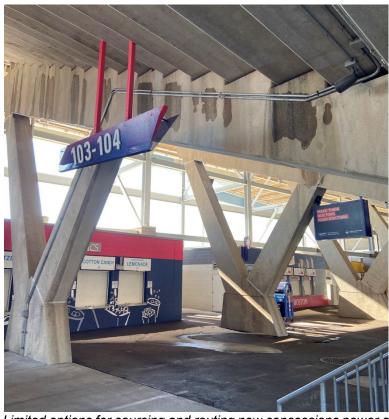
concourse levels

A key limiting factor noted during the facility assessment was the lack of power availability at concourse interior walls. 120V power at these locations is necessary to provide refrigeration and mobile concessions activations as operations move away from keeping ice bins in kiosks. Facilities staff have already been very resourceful in loading up nearby circuits to free up new spares in prior years, but unfortunately the nearby panels have no more available branch circuits. Dealing with the concrete surfaces and large, open-air spans between concessions buildings to the underside of bowl seating is an added challenge.

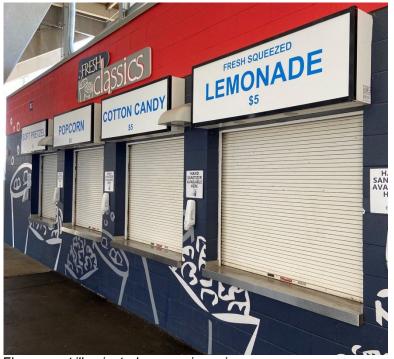
Fluorescent illuminated concessions signage

4. Replace concessions signage with digital monitors.

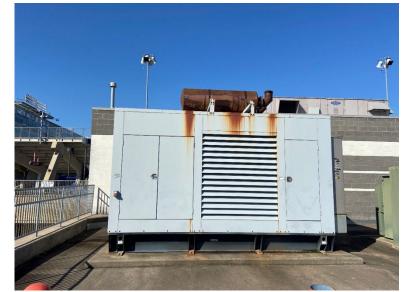
It was noted by maintenance staff that generator testing has not been kept up on an annual basis, as required by NFPA 110.

Unable to access interior of generator enclosure; visible rust runoff from diesel generator muffler on exterior

7. Considering the age of the generator, it is recommended to put in a place a preventative maintenance plan for the facility emergency generator to avoid issues when called upon.

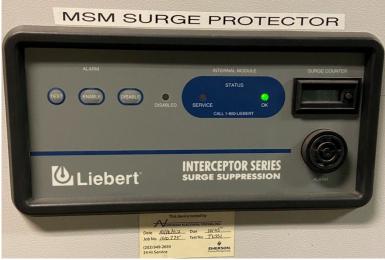
The facility's main utility service entrance switchboards are equipped with surge protection devices (SPDs), and the surge events recorded on switchboard MSM were significantly higher than others. The SPDs are doing their job and protecting the facility, but their lifespan is measured in joules and each surge event reduces the remaining amount of protection. SPD ratings were not able to be visually confirmed during the site visit, but on average, 250kA/phase rated SPDs have a life expectancy >25 years.

6,365 surge events recorded at main switchboard MSM

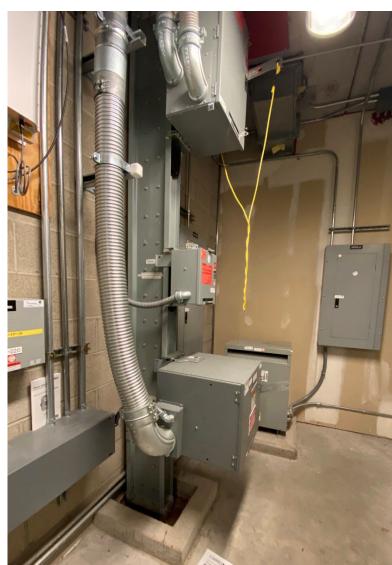
Busway distributes power vertically in the stadium tower.

Recommend including infrared thermal scanning and retorquing of all busway joints (and busplugs) for hotspots as part of annual preventative maintenance and IR scanning of other points in the electrical distribution system (e.g., switchboards).

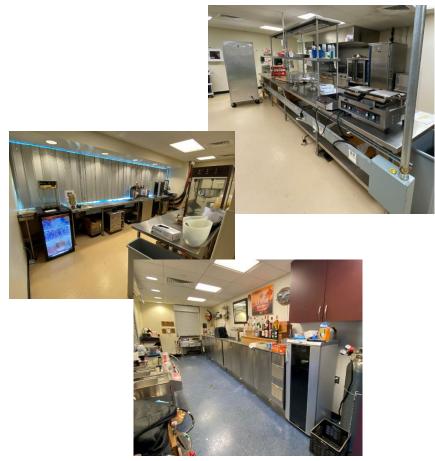
A refresh on the club concession would be good, and it already has a digital menu board. Additionally, something should be done to hide the beverage conduit as it comes down from overhead.

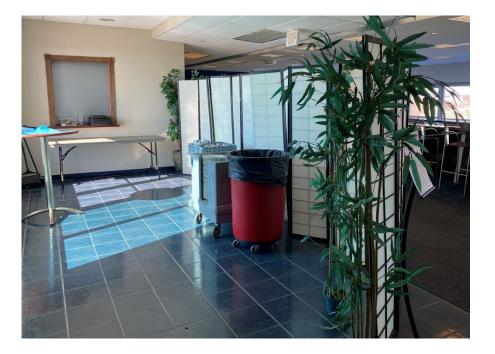
Someone has set up a nice screen partition with some plants to hide what appears to be a staging area for foodservice.

This particular area should really have a wall and door and permanent plumbing fixtures to keep issues with the Health Department at a minimum.

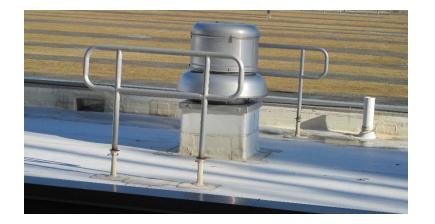
Sections of safety railings are installed adjacent to some rooftop mechanical units, as fall protection (photos above/below); the railings are anchored to metal pipe stanchions that are flashed with EPDM membrane

It is recommended that facility management contract the services of a qualified safety/design consultant in the State of Connecticut to inspect the roofs, project-wide to note existing conditions and to recommend all needed alterations and/or additions to the existing rooftop safety/fall protection equipment, to ensure that the facility is in full compliance with all current OSHA/Connecticut/local building safety codes and requirements.

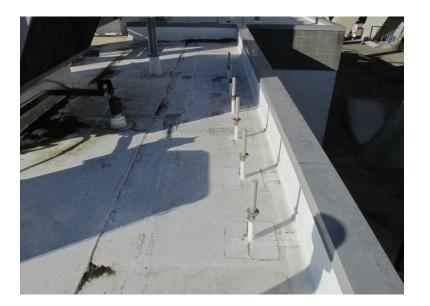
There are numerous rows of metal pipe stanchions, for anchorage of rooftop safety railings on the roofs (Buildings 1-9), that have no safety railings attached (photos above/below)

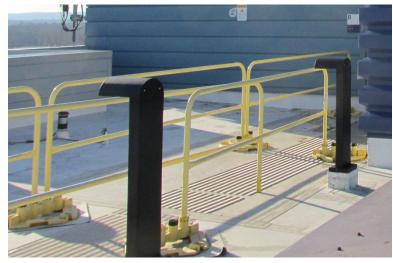
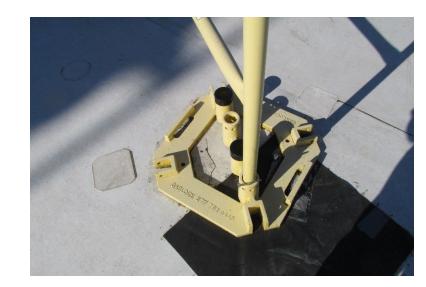
Portable, surface-mounted safety railings are utilized in one area on the main roof of the Tower Building (photo above); the metal pipe rails are attached to heavy steel bases that rest directly atop the surface of the roof membrane (photo below)

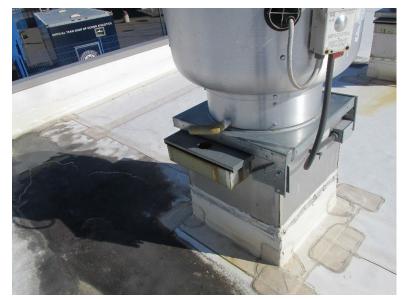
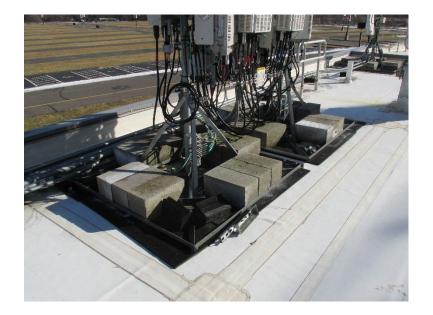
Based upon visual observations of the roofs, including Buildings 1-9 and the Tower Building, there are numerous additional rooftop mechanical units and pieces of telecom equipment on the roofs that are installed in close proximity to roof perimeters, yet they lack any type of fall protection equipment. It generally appears that installers/maintainers of the rooftop telecom equipment have made little or no efforts to place any type of fall protection around their equipment.

Numerous rooftop mechanical units, as well as pieces of rooftop telecom equipment are installed relatively close to roof edges; however, they lack any type of safety railings/fall protection equipment

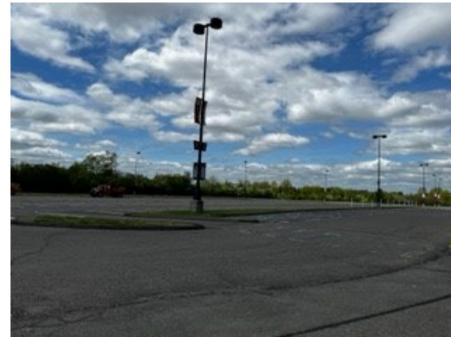
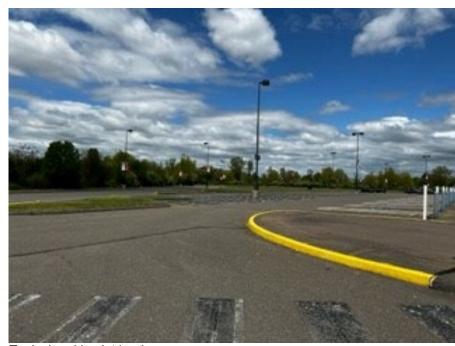
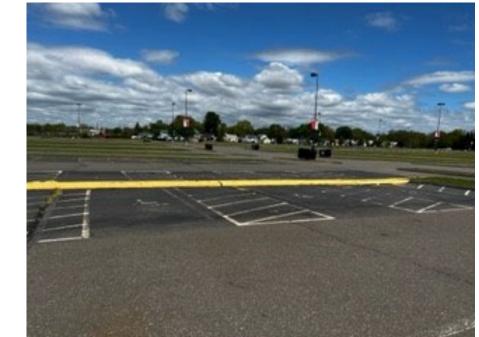
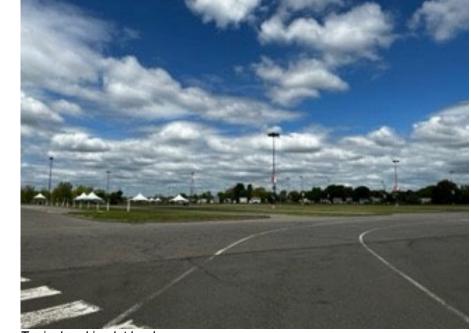
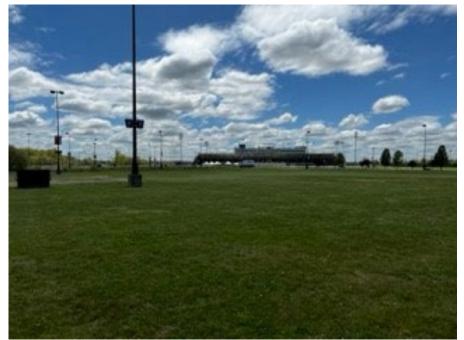
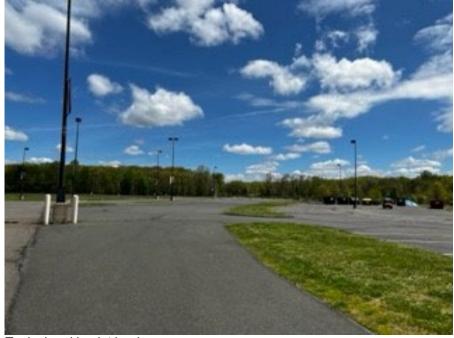
Site Landscaping is non-existent. The entire site, particularly those areas directly adjacent to the stadium, are turfgrass areas that have become overrun with weeds and trampled from pedestrian and vehicular traffic. There are no trees adjacent to the stadium, nor in the parking areas, giving the site the appearance of a barren landscape of weedy turfgrass and pavement.

The site pavement is all asphalt pavement that is significantly deteriorated. Much of the pavement is cracked and needing replacement.

Typical parking lot landscape

We also recommend that shade trees be added within the parking areas and along access drives as to break up the current wide-open space and to highlight the main vehicular paths.

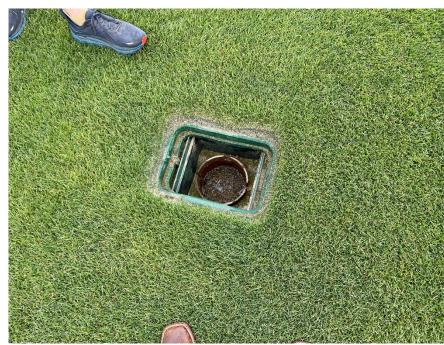
Existing goal post sleeve

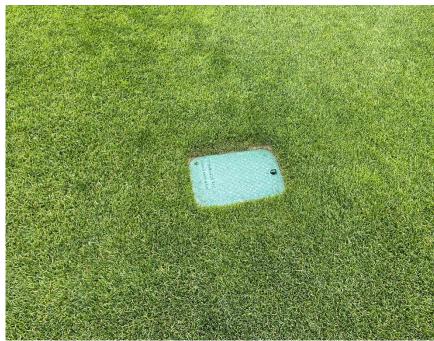
Existing goal post sleeve enclosure

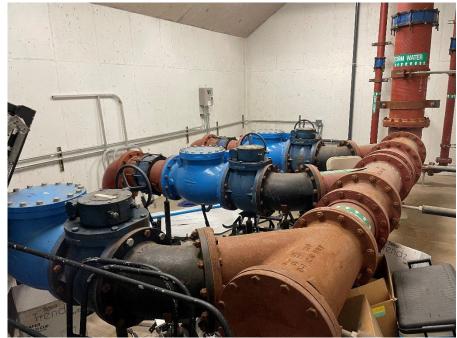
Existing drainage outfall/ejection piping

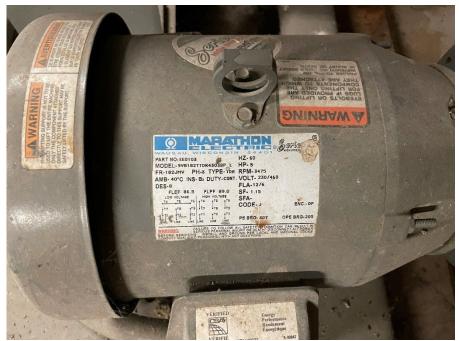
Existing irrigation pump (x2)

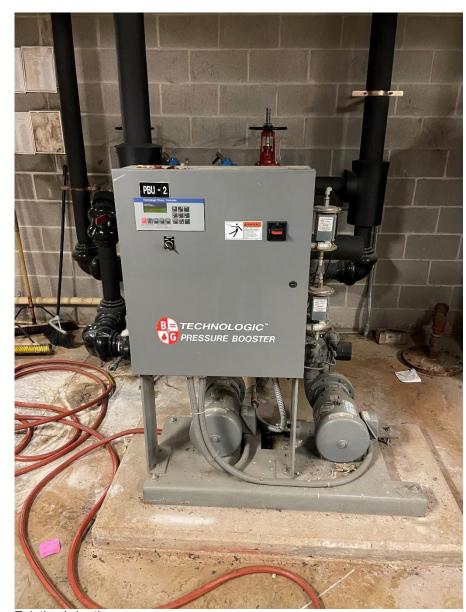
Existing irrigation pump

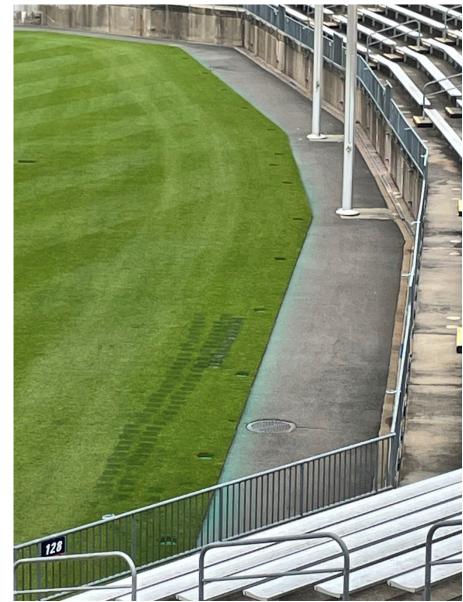
Existing irrigation and subdrainage enclosures within turf area (north)

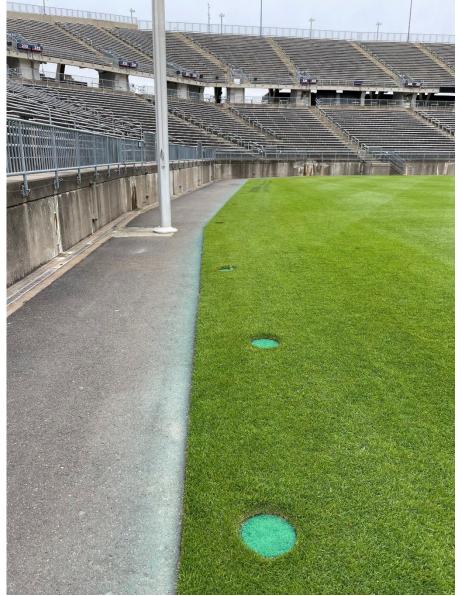
Existing irrigation and subdrainage enclosures within turf area

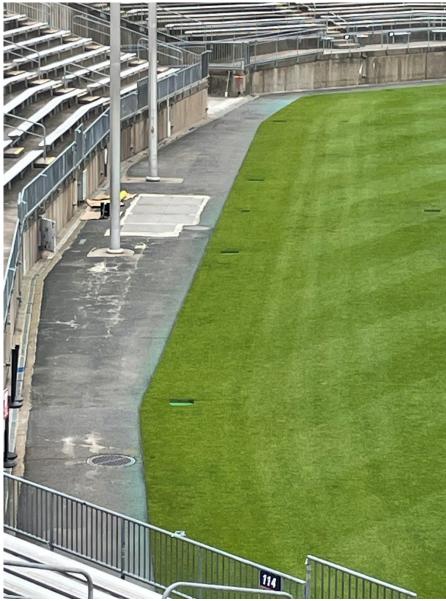
Existing irrigation and subdrainage enclosures within turf area (south)

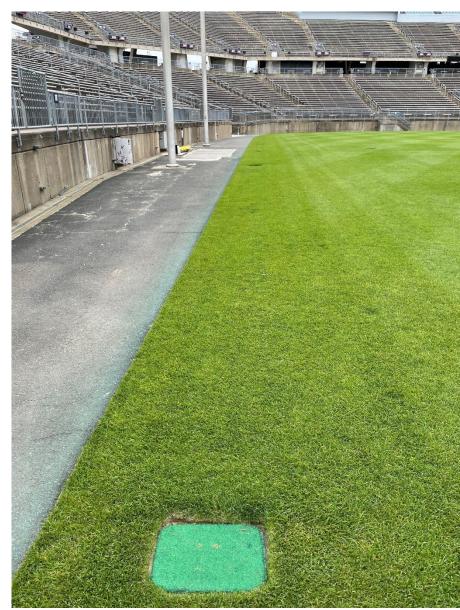
Existing irrigation and subdrainage enclosures within turf area

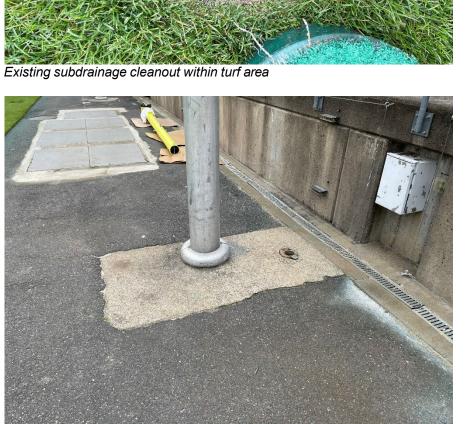
Existing netting post footing

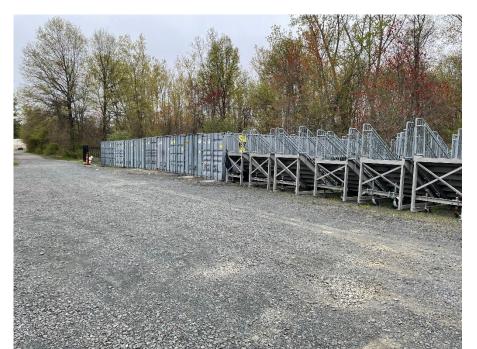
Existing satellite grounds storage area
