# Civil and Exterior Assessment

Rentschler Field at Pratt & Whitney Stadium

September 7, 2022

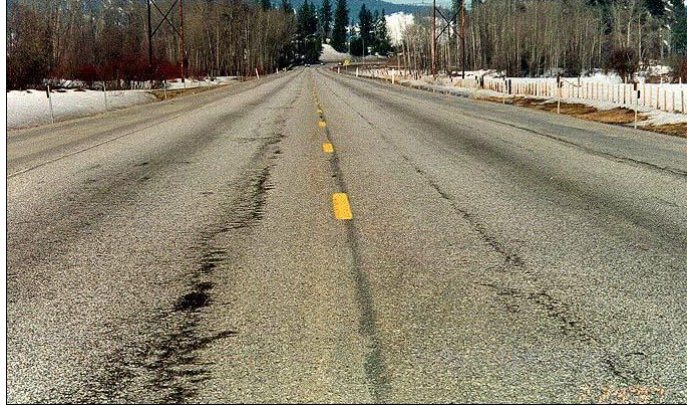
Table 1: Definition of Representative Defects		
Surface Defects		
Raveling	Surface of Hot Mix Asphalt layer begins to disintegrate due to dislodgement of aggregate particles. Potentially caused by loss of bond between aggregate and asphalt binder.

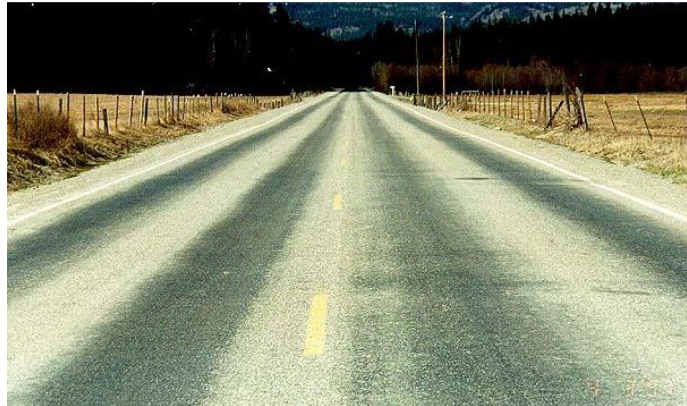
Flushing	Commonly referred to as bleeding. A film of asphalt binder on pavement surface that creates a shiny, sticky surface. Caused when asphalt binder fills aggregate voids in warm weather, and then expands.

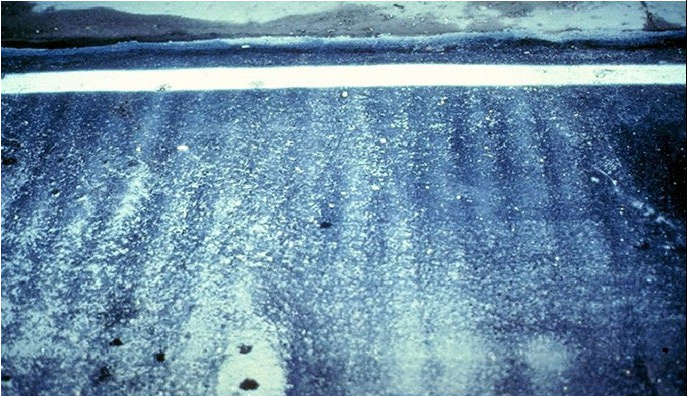
<p>Rippling/Shoving</p>	<p>Formation of ripples across pavement surface, potentially caused by excess asphalt, excess fine aggregate, rounded aggregate, or weak granular base.</p>

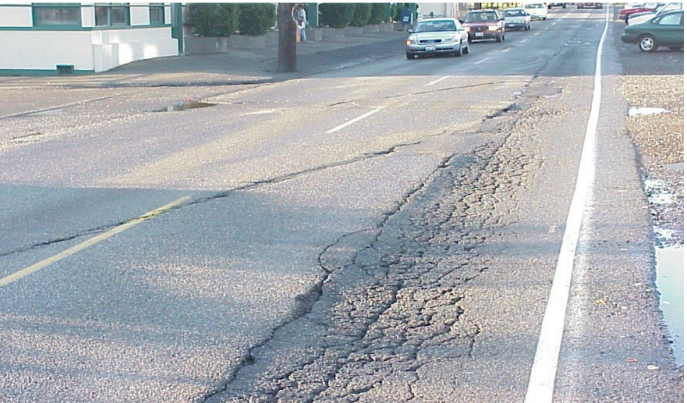
<p>Rutting</p>	<p>Surface depression or deformation in the wheel path. Either Hot Mix Asphalt deformation to cause a rut or subgrade deformation to cause a rut, or both.</p>

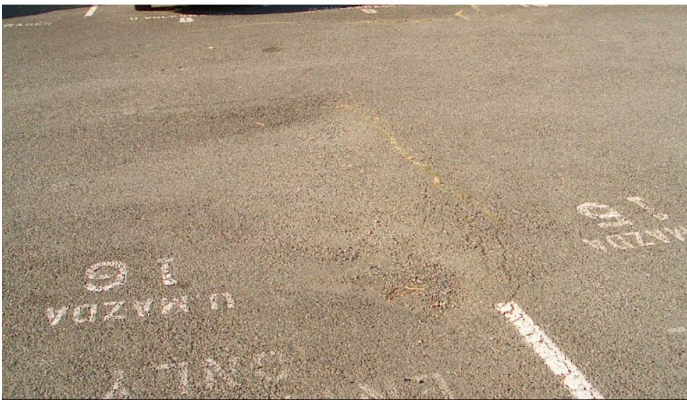
<p>Distortion/Depression</p>	<p>Pavement surface areas with slightly lower elevations than surrounding pavement areas. Potentially caused by frost heave or subgrade settlement due to inadequate compaction. Can cause localized ponding.</p>

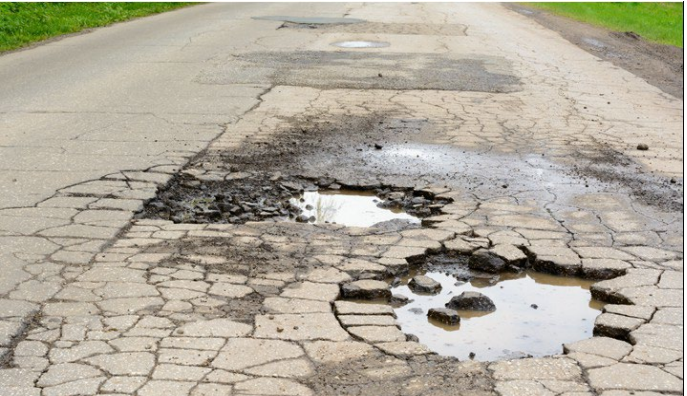
<p>Pot Hole</p>	<p>Small bowl-shaped depressions in pavement that penetrate through pavement section to base course. Caused by fatigue failure of HMA surface (common end result of alligator cracking). Typically exacerbated by winter heaving and snow plowing.</p>

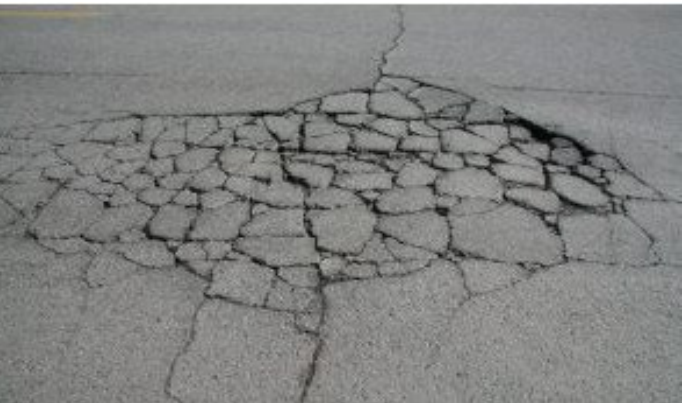
<p><b>Cracking</b></p>		
<p>Alligator Crack</p>	<p>Collection of smaller longitudinal and transverse cracks that create sharp-angled pieces caused by to repeated frequent loading/unloading of the pavement cross section. Also potentially caused by loss of load-carrying capacity due to improper subbase drainage or freeze/thaw issues.</p>

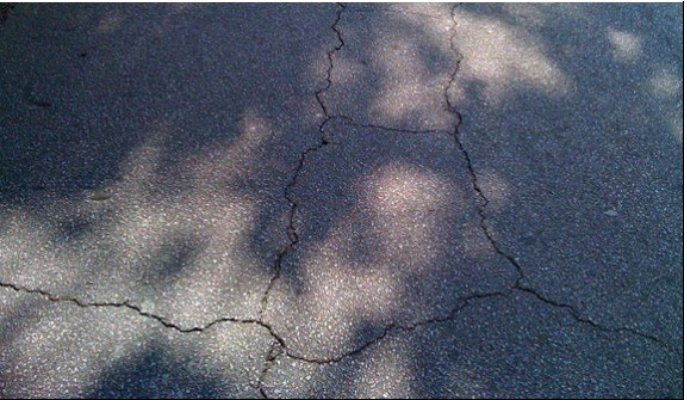
<p>Block Crack</p>	<p>Interconnected cracks that divide pavement into smaller rectangular pieces, potentially caused by hot mix asphalt shrinkage due to asphaltic binder aging (loss of Volatile Organic Compounds that provide pavement elasticity)</p>

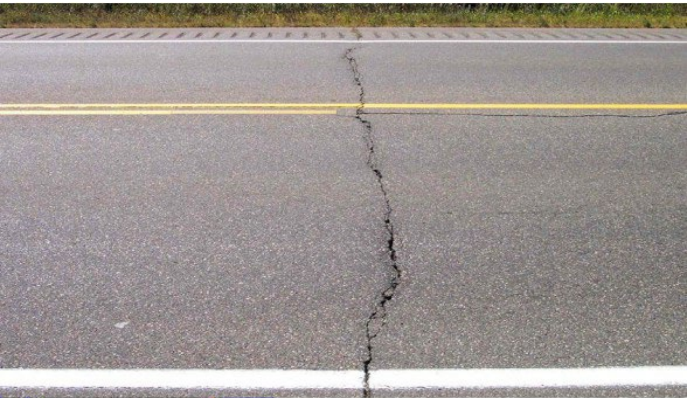
<p>Longitudinal</p>	<p>Cracks parallel to flow of traffic. Often first signs of fatigue cracking and can lead to alligator cracking. Potentially caused by improper joint construction or location.</p>	 
<p>Transverse</p>	<p>Cracks perpendicular to flow of traffic, caused by shrinkage of hot mix asphalt surface in low temperatures.</p>

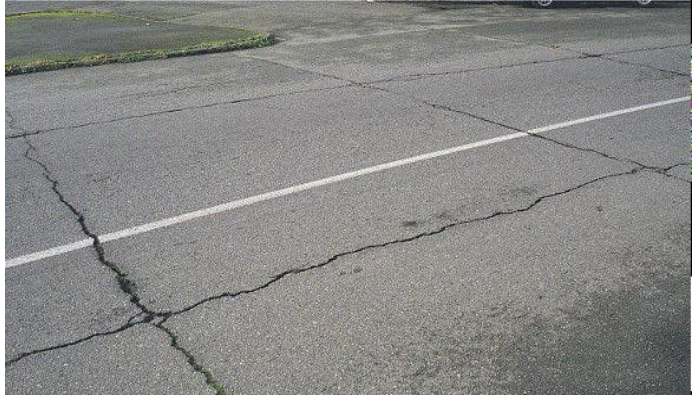
<p>Edge Crack</p>	<p>Longitudinal cracks that develop within 1-2 feet of outer edge of pavement, Potential causes include lack of support at pavement edge, poor drainage conditions, or heavy vegetation along pavement edge.</p>

<p>Joint Reflection</p>	<p>Cracks in flexible overlay of rigid pavement, that occur directly over rigid pavement joints.</p>

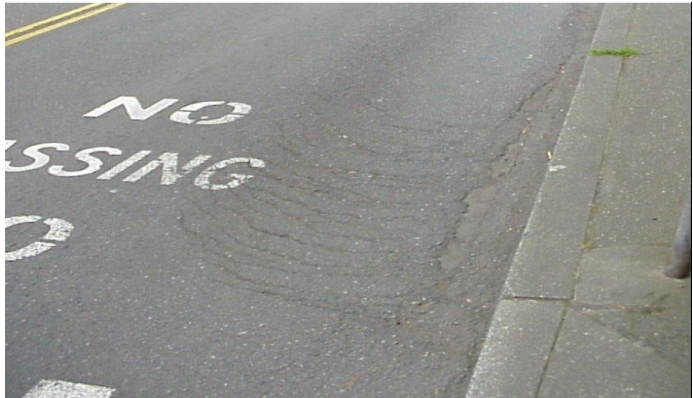
<p>Slippage Cracks</p>	<p>Arc-shaped cracks pointed in direction of traffic, caused by braking/turning wheels sliding over low-strength surface mix or poor bonding between first and second layer of pavement</p>
