# Asbestos Locations

ORIGINAL BUILDING 1959

# CT DEEP Regulated PCB Containing Materials

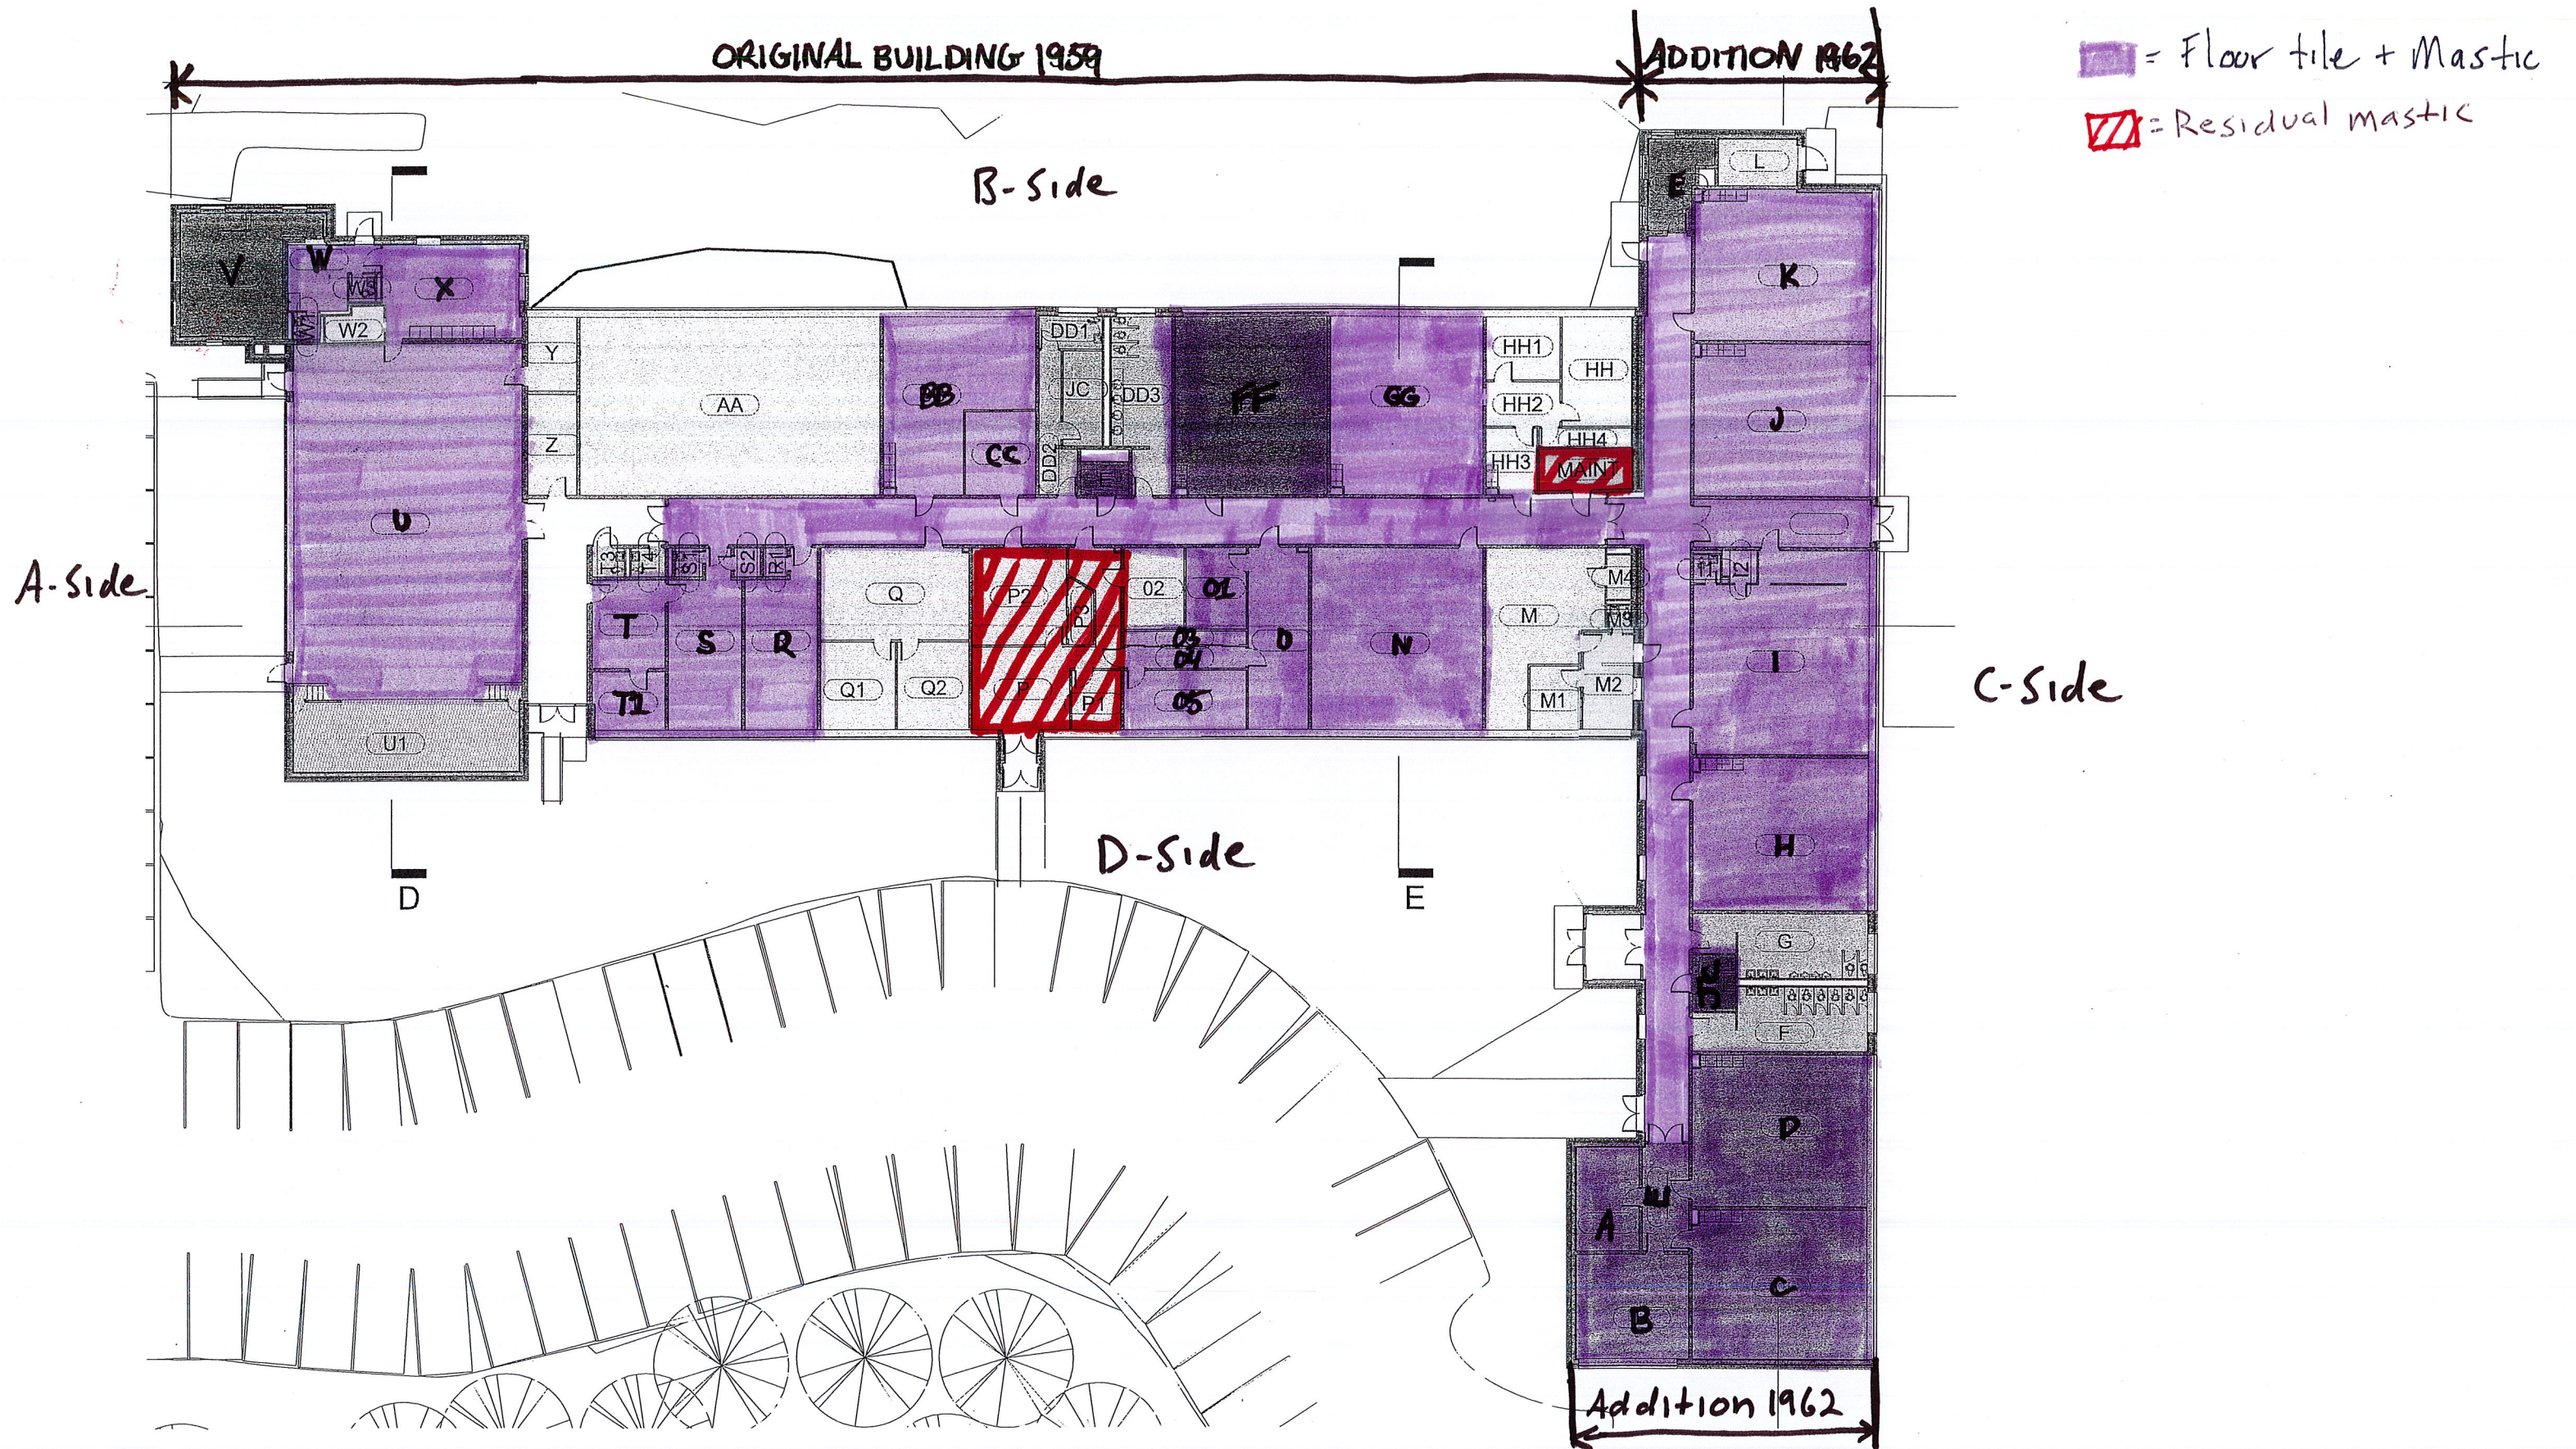
Assume "Destructor"  
and Electrical on/off switches  
ADDITION 1962

- \* = C2 at top of Wall
- ⊗ = C2 in Expansion Joints
- ⊗ = DWG 1,2,4
- ⊗ = LP1
- ▧ = GD1
- = Assumed buried Pipe insulation
- ▭ = BB1 blackboard glue Dubs
- ▭ = BBG-1 Brown Bulletin Board glue

Note:  
Asbestos Pipe Insulations (PI1, PI2) and associated mudded fittings (MF1) are not shown on the Drawing. They are present above ceilings, in wet walls and chases throughout the 1959 Wing.

\* = C2 is also CT DEEP PCB
